CONDITION ASSESSMENT REPORT

## IVY SUBSTATION

9070 Venice Boulevard, Culver City, California

December 21, 2017

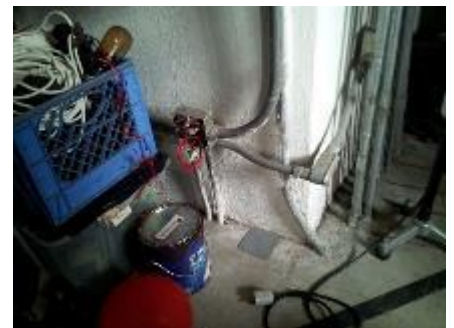
E-14: Open junction box in utility room

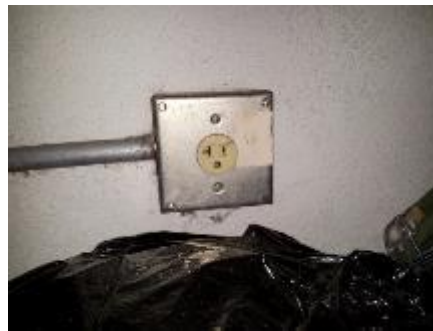
E-16: Old outlet in costume room

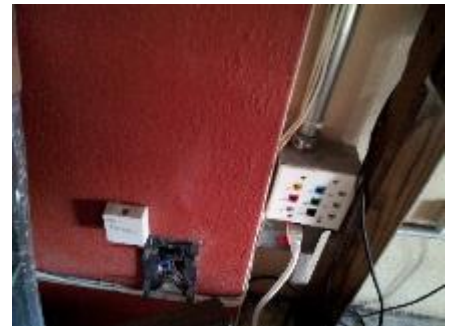
E-22: Open junction box in 2<sup>nd</sup> floor office

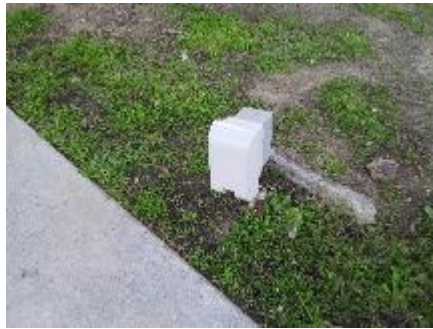
E-30: GFCI outlet near entrance not working

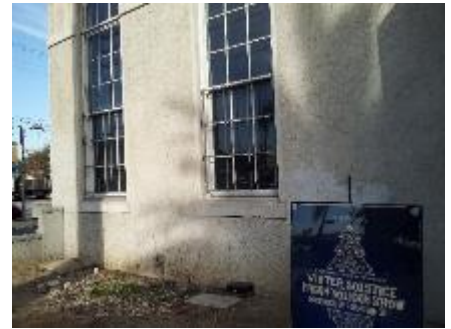
E-31: GFCI outlet on exterior wall not in good working condition

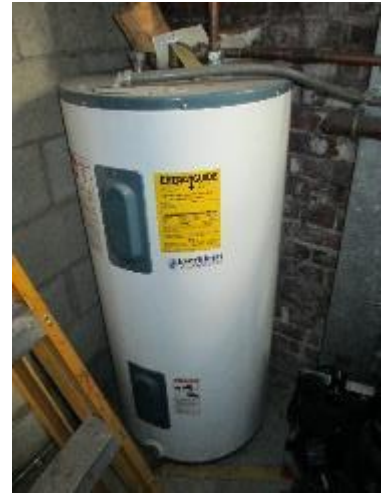
P-2: Existing water heater will have seismic bracing

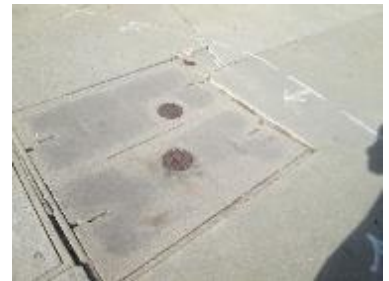
P-4: Structural damage to vault

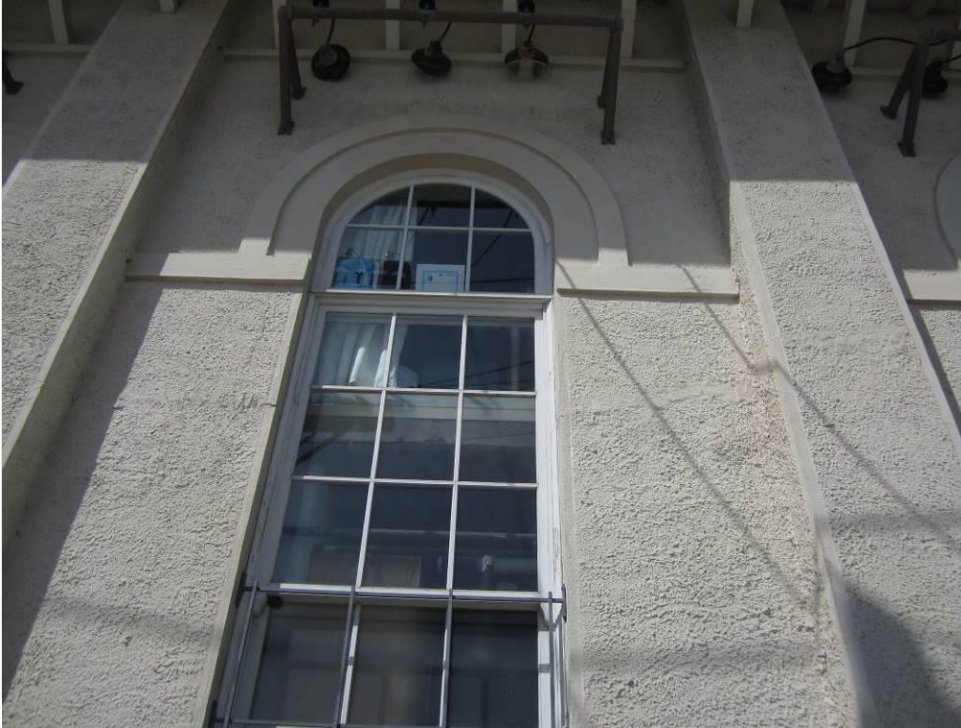
Photo 5 – Exterior cement plaster wall – Note previously patched crack aligned with the mezzanine floor level.

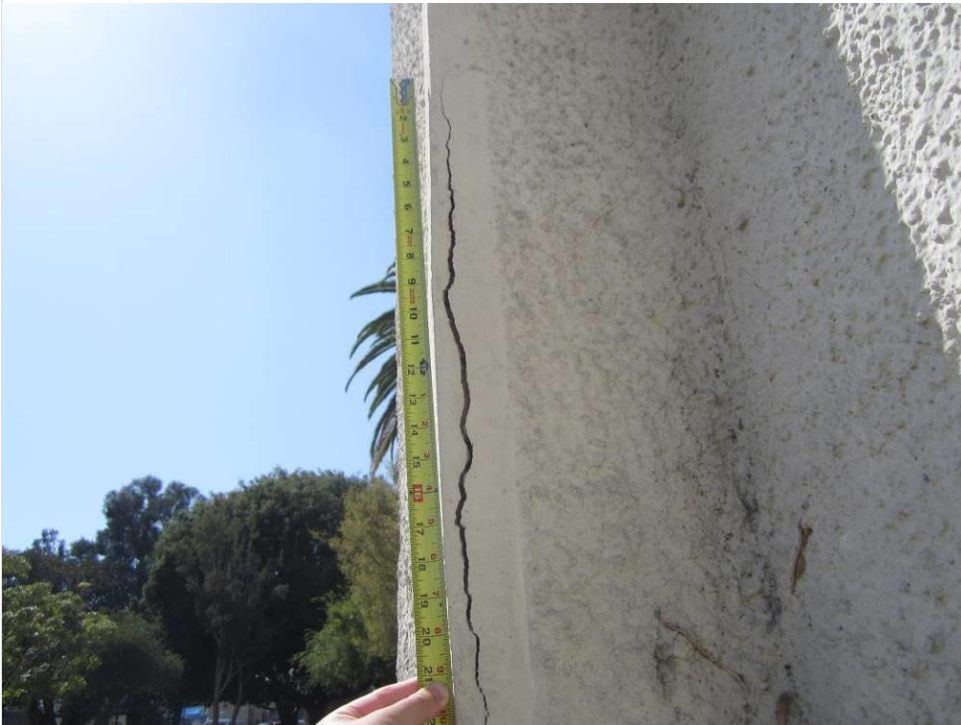
Photo 6 – Vertical crack in existing cement plaster wall.

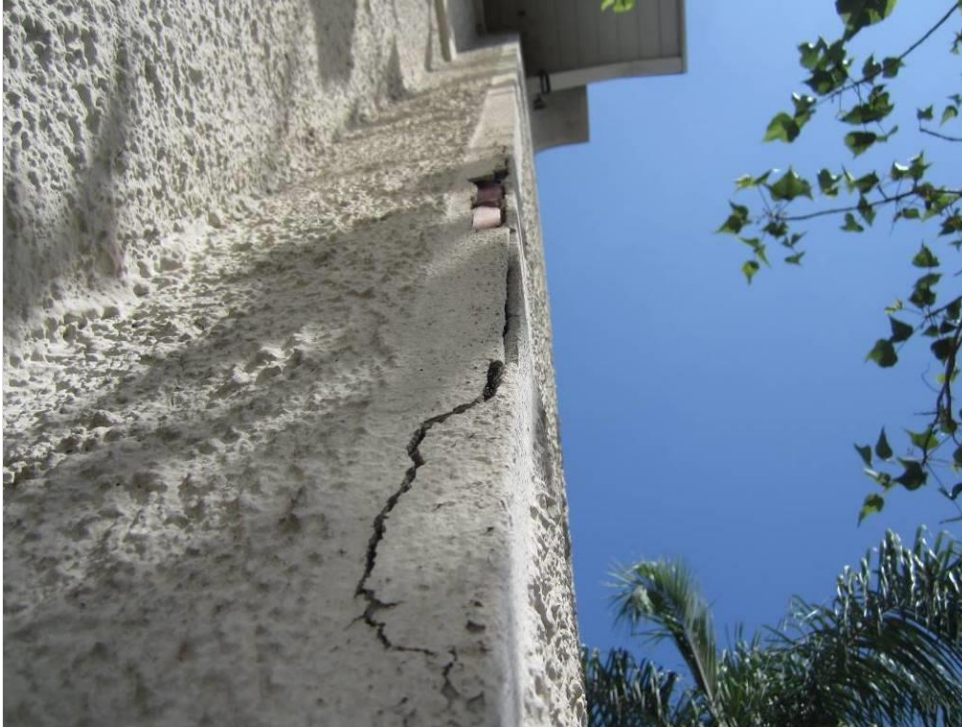
Photo 7 – Vertical crack leading to exposed brick masonry.

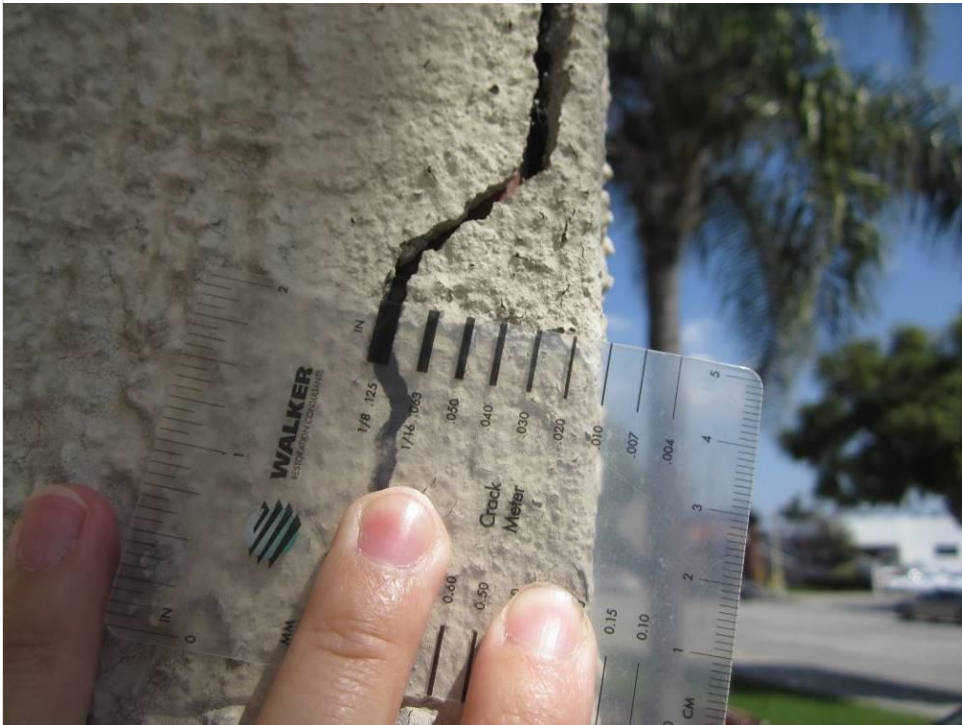
Photo 8 – Width of vertical crack measures 1/8 inch in width.

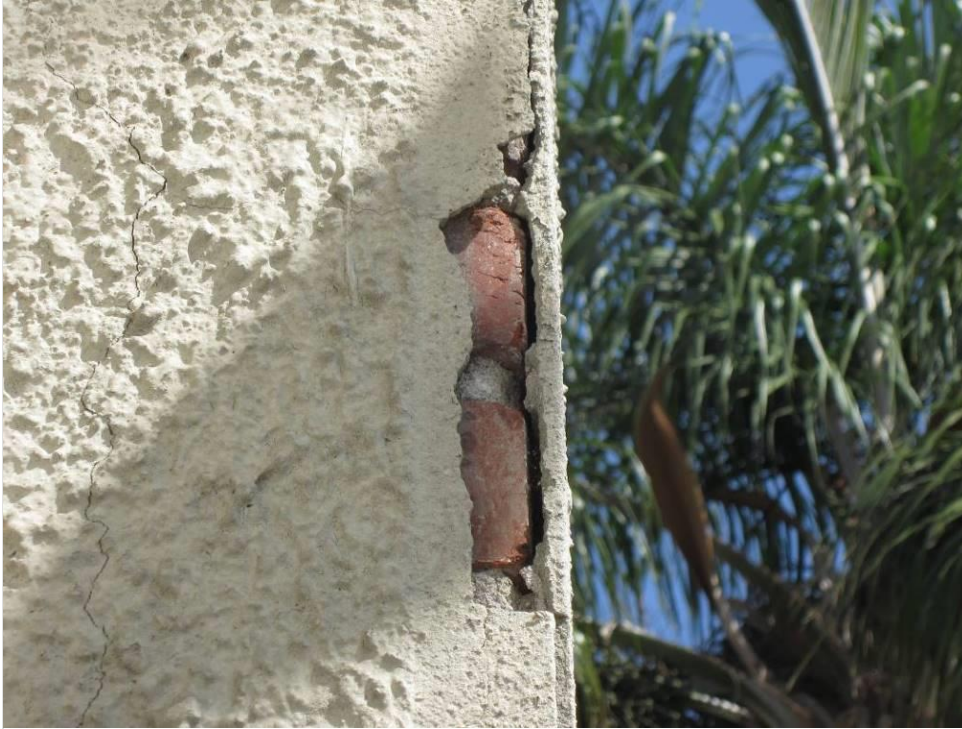
The existing cement plaster has spalled off and the brick masonry was exposed at one (1) east end location of the South Façade. The plaster measured to be approximately 3/16" thick. The mortar joints of the brick wall did not appear to be in good condition. We recommend that the joints be repointed at the locations where existing plaster is removed for replacement. New cracks have also formed in the cement plaster that require repair and sealing if the plaster is to remain in some locations. A previously patched horizontal crack approximately 12'-0" above grade runs the length of the building along the South Façade. This continuous crack is aligned with the Second Floor mezzanine level on the interior of the building. The concrete slab of the mezzanine level is visible through the window glazing. We recommend that this crack be further reviewed at the brick masonry wall level after the delaminated plaster is removed from the exterior.

Photo 9 – Exposed brick masonry and mortar joints behind cement plaster.

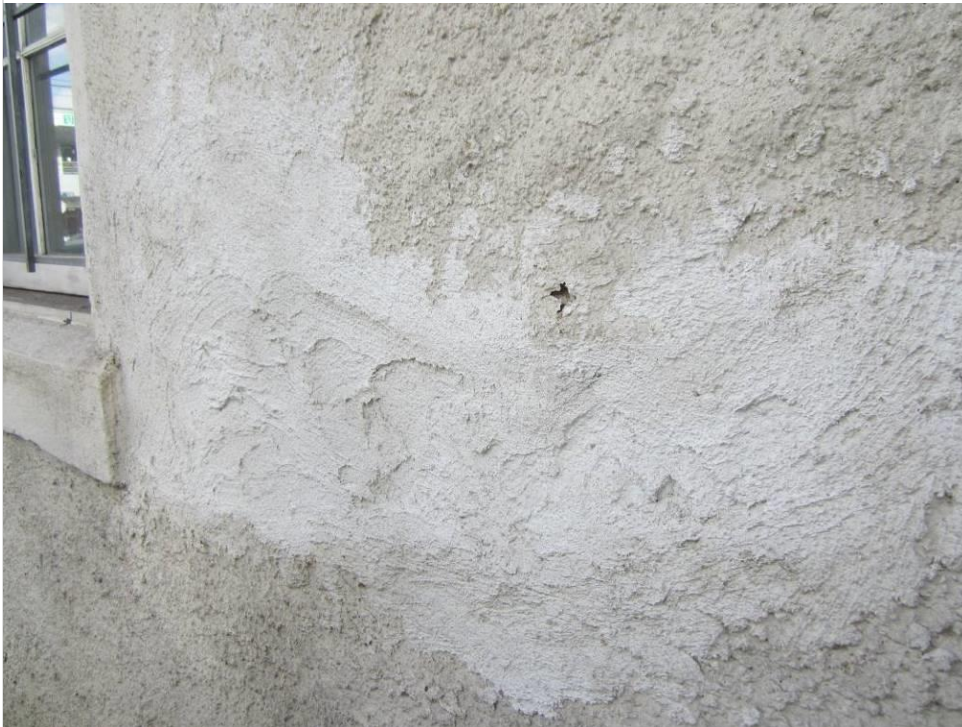
Photo 10 – Previously patched cement plaster wall area.

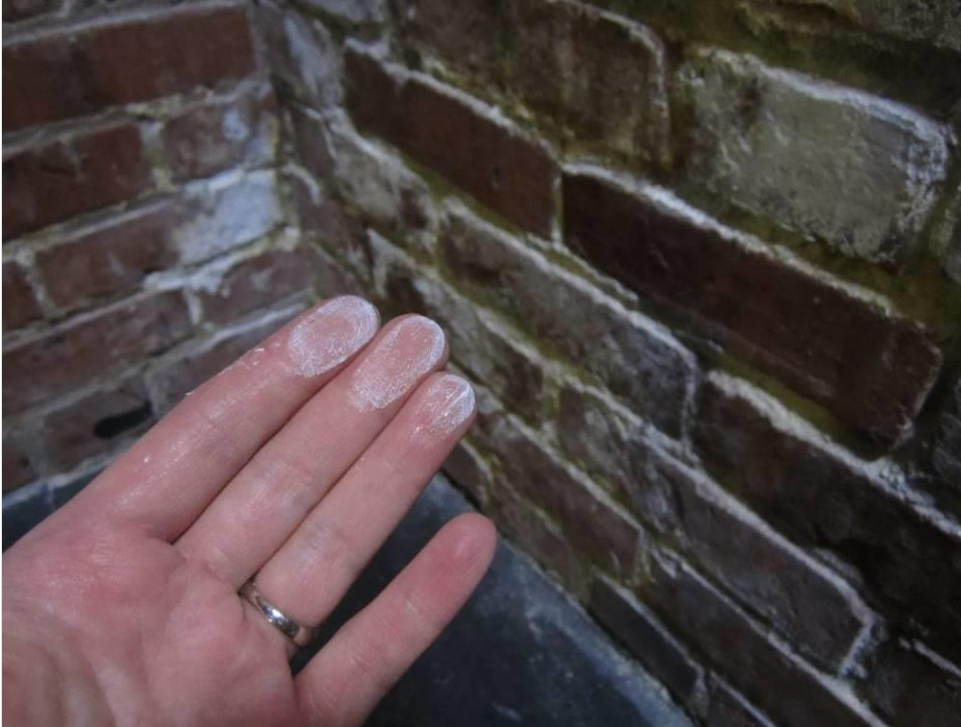
The presence of water intrusion through the exterior walls is further evidenced by the efflorescence that was observed at the interior side of the walls. Cracks in the brick masonry units and mortar joints were observed. We recommend that the cracks and joints be repaired. The brick units appear to be in fair condition and were spot checked throughout the interior of the building where they were visible and not concealed by interior finishes or stored equipment. At some of the previous brick masonry repair locations, mortar patching material or grout appears to have seeped in through the vertical joints and into the building interior. It is possible that the material was installed from the exterior side of the wall and was too viscous at the time of installation. The most notable example of this is located at the upper level of the West Façade interior, where extensive cracking was noted in the cement plaster according to the previous remediation drawings.

Photo 11 – Efflorescence at interior brick masonry wall.

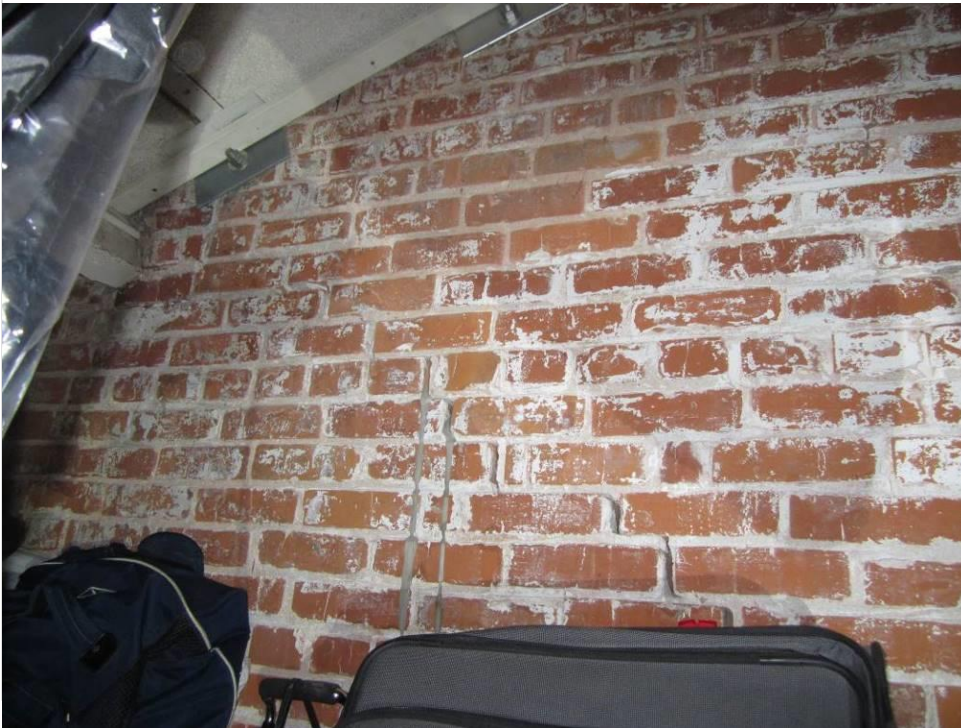
Photo 12 – Separation in brick masonry units and patching material or grout that has seeped into the interior of the building.

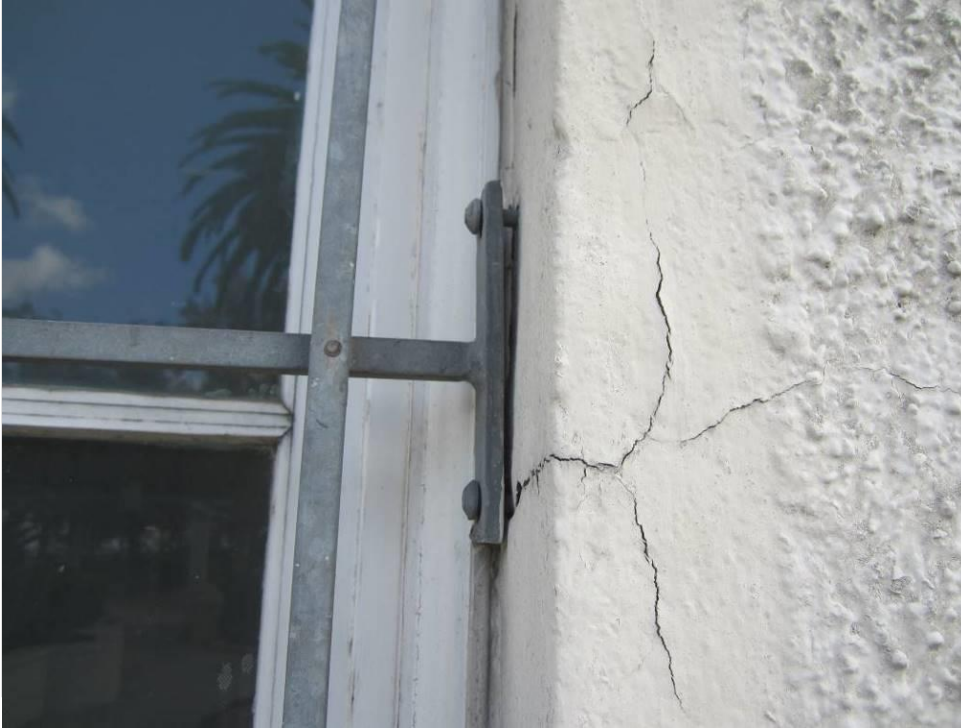
Metal security bars have been installed over the bottom portion of the existing windows. The bars are anchored and fastened through the cement plaster walls. Walker recommends that sealant be applied at each of these connection points in order to prevent water intrusion.

Photo 13 – Cracks in cement plaster along window jamb. Note that window security bar anchors are not sealed.

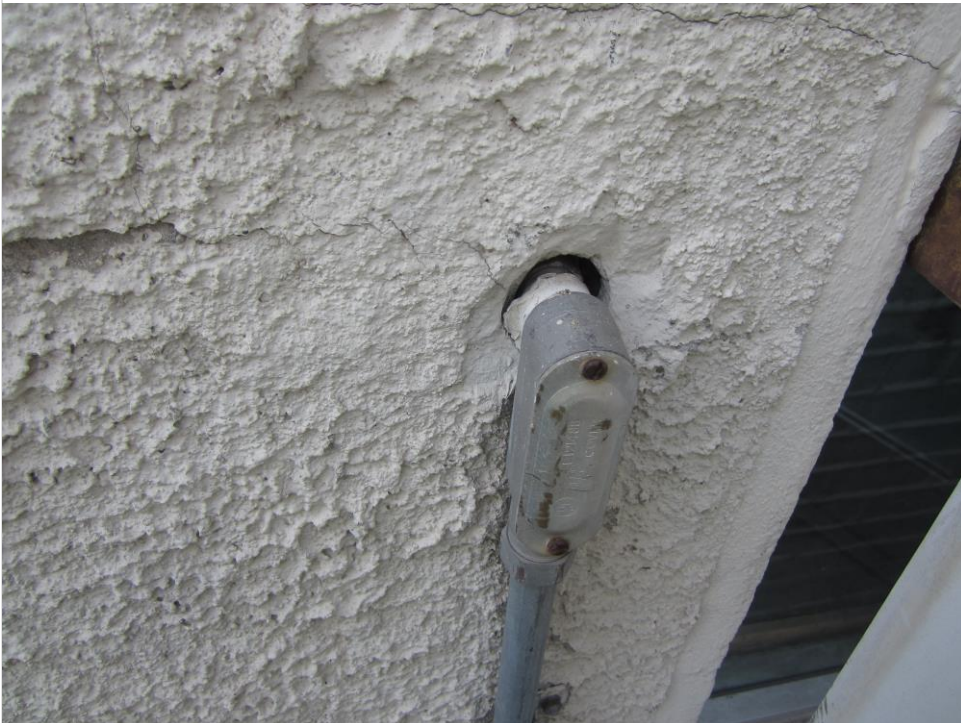
Walker observed that the exterior wall penetrations are generally not sealed and are likely contributing to water intrusion and the delamination of the plaster. This includes the interfaces where the utility lines connect to the building, at the diagonal wood struts that support the roof eaves, where the window security bars are anchored to the walls, and at other miscellaneous penetrations. In addition to this, a continuous gap was visible at the wall-to-roof interface along the North and South Façades. We recommend that this be sealed, especially at the large gaps located at the ends of the walls where they meet the West and East Façade parapet walls.

Photo 14 – Wall penetration is not sealed.

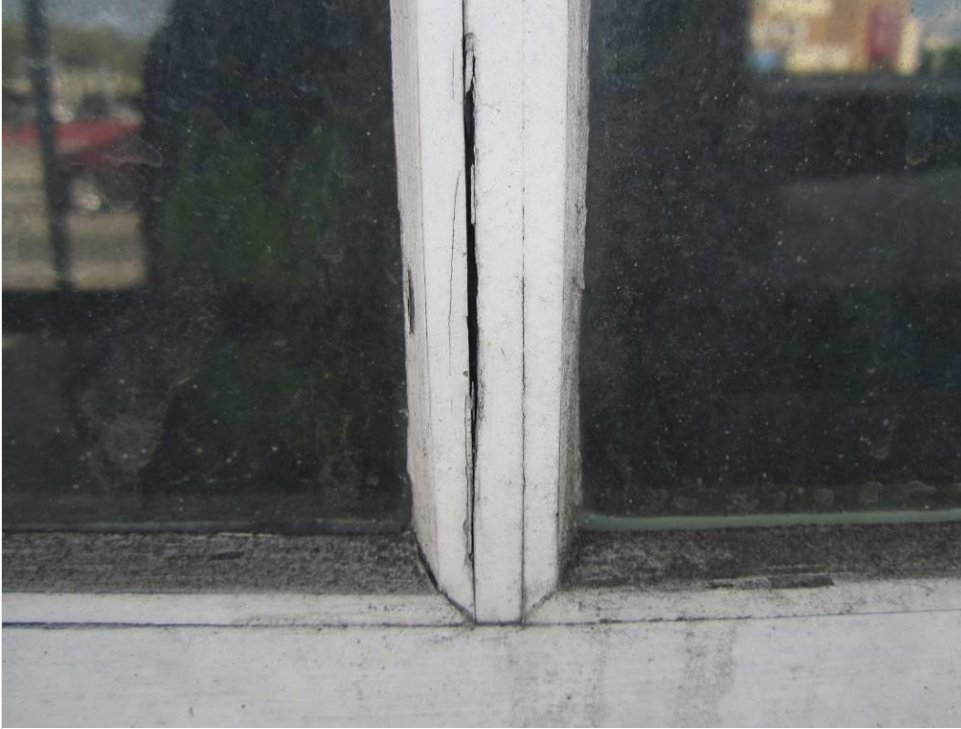
Photo 15 – Wood window muntin needs repair.

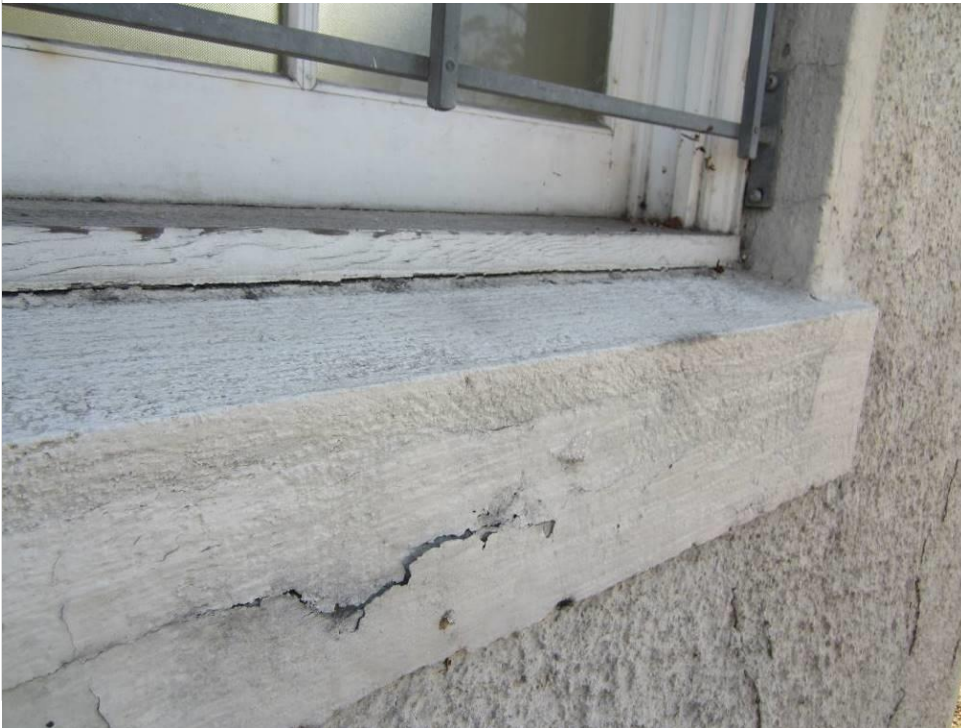
Repair and possible replacement of some of the wood window sills will be needed. Multiple cracks or splits in the wood was observed since the paint coating is deteriorated and is no longer providing adequate coverage or protection in some locations. New paint coating is also recommended at the wood sills. There are smooth concrete ledgers directly below the wood sills. Walker observed some cracks in the ledgers that will need to be repaired. New elastomeric coating is recommended over the concrete ledgers.

Photo 16 – Wood window sill and concrete ledger with crack in paint coating. Note that the joint between the wood sill and ledger is not sealed.

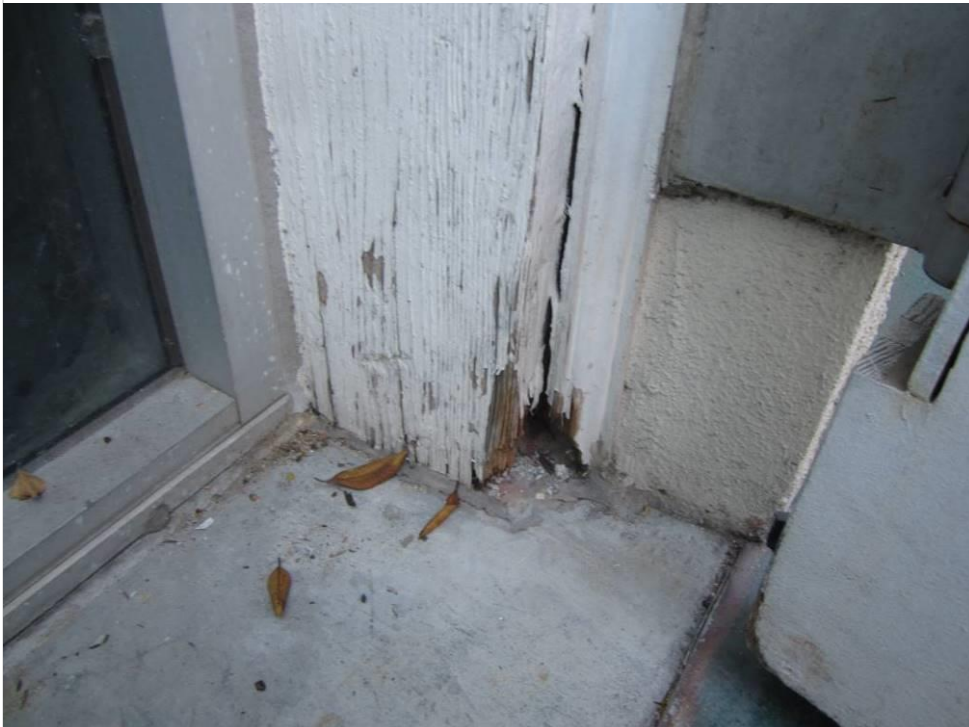
The large wooden doors or gates at the West and East Façade are exhibiting signs of minor wood decay. Wood splits and were observed at the top and bottom of the doors, as well as at the base of the wood door frame. The existing paint coating is deteriorated at some locations, and previously installed sealant is visible at some of the joints. Walker recommends that new paint coating be applied over the doors and frames, and that the joints that are susceptible to water entry be caulked. Sheet metal flashing is recommended over the top of the doors in order to protect the leading edge of the wood from further splitting or accelerated decay.

Photo 18 – Wood decay at the base of the wood door frames.

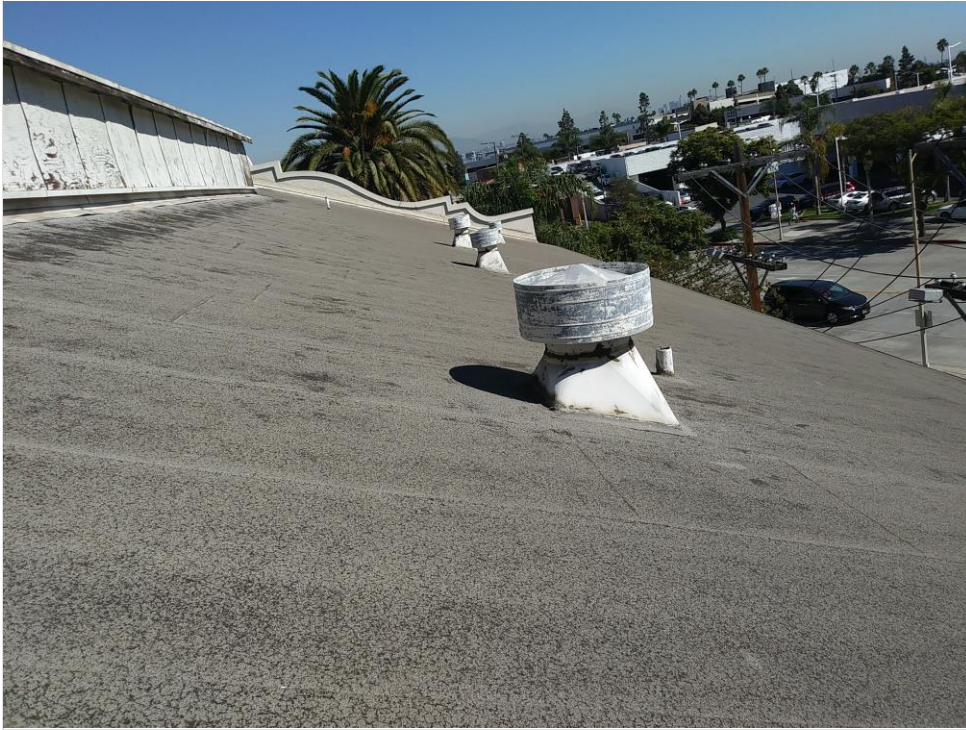
Vent penetrations and vent stacks through the roof assembly were observed on the south side of the roof. The flashing appears to be in fair condition, and may or may not need to be replaced as part of the reroofing.

Photo 21 – Existing roofing membrane and vent penetrations.

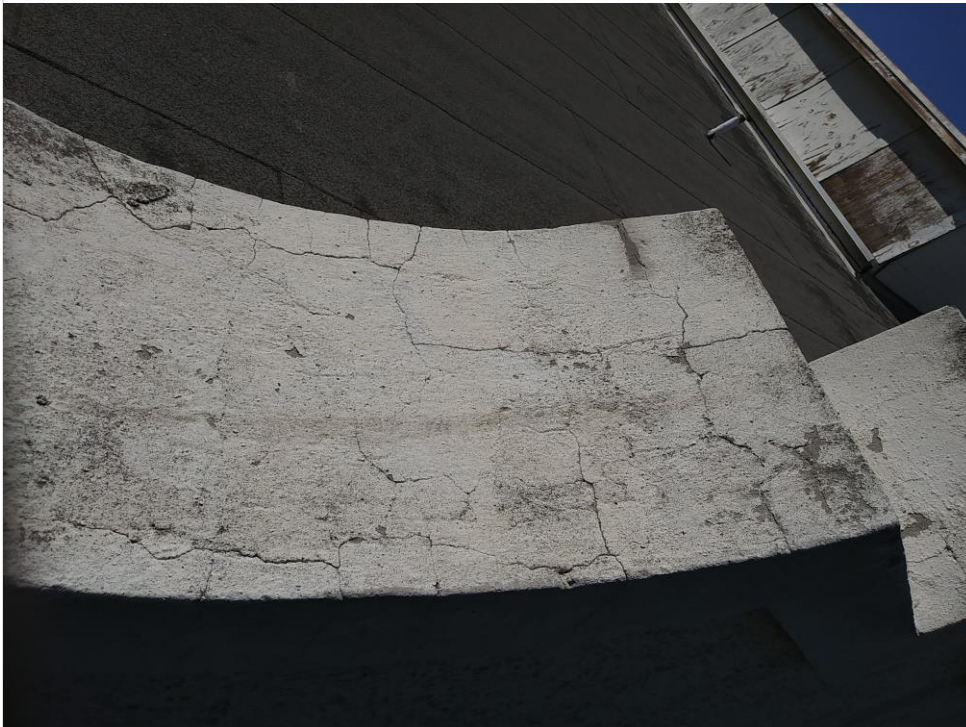
Photo 22 – Cracks at top of parapet wall.

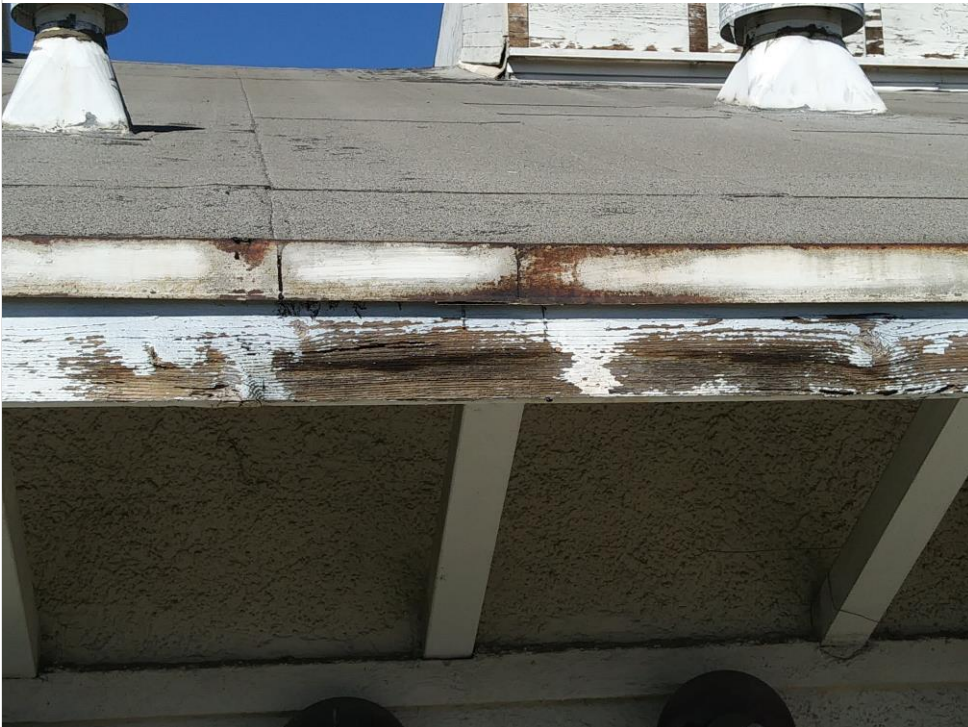
Photo 24 – Deteriorated wood fascia board and corroded edge flashing at roof eave.

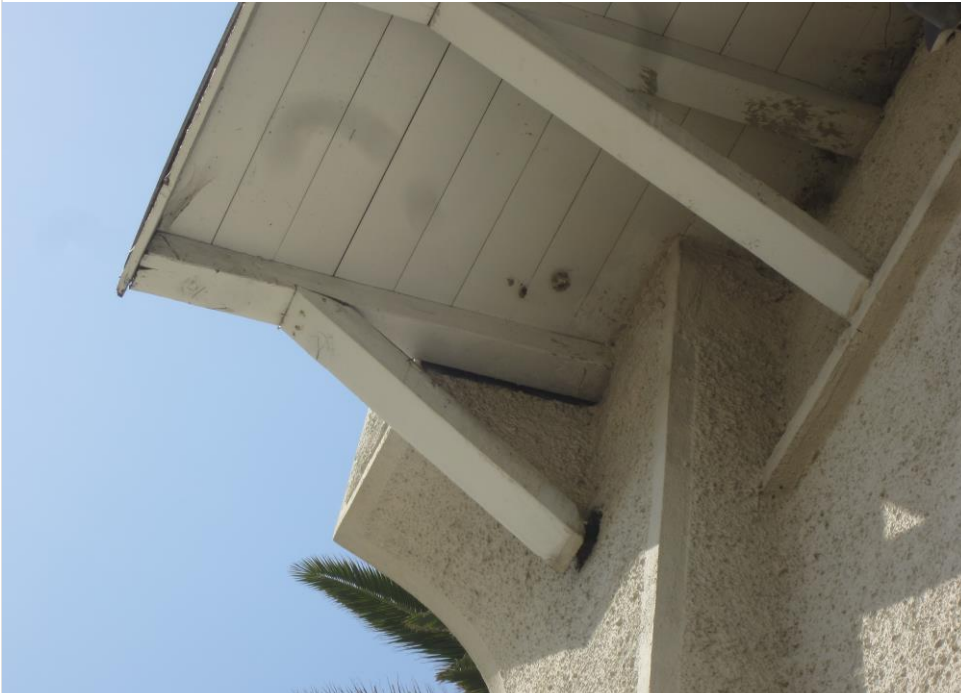
Photo 26 – Diagonal wood strut needs to be reattached to the wall. Gap between the wall and roof interface needs to be sealed.

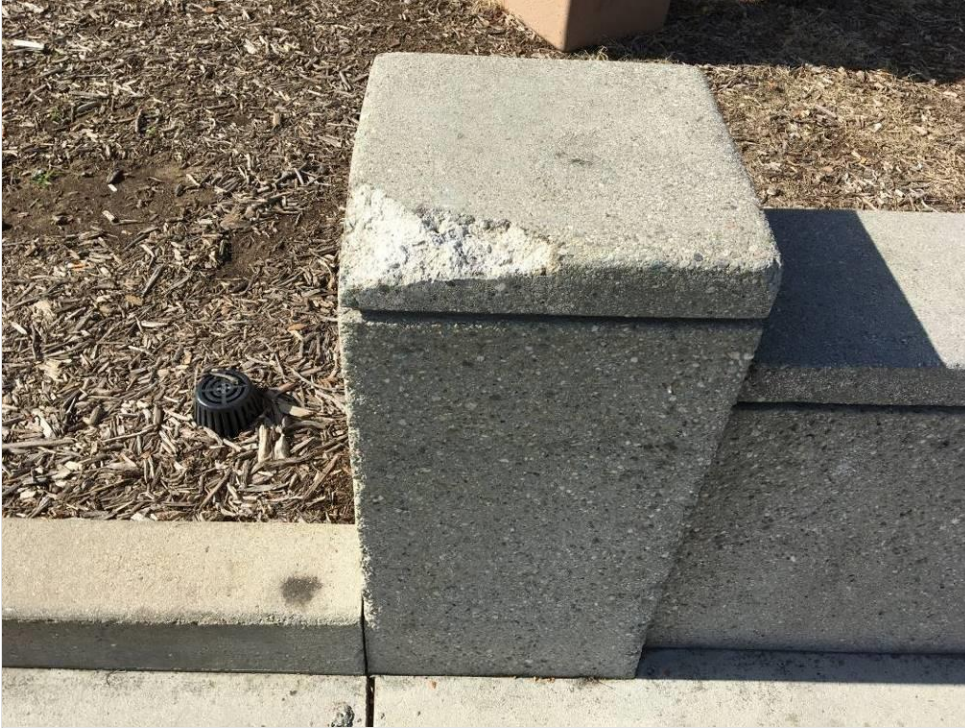
cracking or spalling of the concrete. A few spalled locations were observed near the southwest corner of the building and were probably a result of impact damage. These locations shall be patched.

Photo 31 – Spall at concrete landscape wall probably caused by impact damage.

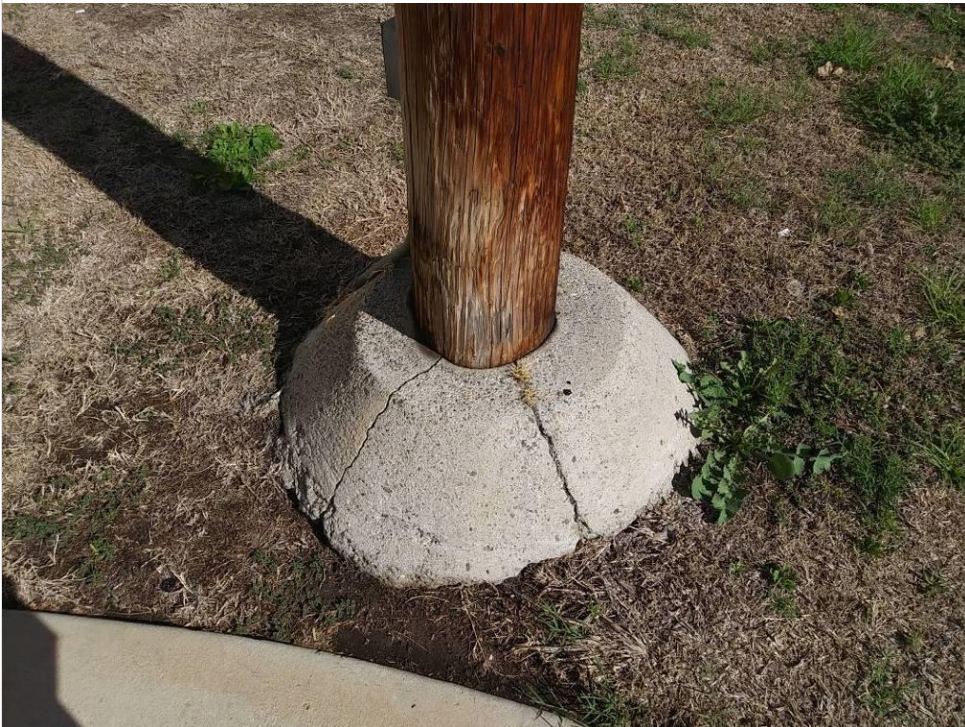
The existing wood power poles at the south side of the building have splits at the base of the poles, and the concrete foundation is cracked. The top cross-arms, electrical conductors, and insulators appear to be in fair condition. We recommend that the stability of each power pole be monitored and assessed.

Photo 32 – Existing wood power pole at south end of building. Note cracks in concrete foundation.
