CONDITION ASSESSMENT REPORT

## IVY SUBSTATION

9070 Venice Boulevard, Culver City, California

December 21, 2017

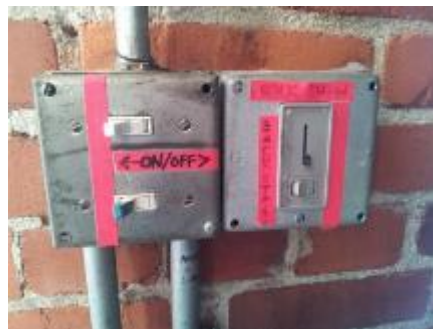
E-1: Light switches near front entrance

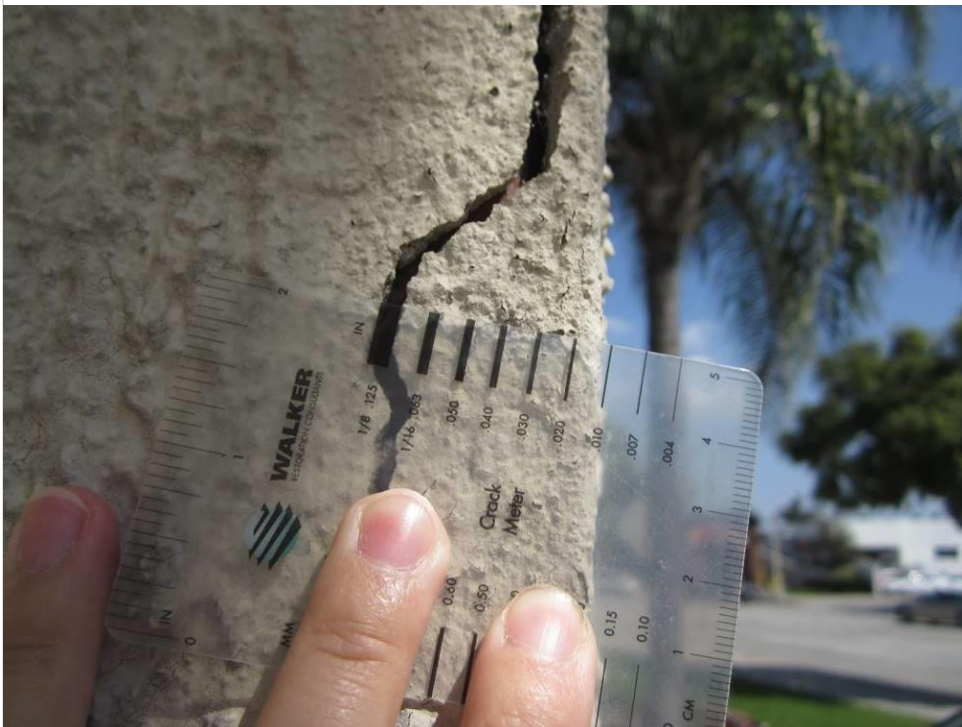
Photo 8 – Width of vertical crack measures 1/8 inch in width.

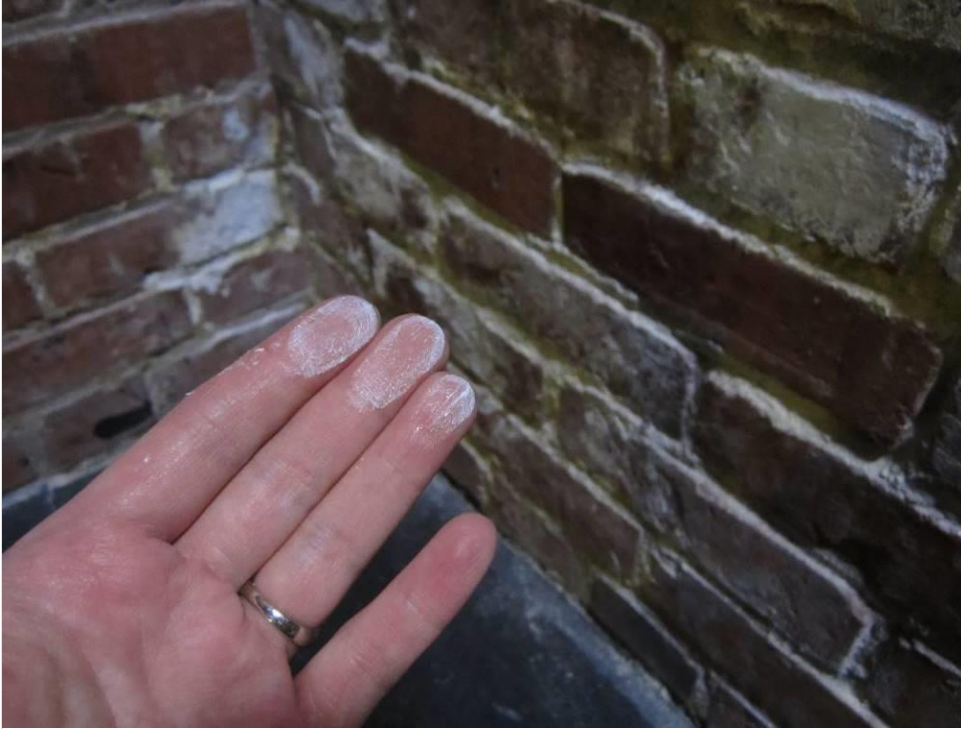
The presence of water intrusion through the exterior walls is further evidenced by the efflorescence that was observed at the interior side of the walls. Cracks in the brick masonry units and mortar joints were observed. We recommend that the cracks and joints be repaired. The brick units appear to be in fair condition and were spot checked throughout the interior of the building where they were visible and not concealed by interior finishes or stored equipment. At some of the previous brick masonry repair locations, mortar patching material or grout appears to have seeped in through the vertical joints and into the building interior. It is possible that the material was installed from the exterior side of the wall and was too viscous at the time of installation. The most notable example of this is located at the upper level of the West Façade interior, where extensive cracking was noted in the cement plaster according to the previous remediation drawings.

Photo 11 – Efflorescence at interior brick masonry wall.

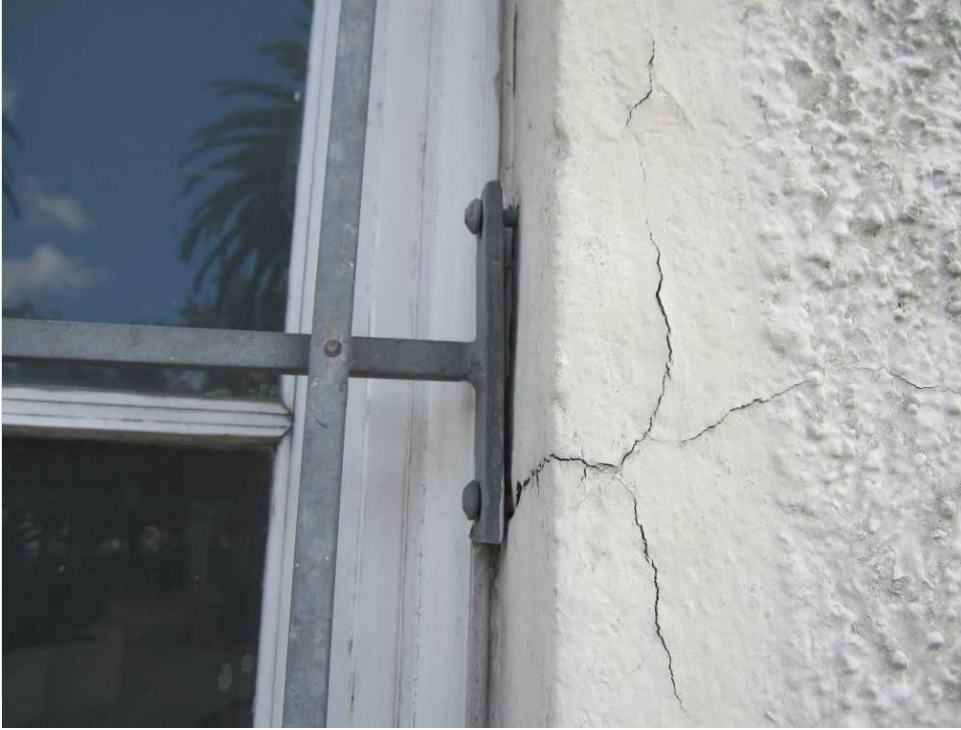
Metal security bars have been installed over the bottom portion of the existing windows. The bars are anchored and fastened through the cement plaster walls. Walker recommends that sealant be applied at each of these connection points in order to prevent water intrusion.

Photo 13 – Cracks in cement plaster along window jamb. Note that window security bar anchors are not sealed.

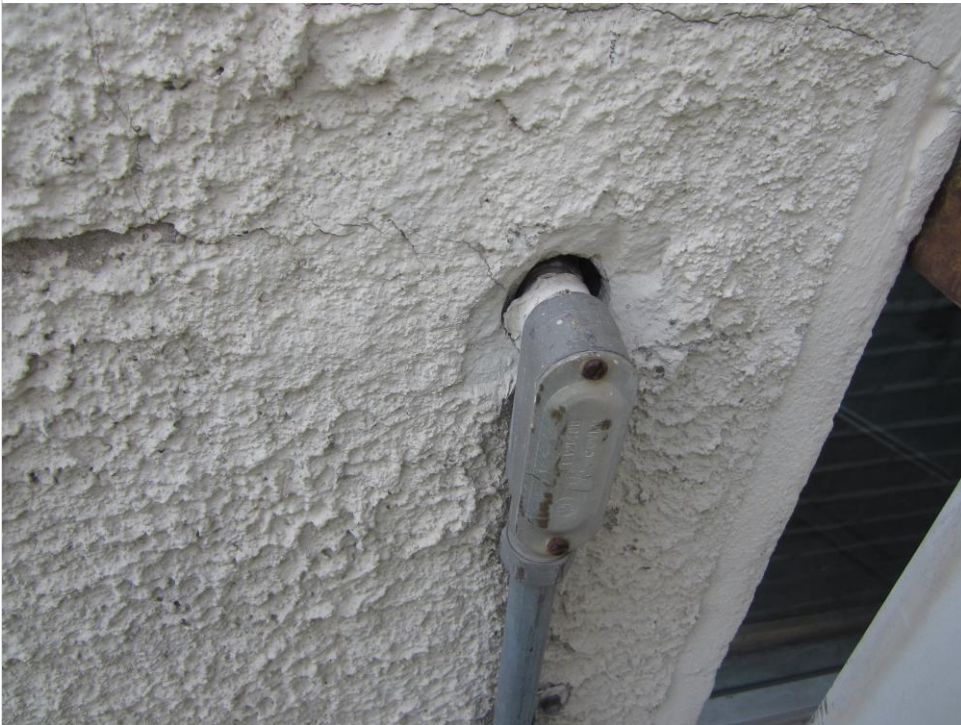
Walker observed that the exterior wall penetrations are generally not sealed and are likely contributing to water intrusion and the delamination of the plaster. This includes the interfaces where the utility lines connect to the building, at the diagonal wood struts that support the roof eaves, where the window security bars are anchored to the walls, and at other miscellaneous penetrations. In addition to this, a continuous gap was visible at the wall-to-roof interface along the North and South Façades. We recommend that this be sealed, especially at the large gaps located at the ends of the walls where they meet the West and East Façade parapet walls.

Photo 14 – Wall penetration is not sealed.

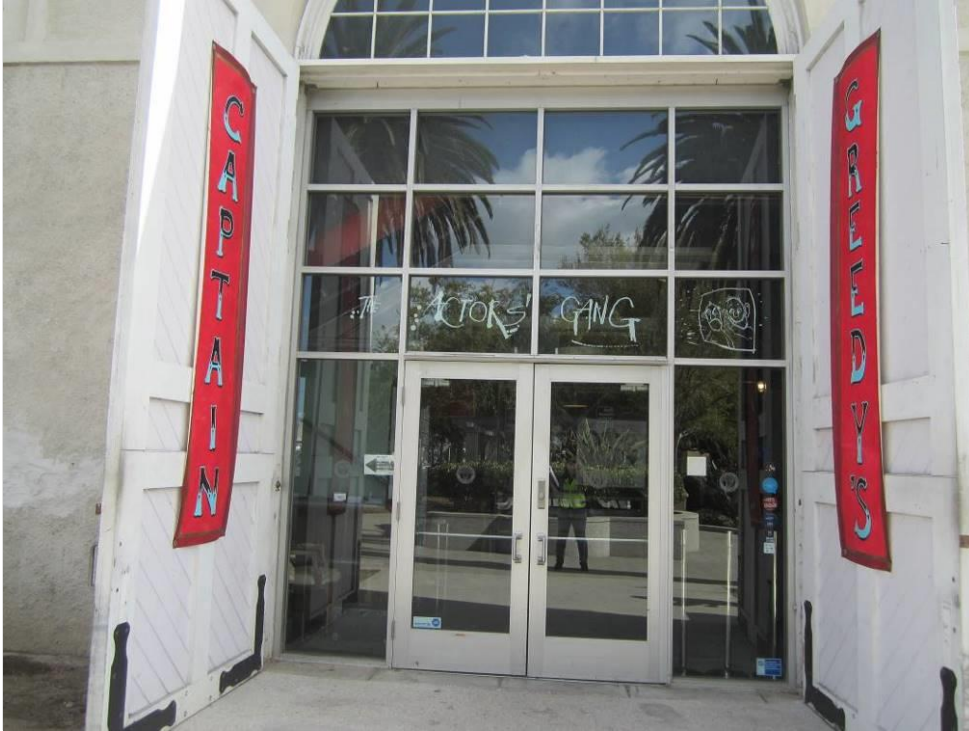
Glazed aluminum storefront systems were installed at the West and East Façade entries as part of the previous remediation project. The perimeter of the storefront is sealed. Both sets of double doors are vertically misaligned by approximately 3/8", which has resulted in operability issues in the past. Realignment and rebalancing of these doors are recommended.

Photo 17 – Wood entry doors and aluminum storefront system at West Façade.

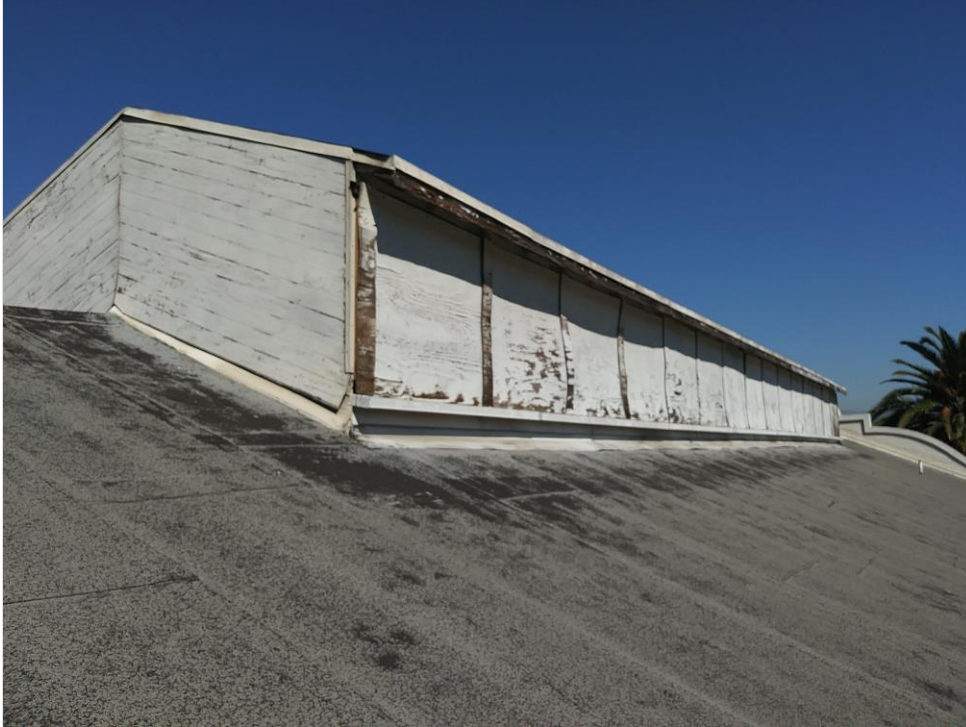
The existing roofing is a built-up system with a granulated cap sheet. According to the previous remediation drawings, the membrane was replaced in the early 1990s. The age of the roof is now approximately twenty-five (25) years old. The membrane at the southern half of the roof is in poor condition and loss of granules in the cap sheet was observed, exposing the asphalt in the membrane sheets. A pattern of small cracks throughout the membrane sheets is visible, indicating the membrane is deteriorating from the ultra-violet (UV) exposure. The membrane at the northern half of the roof appeared to be in better condition, though a ring of vegetation staining from a nearby palm tree was visible. Based on our review and the age of the roof, Walker recommends that the existing membrane be replaced with a new multi-ply system.

Photo 19 – Existing roofing membrane and view of raised monitor roof from the west.

- Replace existing built-up roofing membrane system at the main roof and raised monitor roof.
- Install new sheet metal counterflashing at the parapet walls and at the base of the monitor roof. Replace existing sheet metal edge flashing along the edges of the roofs, including wood fascia boards.
- Remove and replace cement plaster system at the interior face of the parapet walls, as well as the cement plaster that wraps over top of the parapet walls. Provide slope at the top of the walls and install new elastomeric coating system over the plaster.
- Remove existing plywood at raised monitor roof in order to review condition of clerestory windows.
- Reattach diagonal wood struts at roof eaves along the north and south ends of the building.
- Replace existing wood truss members if they are split along more than half the length of the member.

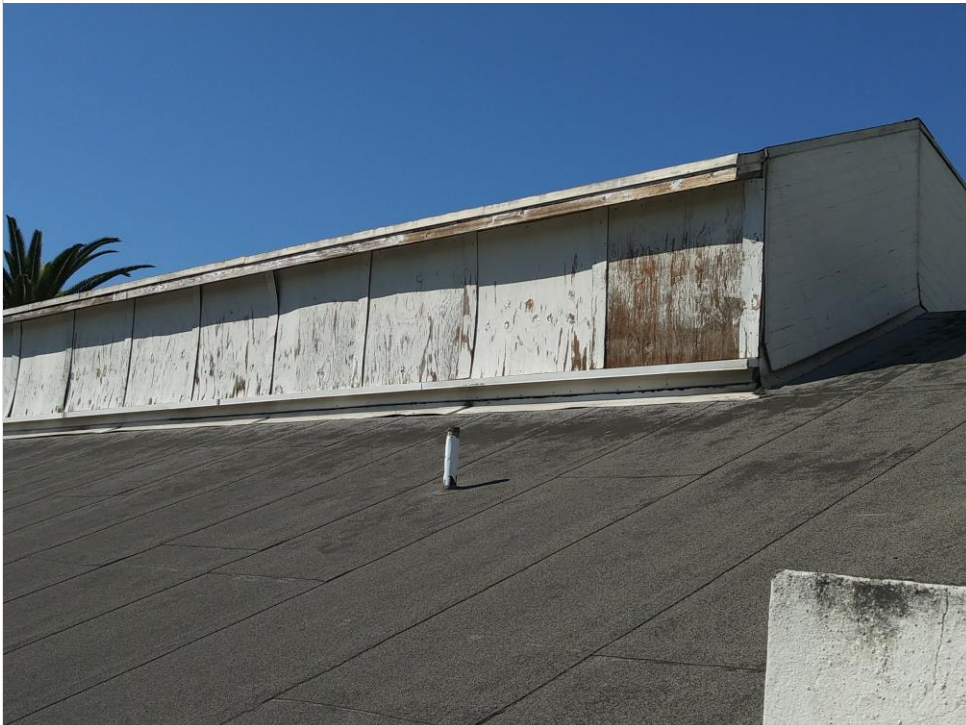
The raised monitor roof at the center of the main gable roof was visually reviewed from the boom lift. A layer of plywood has been installed over the rows of clerestory windows that are located along the North South side of the roof. In order for the condition of the windows to be assessed, the plywood would need to be removed. Currently, the plywood is extremely weathered and is splitting, and the paint coating is deteriorated. The plywood is bowing at the base where it meets the main gable roof. Walker was able to see the sheet metal edge flashing at the perimeter of the monitor roof above the windows. Similar to the main gable roof, we recommend that this edge flashing be replaced.

Photo 20 – Existing roofing membrane and view of raised monitor roof from the east.

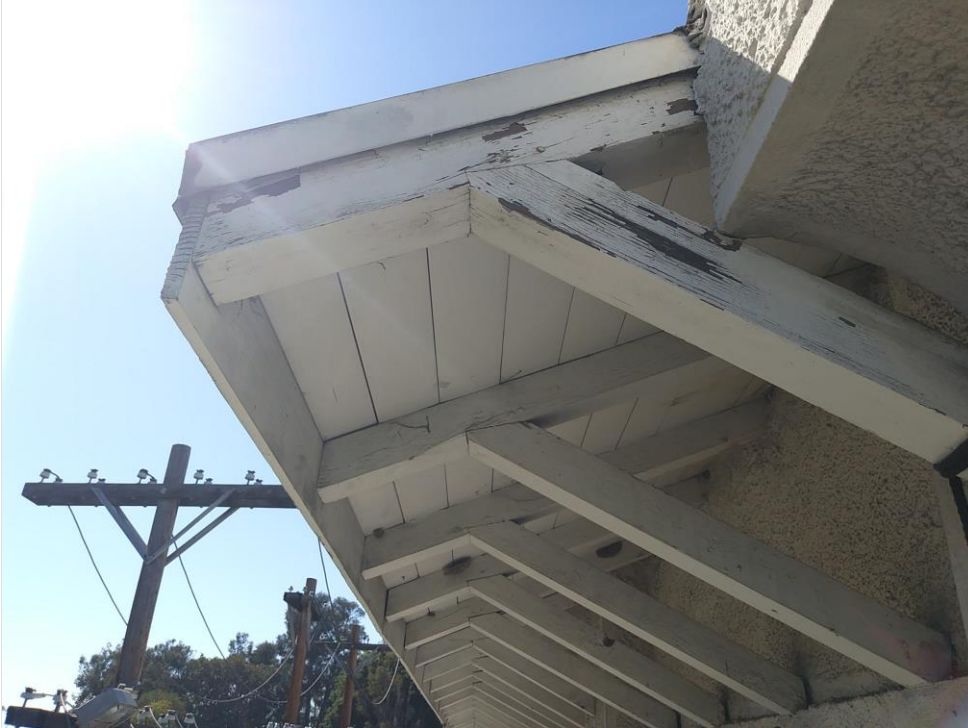
Walker reviewed the wood rafters and decking boards that are exposed at the underside of the roof eaves along the North and South Façades. They appear to be in fair condition and the paint coating is intact with the exception of the end rafters and diagonal wood struts. Some of the diagonal struts that are attached to the wall and extend to the underside of the eave appear to be separating from the wall and need to be reattached or possibly resized and replaced.

Photo 25 – Paint coating is worn at the edge rafters and diagonal struts that support the roof eave.

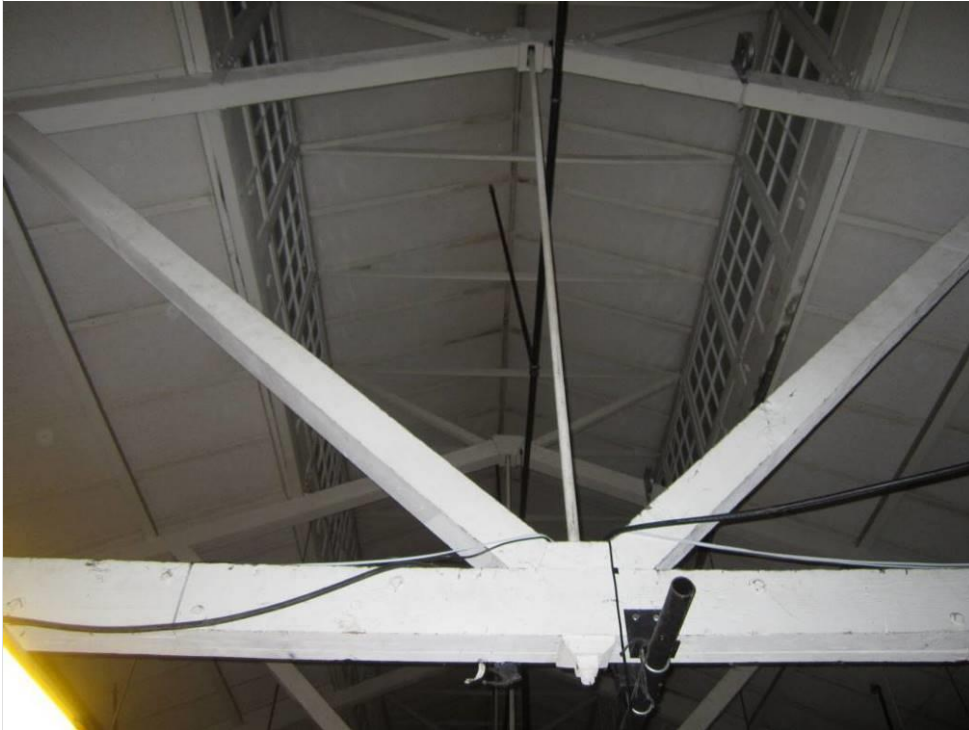
Photo 27 – Existing wood truss at the interior of the building.

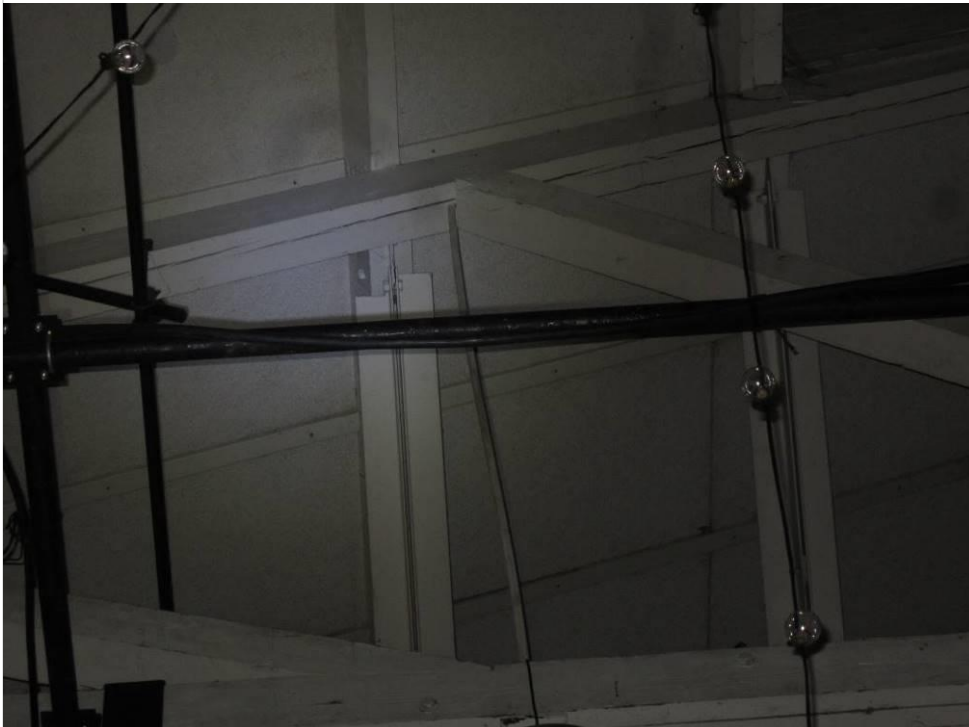
A visual review of the interior wood roof trusses was performed from the ground level. The trusses appeared to be in fair condition, with about twenty percent (20%) of the members exhibiting some sign of distress. Observed distresses include splits, including some locations that occurred along more than half the length of the member. Checks in the wood, knothole voids, and minor cracks were also observed. We recommend that the truss members be replaced in kind where they are split along more than half the length of the member.

Photo 28 – Split in wood truss member.
