BUILDING ENVELOPE
CONSULTING
FORENSIC RESTORATION
PARKING DESIGN
PLANNING

CONDITION ASSESSMENT REPORT

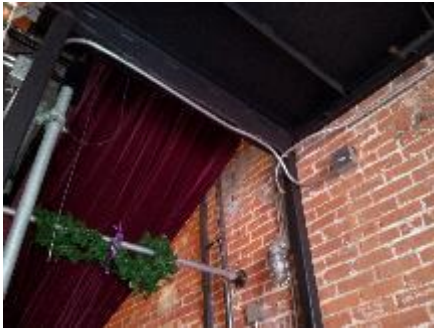
E-3: Vapor tight wall sconces found in both 1st and 2nd floors

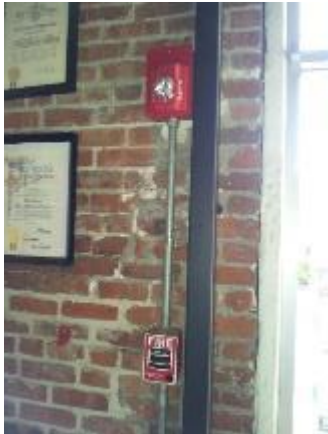
E-4: Fire alarm pull station and strobe

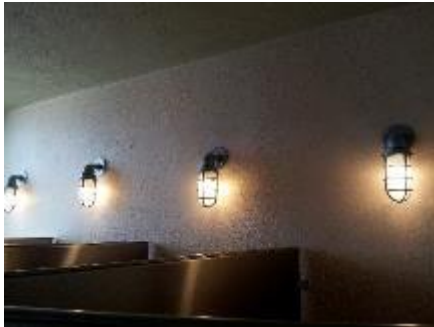
E-7: Vapor tight wall sconces found in both men's and women's restroom

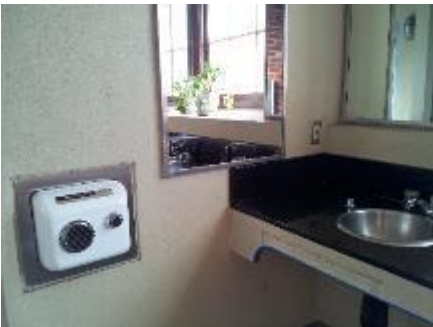
E-8: Hand dryer and GFCI in men's restroom

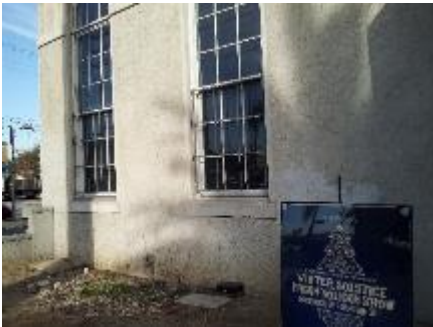
E-31: GFCI outlet on exterior wall not in good working condition

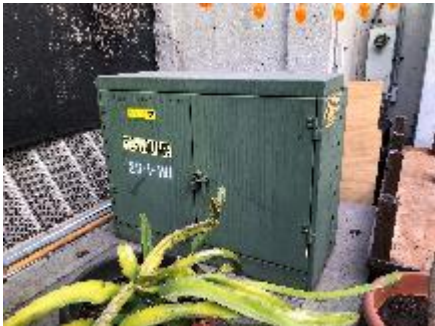
E-32: Utility Transformer

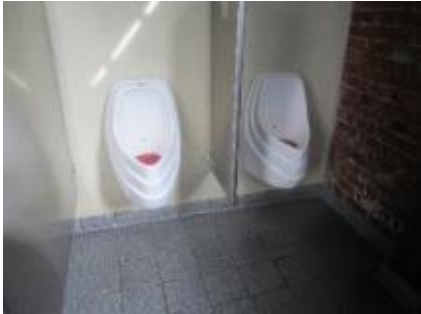
P-1: One urinal shall be ADA accessible

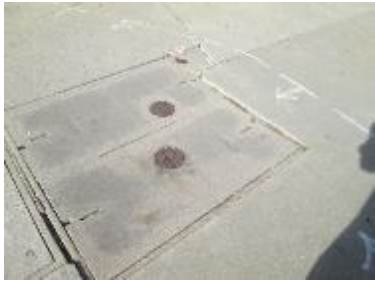
P-4: Structural damage to vault

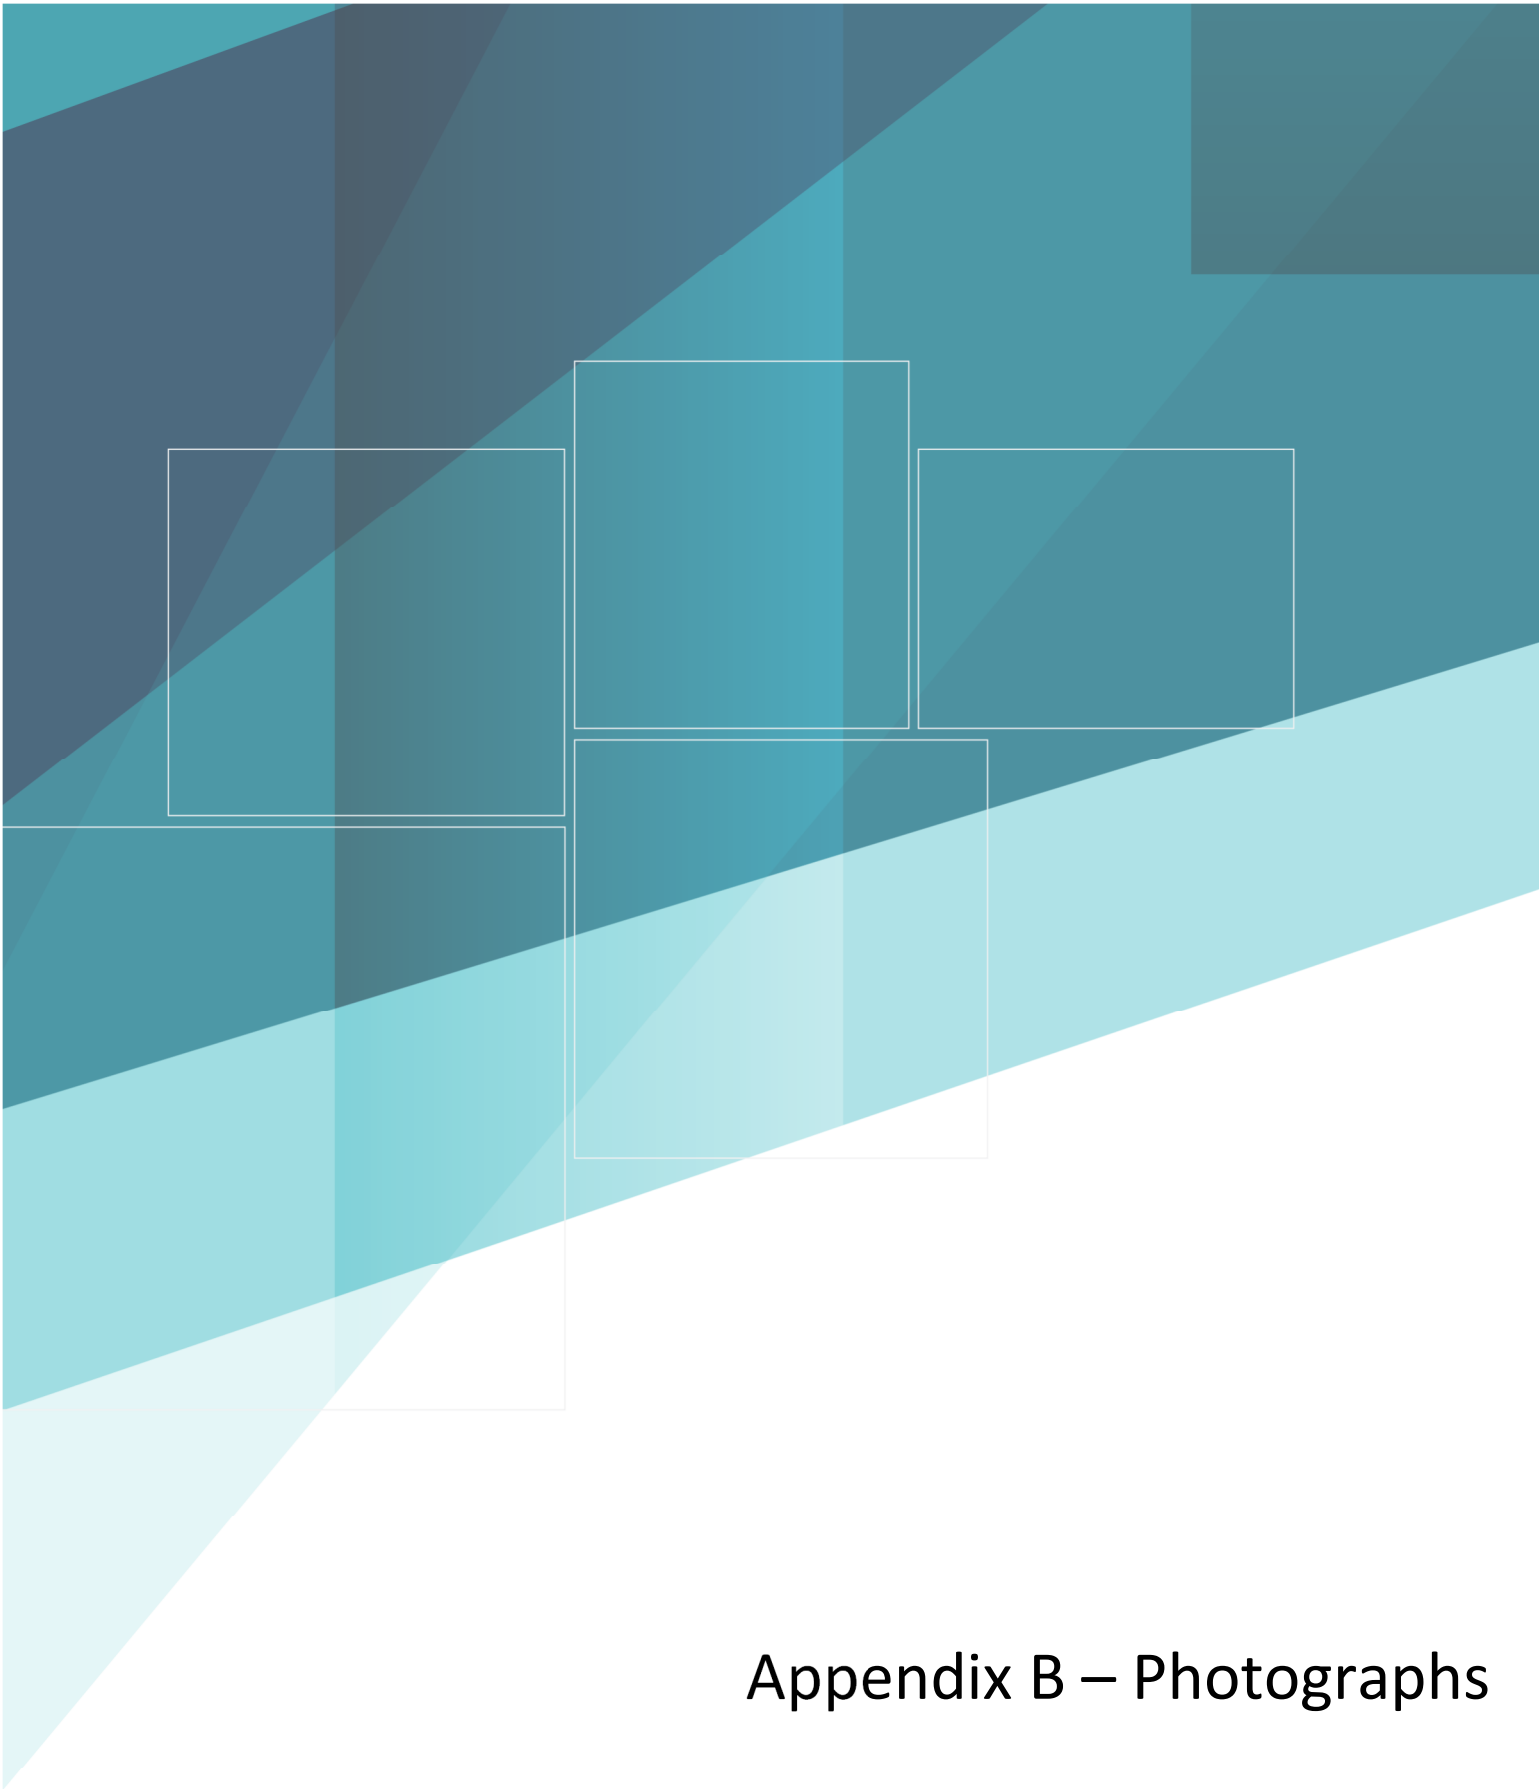
Appendix B – Photographs

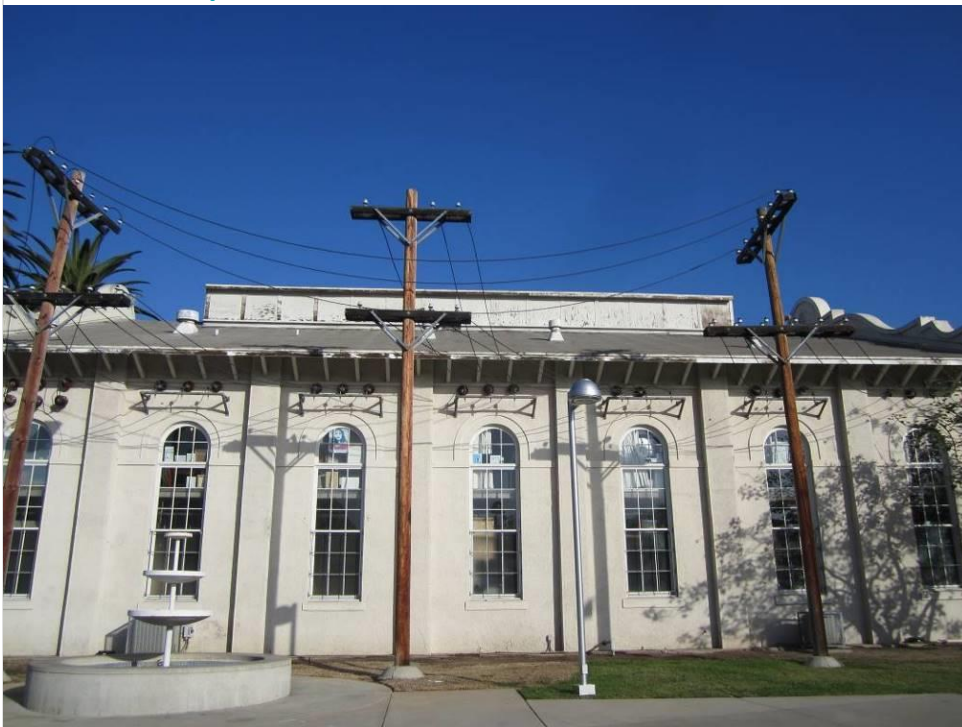
Photo 4 – South Façade.

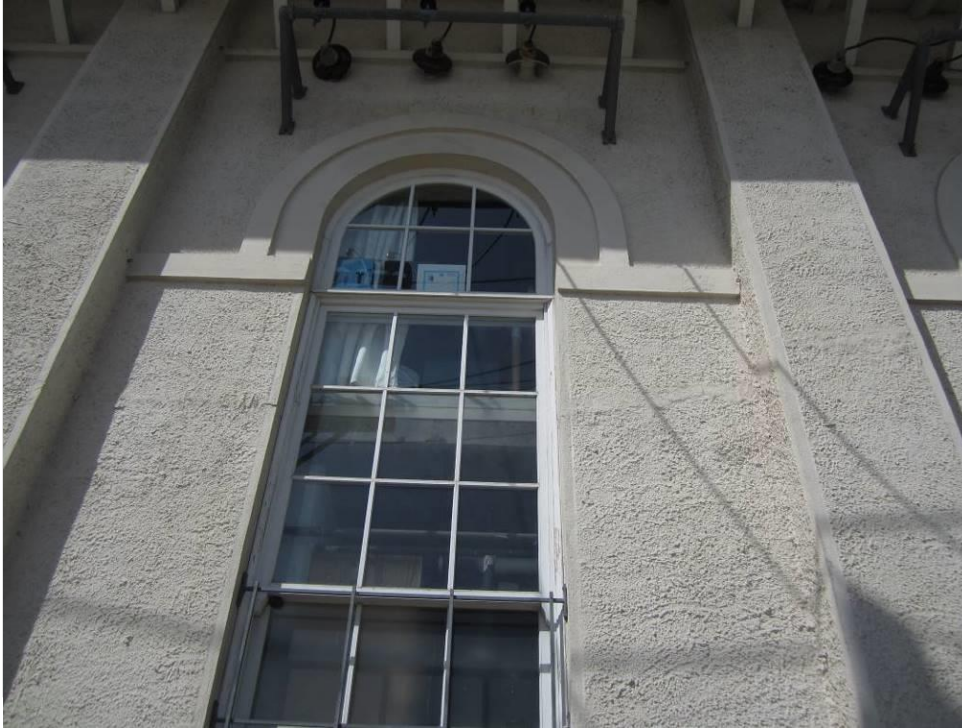
Photo 6 – Vertical crack in existing cement plaster wall.

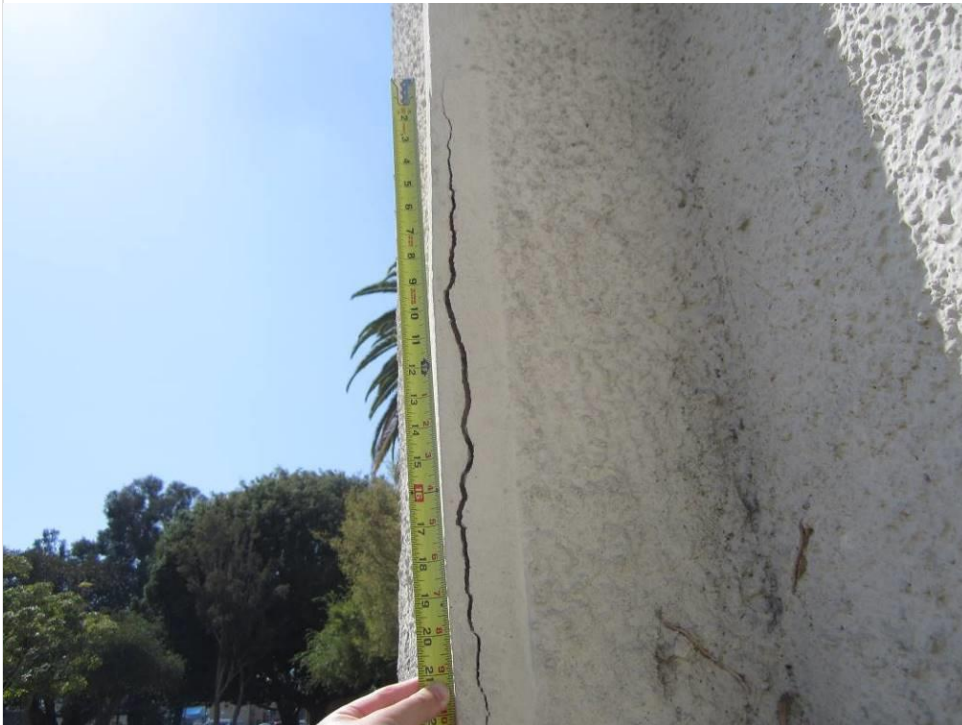
Photo 7 – Vertical crack leading to exposed brick masonry.

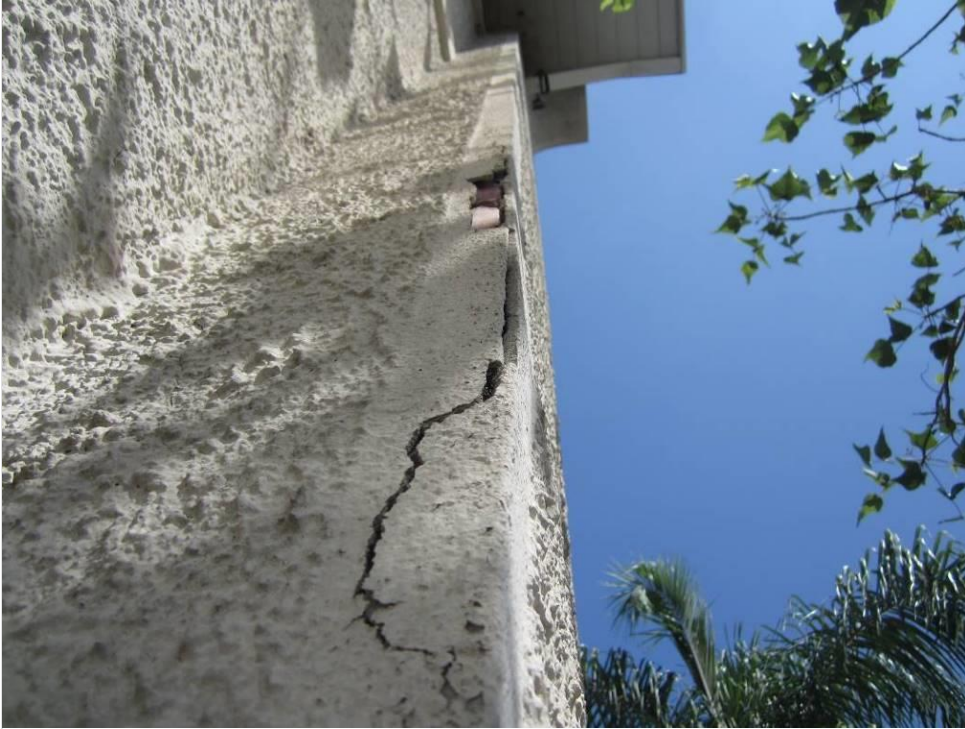
Photo 8 – Width of vertical crack measures 1/8 inch in width.

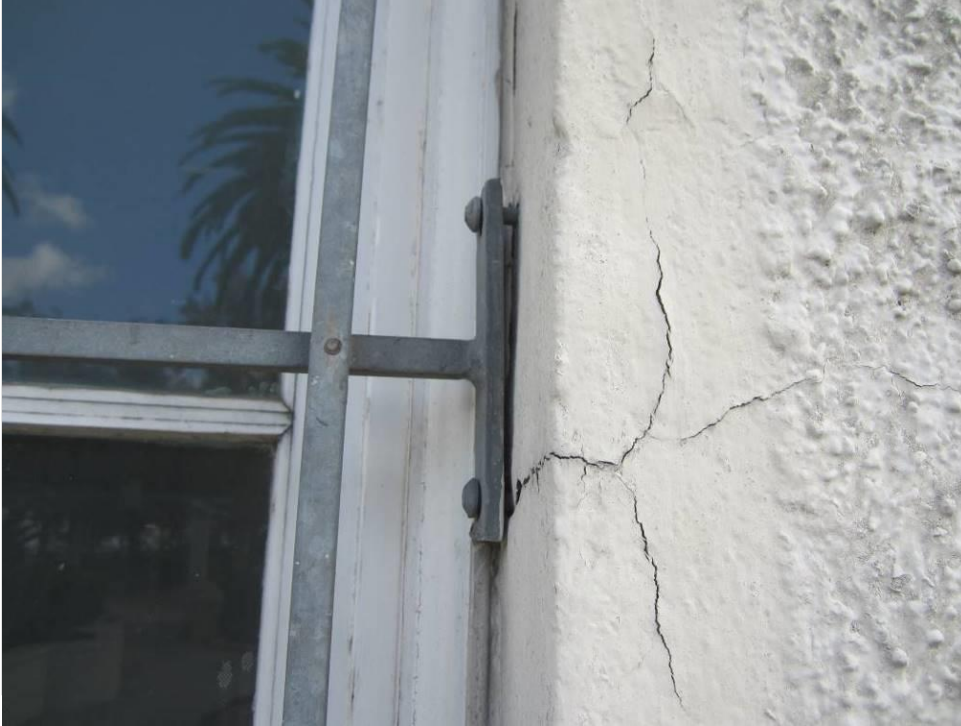
Photo 14 – Wall penetration is not sealed.

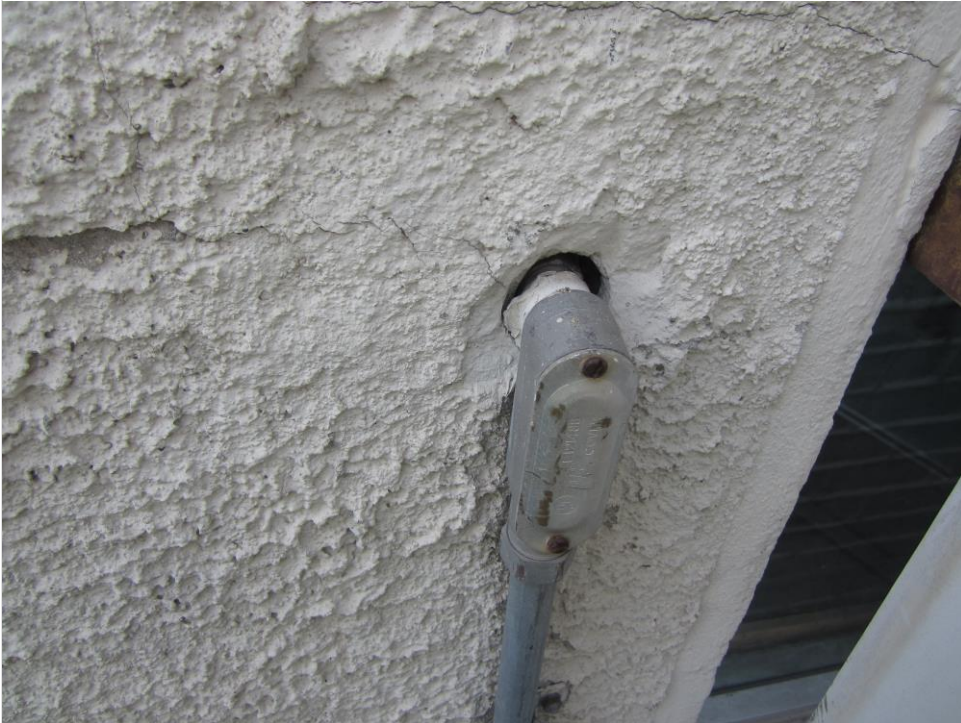
Photo 15 – Wood window muntin needs repair.

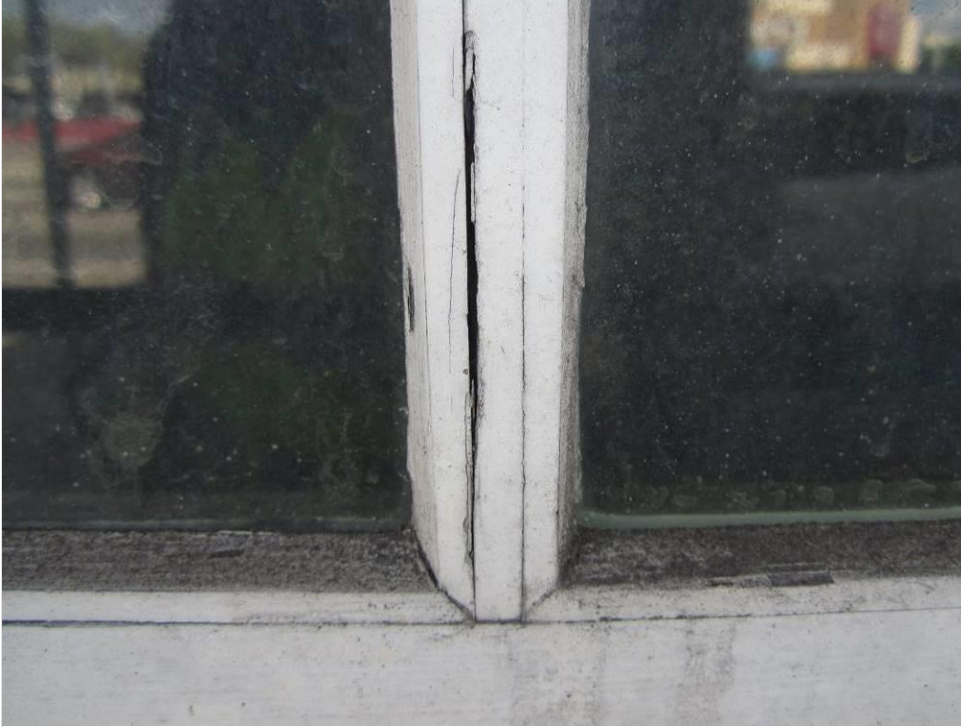
Photo 16 – Wood window sill and concrete ledger with crack in paint coating. Note that the joint between the wood sill and ledger is not sealed.

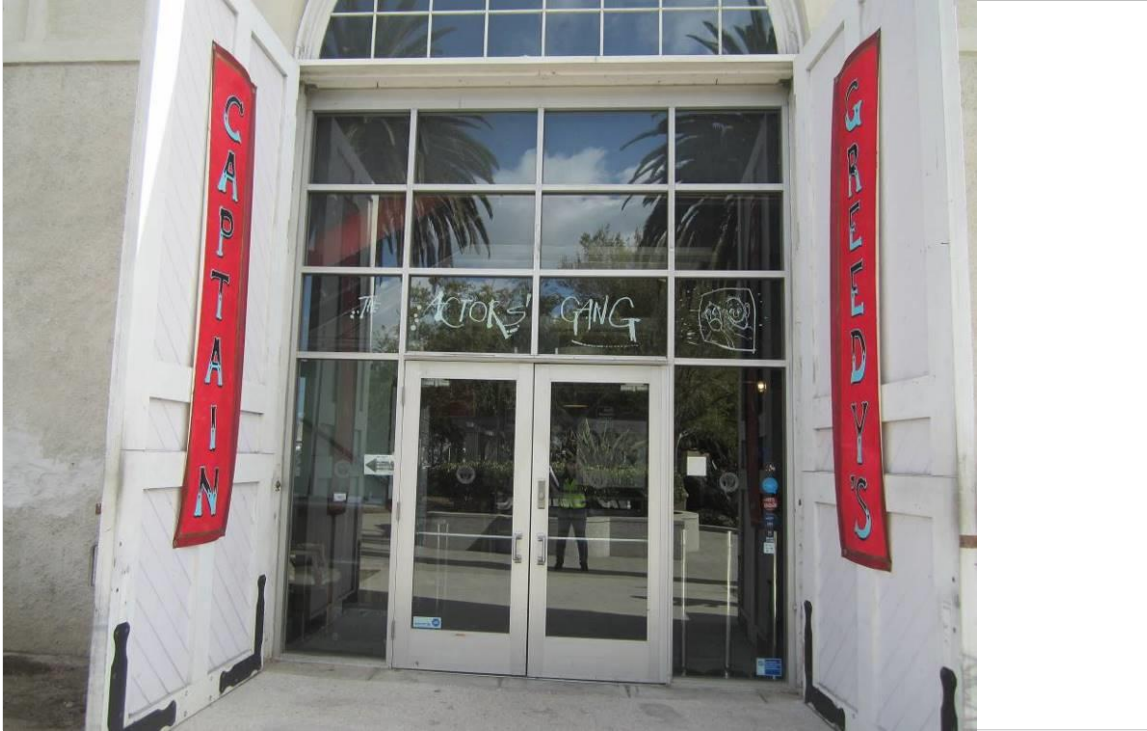
Photo 18 – Wood decay at the base of the wood door frames.

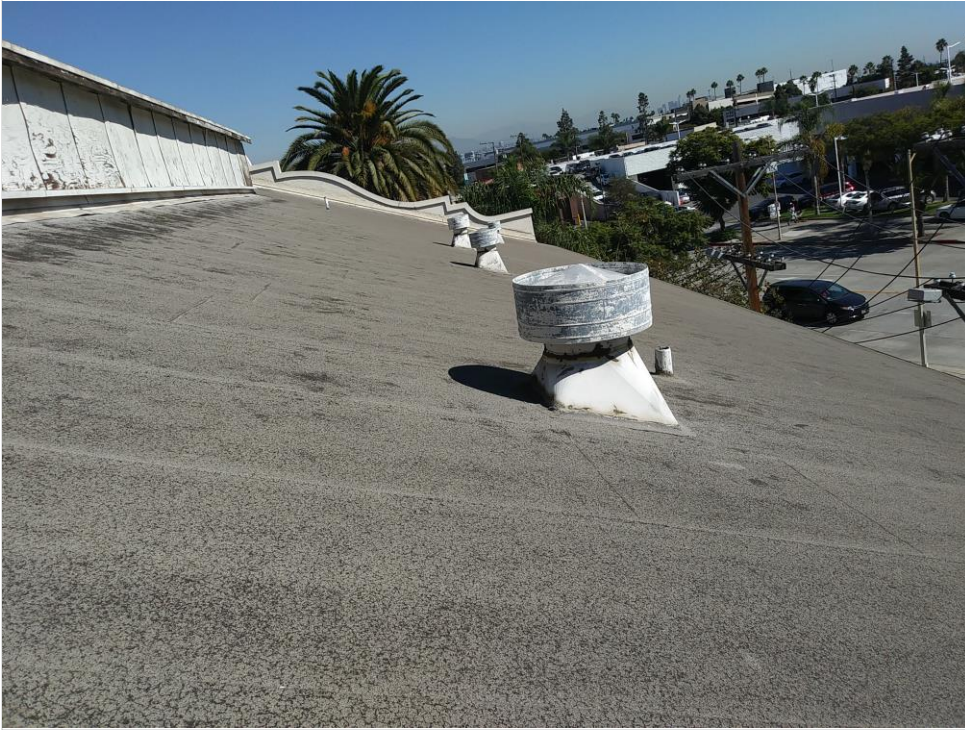
Photo 22 – Cracks at top of parapet wall.

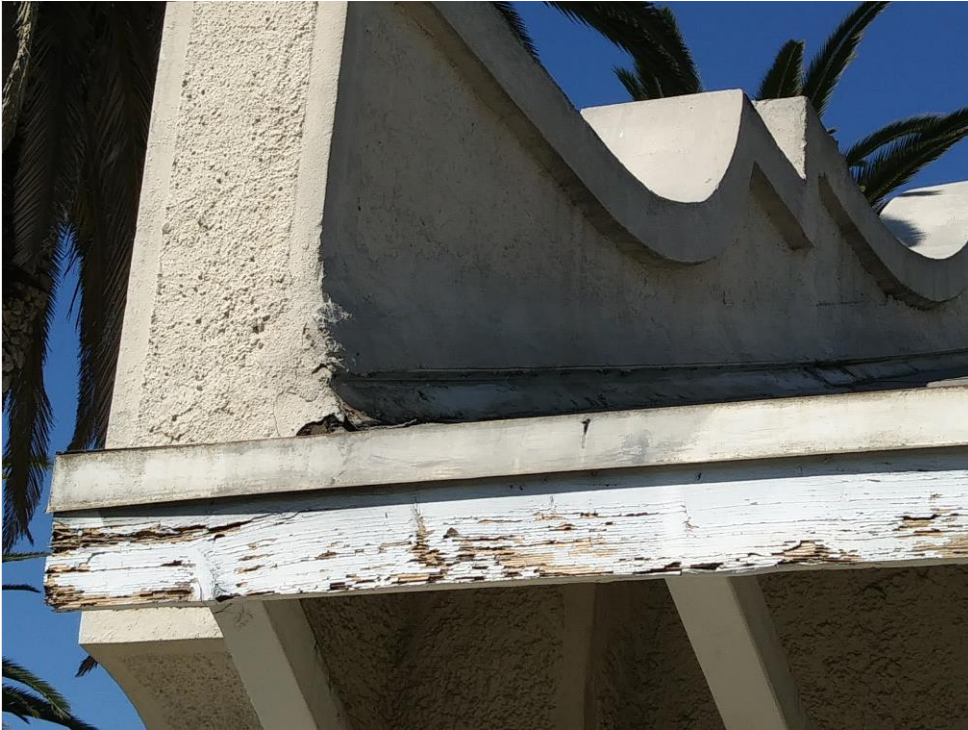
Photo 24 – Deteriorated wood fascia board and corroded edge flashing at roof eave.

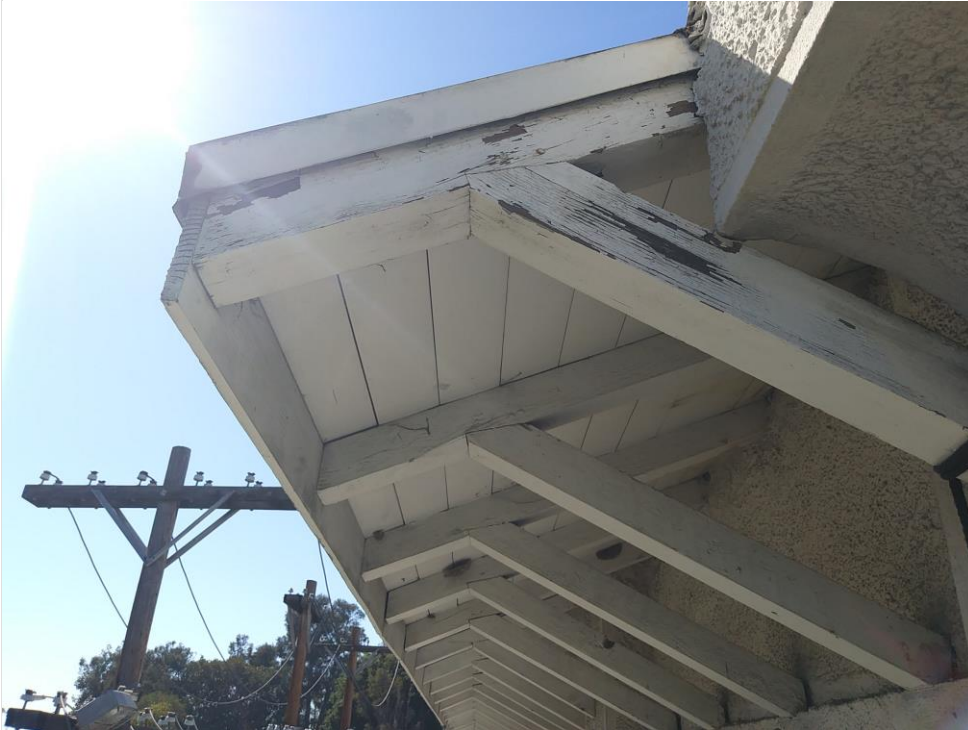
Photo 26 – Diagonal wood strut needs to be reattached to the wall. Gap between the wall and roof interface needs to be sealed.

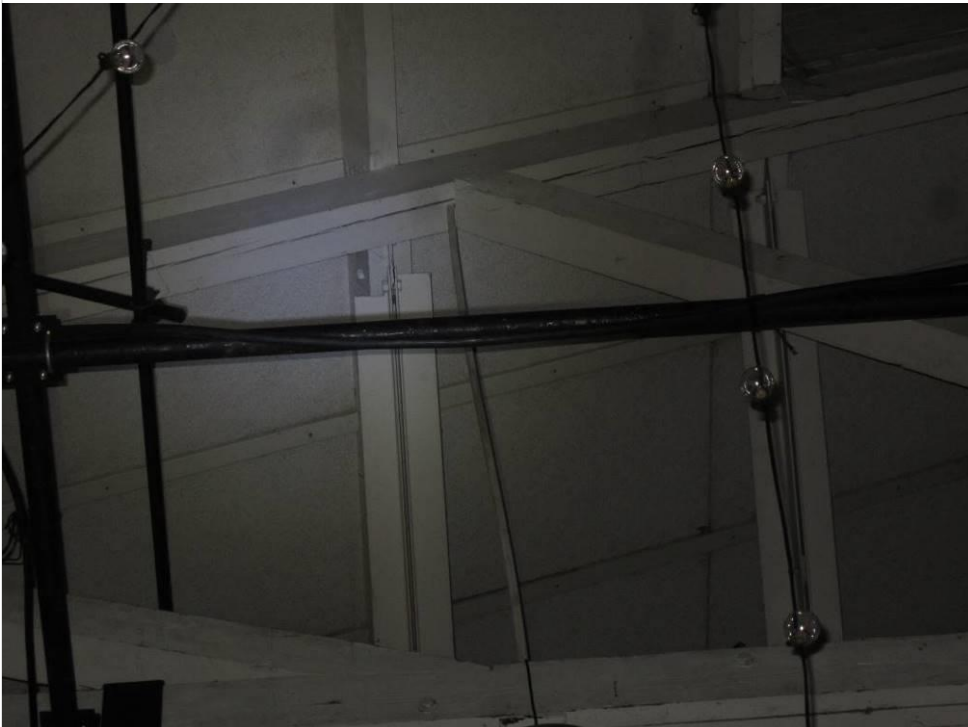
Photo 29 – Underside of concrete mezzanine slab located at the south end of the building. Note significant water staining and missing concrete at the bottom of the steel I-beams.

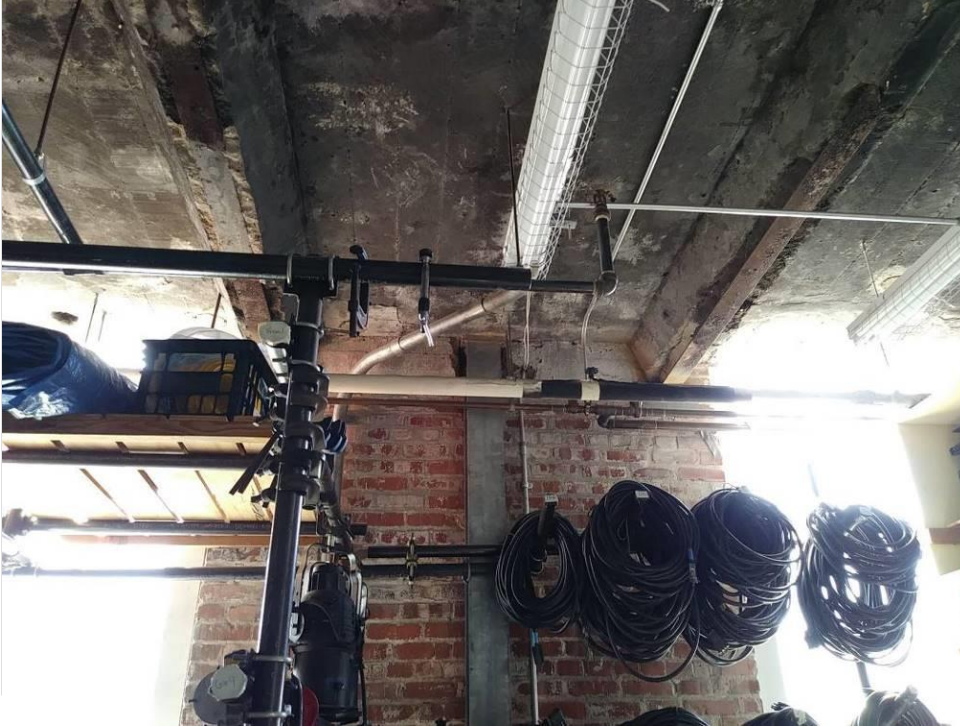
Photo 30 – Existing concrete landscaping walls with staining.

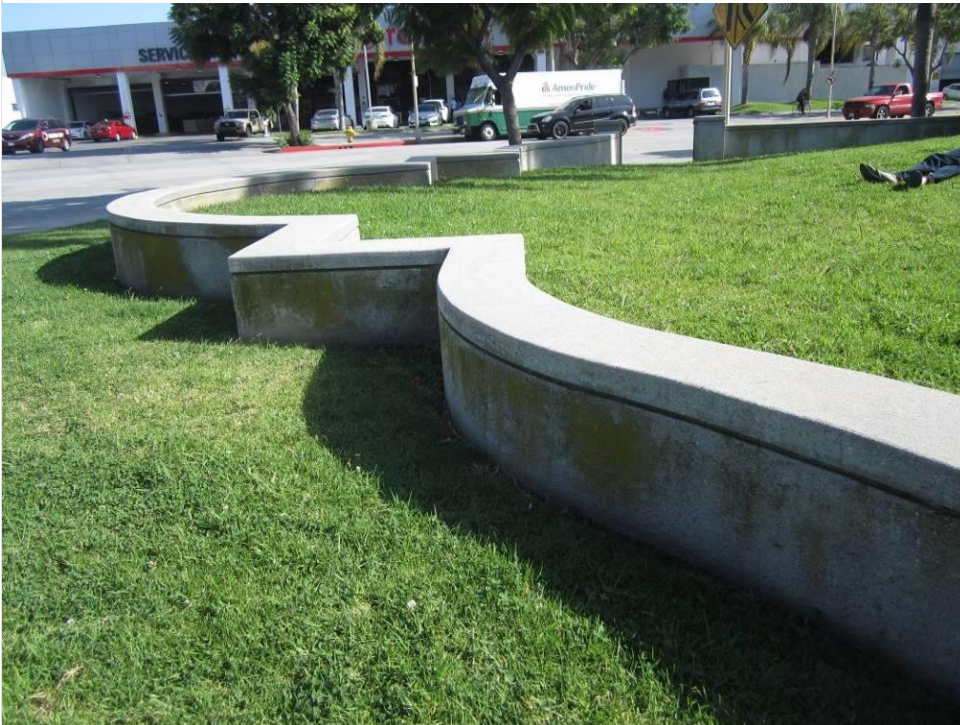
Photo 31 – Spall at concrete landscape wall probably caused by impact damage.

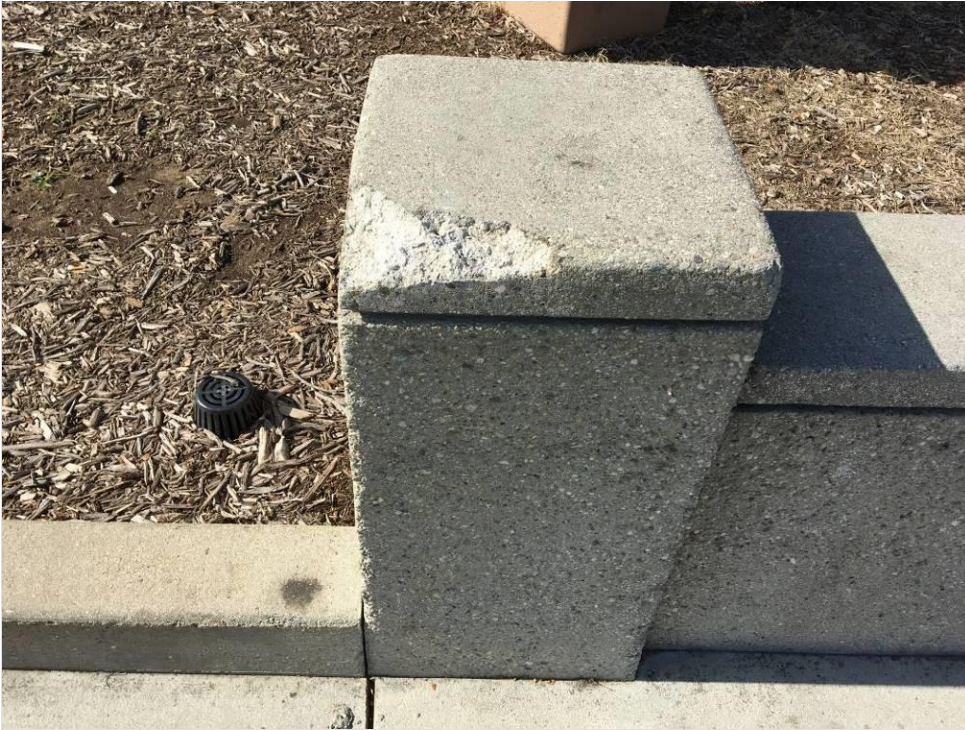
Photo 32 – Existing wood power pole at south end of building. Note cracks in concrete foundation.
