**Subject: Soil Management Plan  
Beyond/Hello Project  
3800 Sepulveda Boulevard  
Culver City, California**

# Soil Management Plan

Beyond/Hello Project  
3800 Sepulveda Boulevard Culver  
City, California

## Phase I Environmental Site Assessment

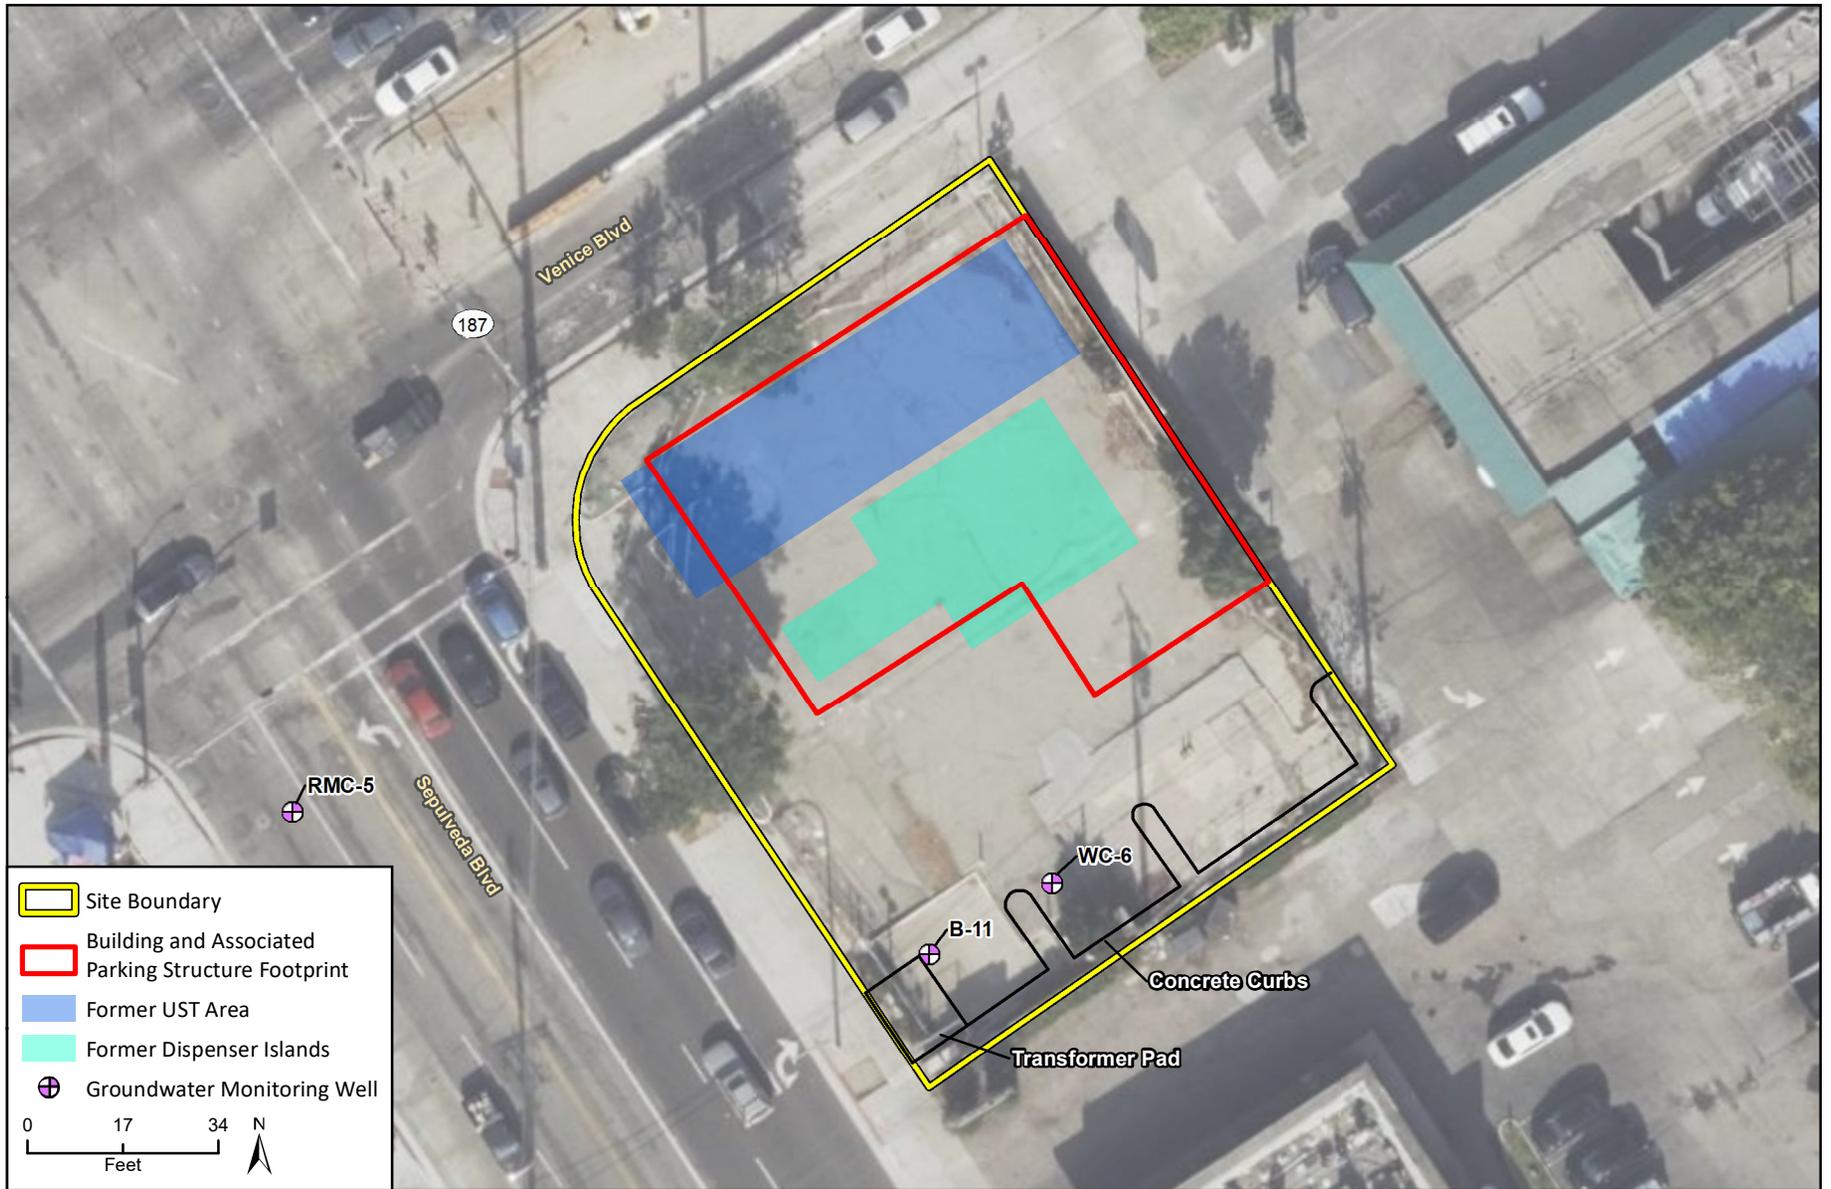
Figure 3 Proposed Building Footprint, Groundwater Monitoring Wells, and Historical Retail Facility Locations

The site has approximately 16 groundwater monitoring wells associated with the environmental case. To date, all but six of the wells have been destroyed, and of those six only two wells are located onsite. Wells B-11 and WC-6 are located in the existing parking lot along the southern boundary of the site. These wells are to be kept in-tact and undamaged during the course of the entire project. Measures will be executed to ensure these wells are not damaged in any way.

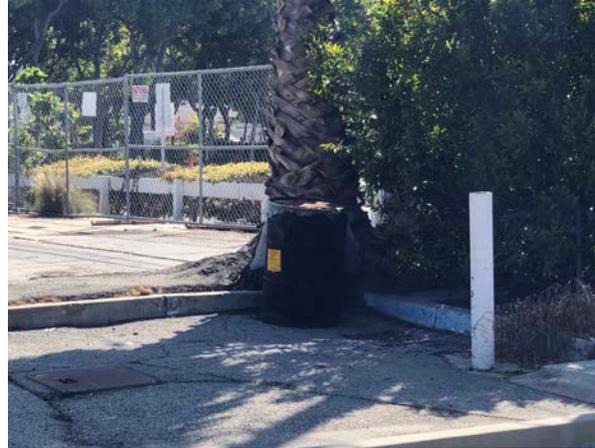
**Photograph 2.** View of the onsite 55-gallon drum.

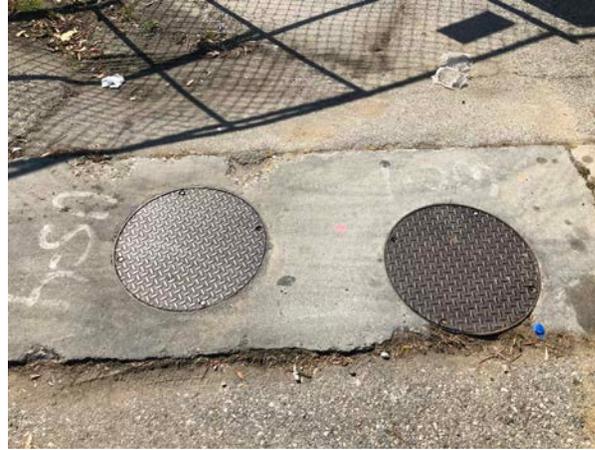
**Photograph 8.** View of two out of multiple onsite wells observed.

Based on the current subject property case status, we recommend continued monitoring of the site wells by Exxon Mobil as determined by the LA RWQCB to move forward in achieving case closure. Once closure is obtained, Exxon Mobil should abandon all the wells, probes, etc. that exist onsite and offsite.
