Patt Conservation
Sculpture and Collection Care

Assessment

Date: September 2, 2025
Client: City of Culver City
9770 Culver Boulevard
Culver City, CA 90232-0507
Attn: Sally Unsworth
RE: Assessment of the historic MGM Sign stored at the Dependable Distribution Center in Downtown LA

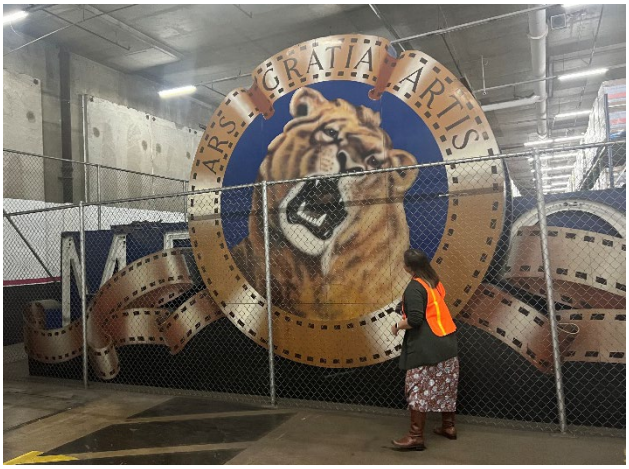
The historic artwork consists of the MGM lion logo, hand-painted on a metal backing. The sign measures approximately 10–12 feet in height and is double-sided, with the same logo applied to both faces. A solid steel frame is sandwiched between the two sides, originally serving as the mounting system for attachment to the building. Based on current information, the central beam and ladder bracing are slated for removal due to excessive weight and associated climbing hazards.

At the base, the curvature has been infilled with several sections of plywood cut to follow the arc of the logo on the upper edge and squared off at the bottom to sit flush with the floor. The purpose of this plywood intervention is unclear; it appears temporary, non-structural, and not load-bearing. The method of attachment between the painted sign faces and the internal bracing remains undetermined.

A full condition assessment could not be carried out because the artwork is presently stored in a facility with restricted access, allowing only partial visual inspection from a short distance. Certain areas were obscured entirely. From the visible surfaces, the artwork appears to be in fair to good condition.

- Paint layer: Losses are visible and range in size. Areas of fading and surface dryness are visible and consistent with prolonged UV exposure.
- Metal substrate: Red-orange corrosion is visible where the underlying metal is exposed, particularly along edges and at points of structural vulnerability.
- Dust/dirt: A layer of dust is present overall.

Despite these conditions, the artwork appears stable at present. A treatment of surface cleaning, paint consolidation, selective in-painting, and the application of a clear, UV-resistant acrylic protective coating will be recommended in a formal treatment proposal.
