CONDITION ASSESSMENT REPORT

## IVY SUBSTATION

9070 Venice Boulevard, Culver City, California

December 21, 2017

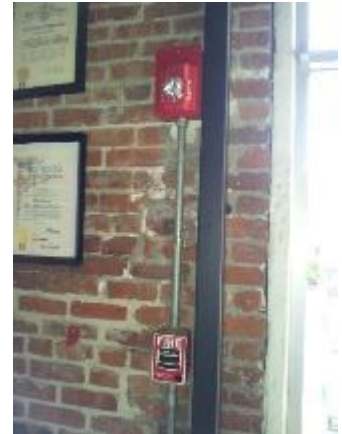
E-4: Fire alarm pull station and strobe

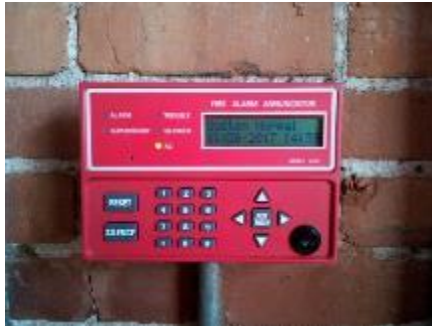
E-5: Fire alarm annunciator near front entrance

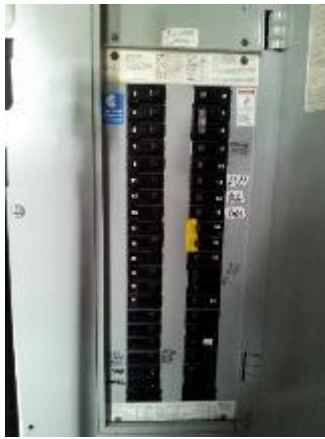
E-9: Panelboard "B" in utility room

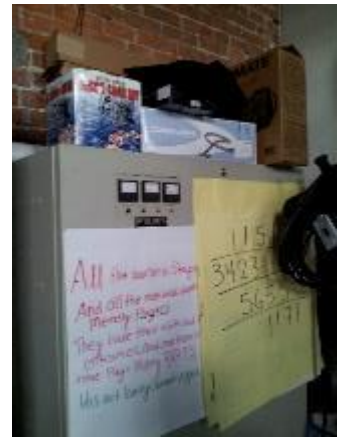
E-10: Inverter not in use

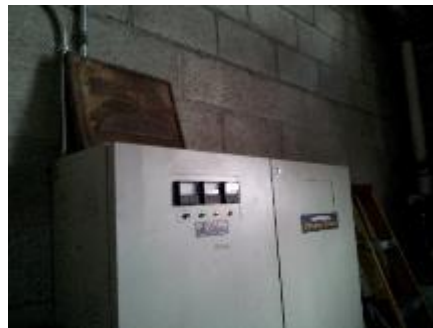
E-11: Inverter in use

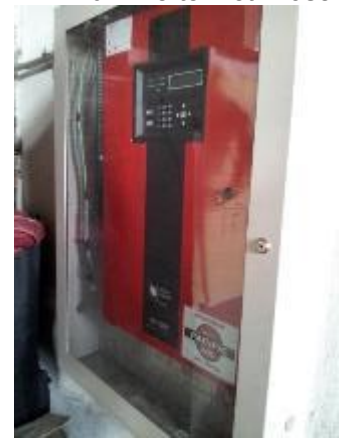
E-12: Fire Alarm Control Panel

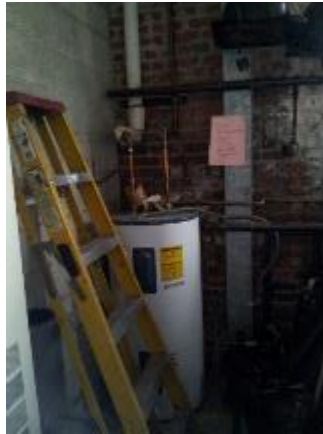
E-15: Electric water heater

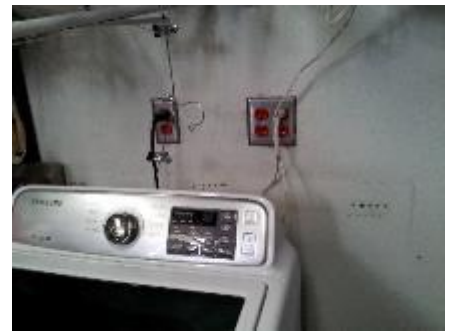
E-17: Outlets in use

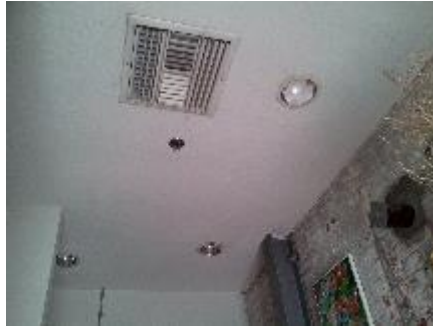
E-19: Downlights in 2<sup>nd</sup> floor restroom

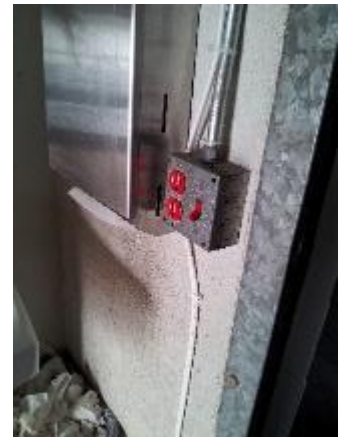
E-20: Outlet in 2<sup>nd</sup> floor restroom

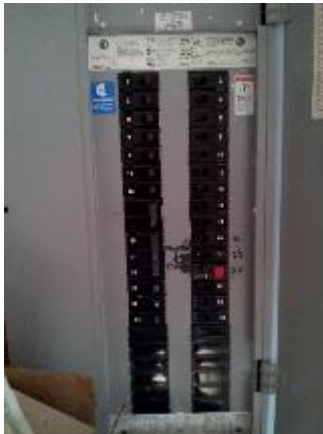
E-21: Panelboard "A" in office room

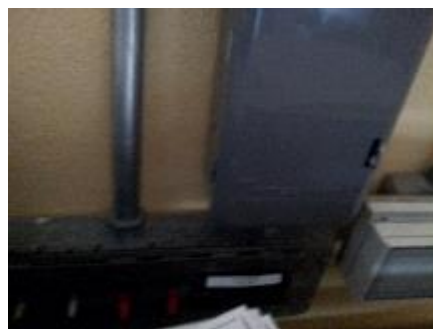
E-23: Switches in office room

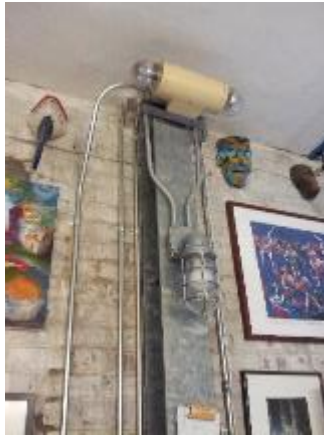
E-24: Emergency lights in open office area

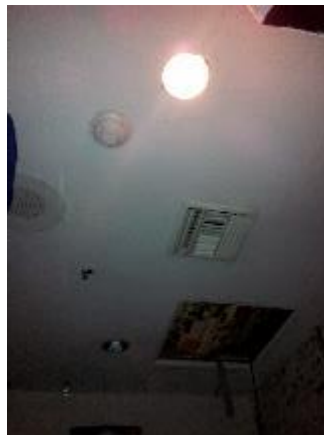
E-25: Recessed downlight in “dungeon” room

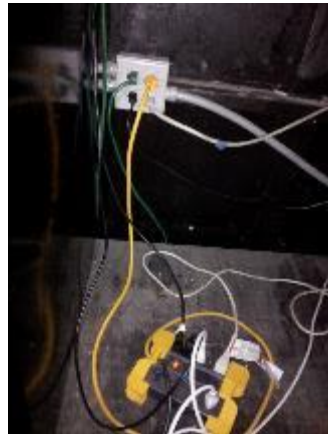
E-26: Quad outlet in control room

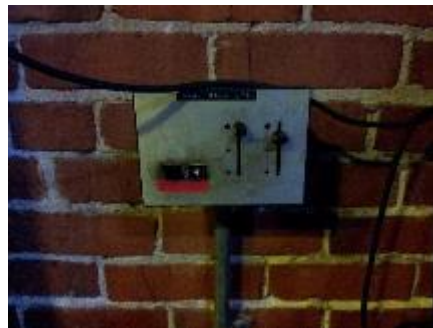
E-27: Dimmer switch controlling (5) 2x4 light fixtures

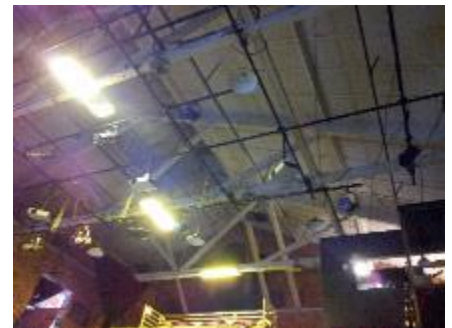
E-28: (3) 2x4 fixtures above seating area

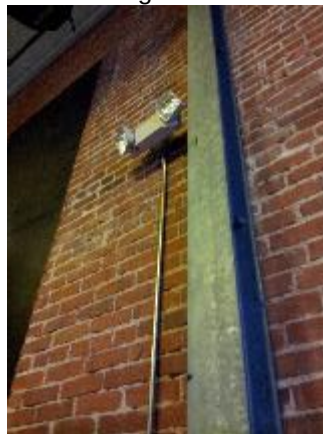
E – 29: Emergency lighting in performance hall

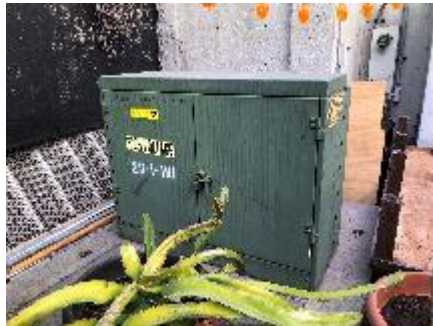
E-32: Utility Transformer

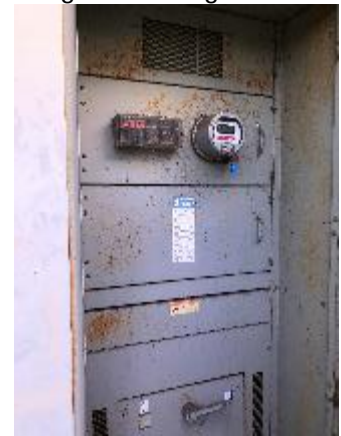
E-33: Main Switchboard

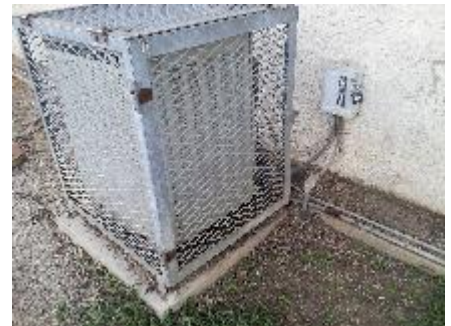
E-35: Exterior AC Unit with disconnect

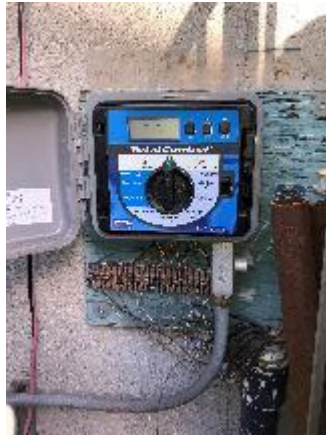
E-36: Exterior irrigation controller

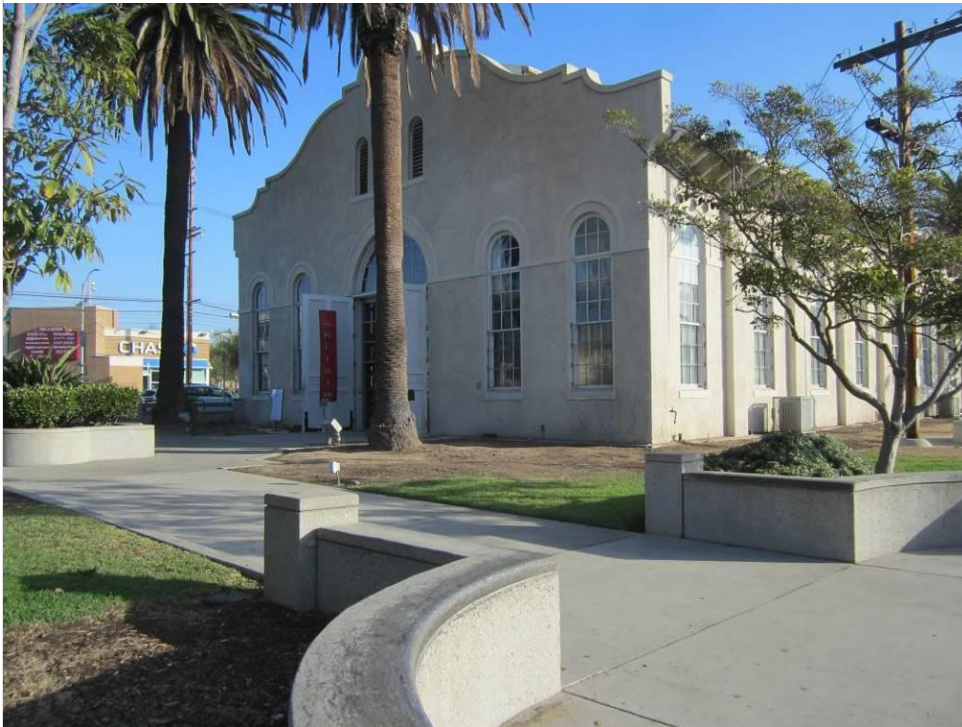
Photo 3 – East Façade.
