CONDITION ASSESSMENT REPORT

## IVY SUBSTATION

9070 Venice Boulevard, Culver City, California

December 21, 2017

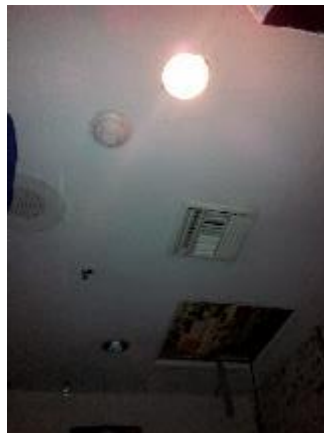
E-25: Recessed downlight in “dungeon” room

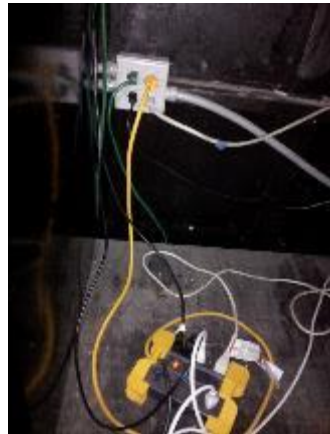
E-26: Quad outlet in control room

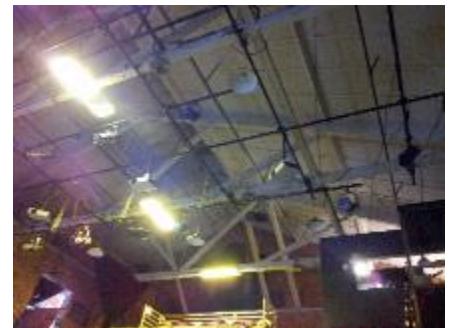
E-28: (3) 2x4 fixtures above seating area

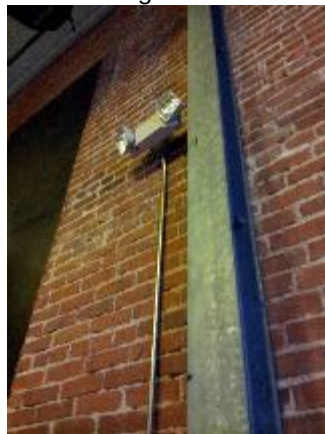
E - 29: Emergency lighting in performance hall

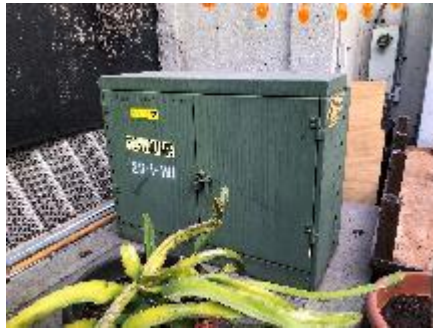
E-32: Utility Transformer

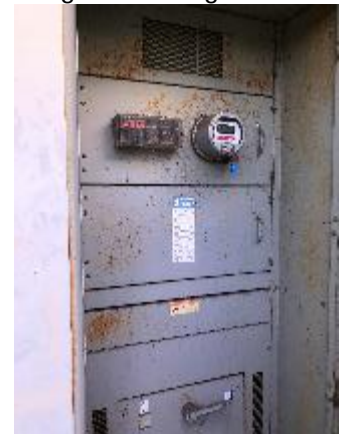
E-33: Main Switchboard
