# APPENDIX - VAN BUREN PARKING GARAGE

## EAST - WEST SECTION - 36" OFFSET & 3' SETBACK

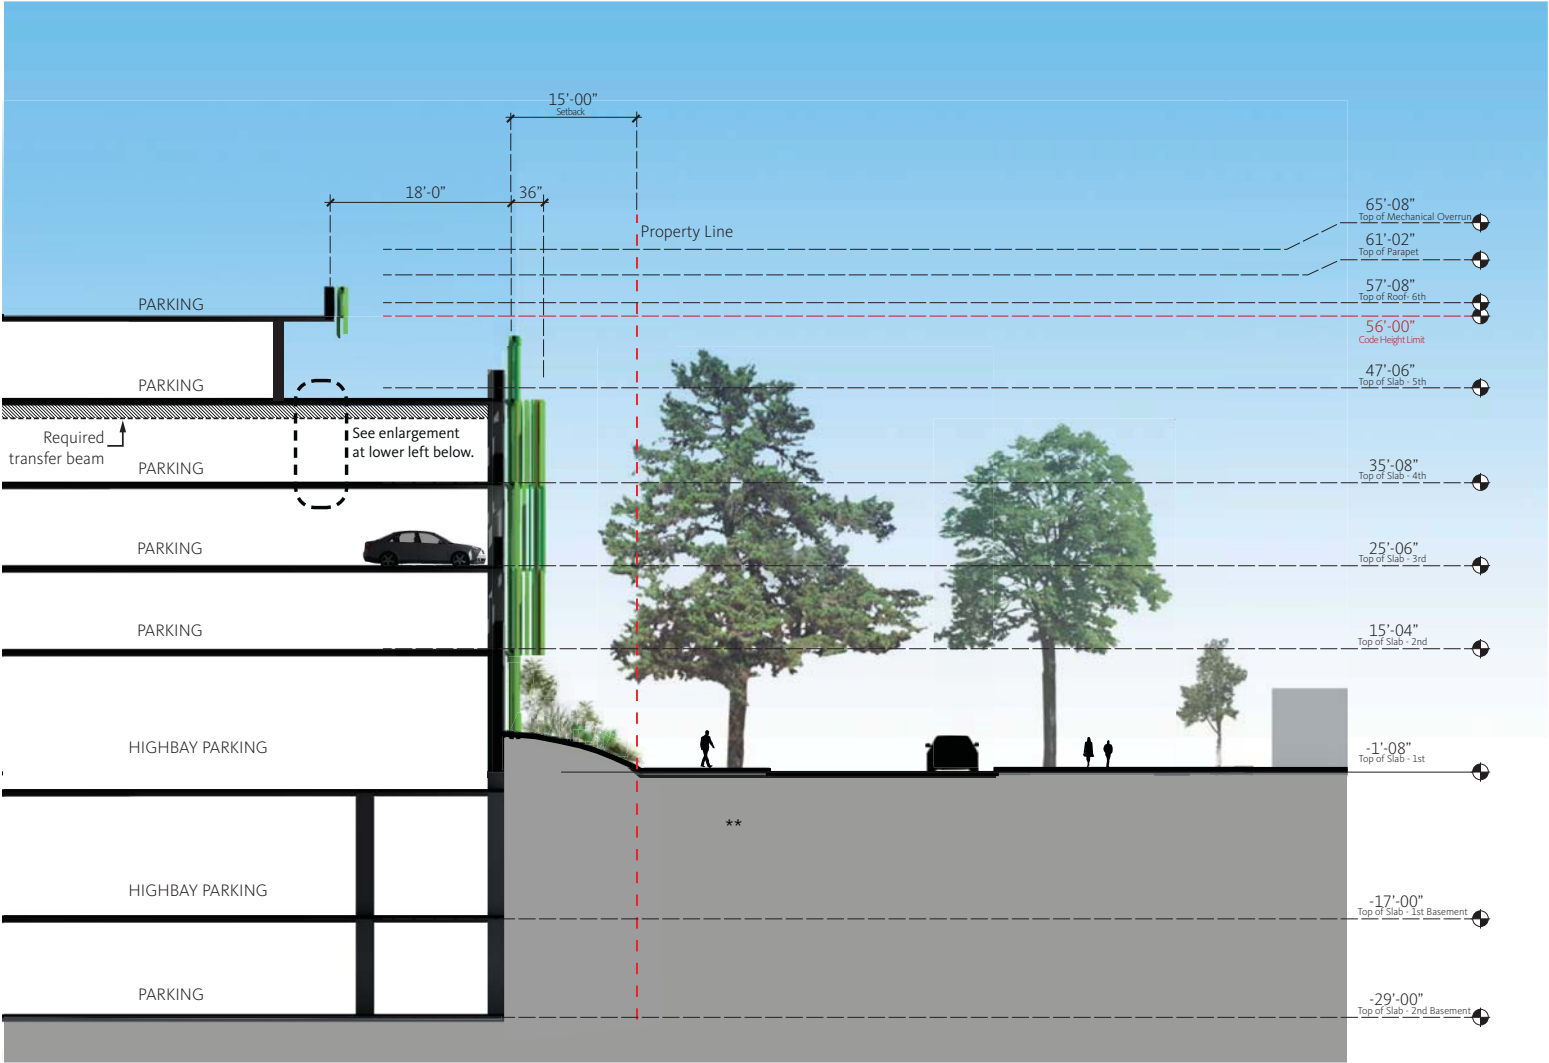
An upper level setback of 18-feet from the Van Buren place elevation results in a significant loss of parking, 41 spaces.

A 18-foot+ shift of the upper level columns would require a transfer beam at the 4th level to shift loads from the outside columns along Van Buren Place to the offset column needed for the upper level. The required transfer beam is conceptually estimated to need an additional 20 inches of depth, above the standard dimension, to accommodate the new load. To accommodate this additional depth and retain required operational clearance, the fifth and sixth levels are shifted 1-foot 8-inches up in elevation - exceeding the 56-foot top of roof height limit.

The garage cannot be nestled deeper below grade to accommodate the added depth of the transfer beam due to required emergency access through the garage at the ground level to and from Van Buren Place.

**ENLARGEMENT OF TRANSFER BEAM SECTION.**
