MEMORANDUM

RE: Assessment of Circulation and Parking for
10950 Washington Boulevard Parking Improvement Project
Culver City, California

Ref: J1614

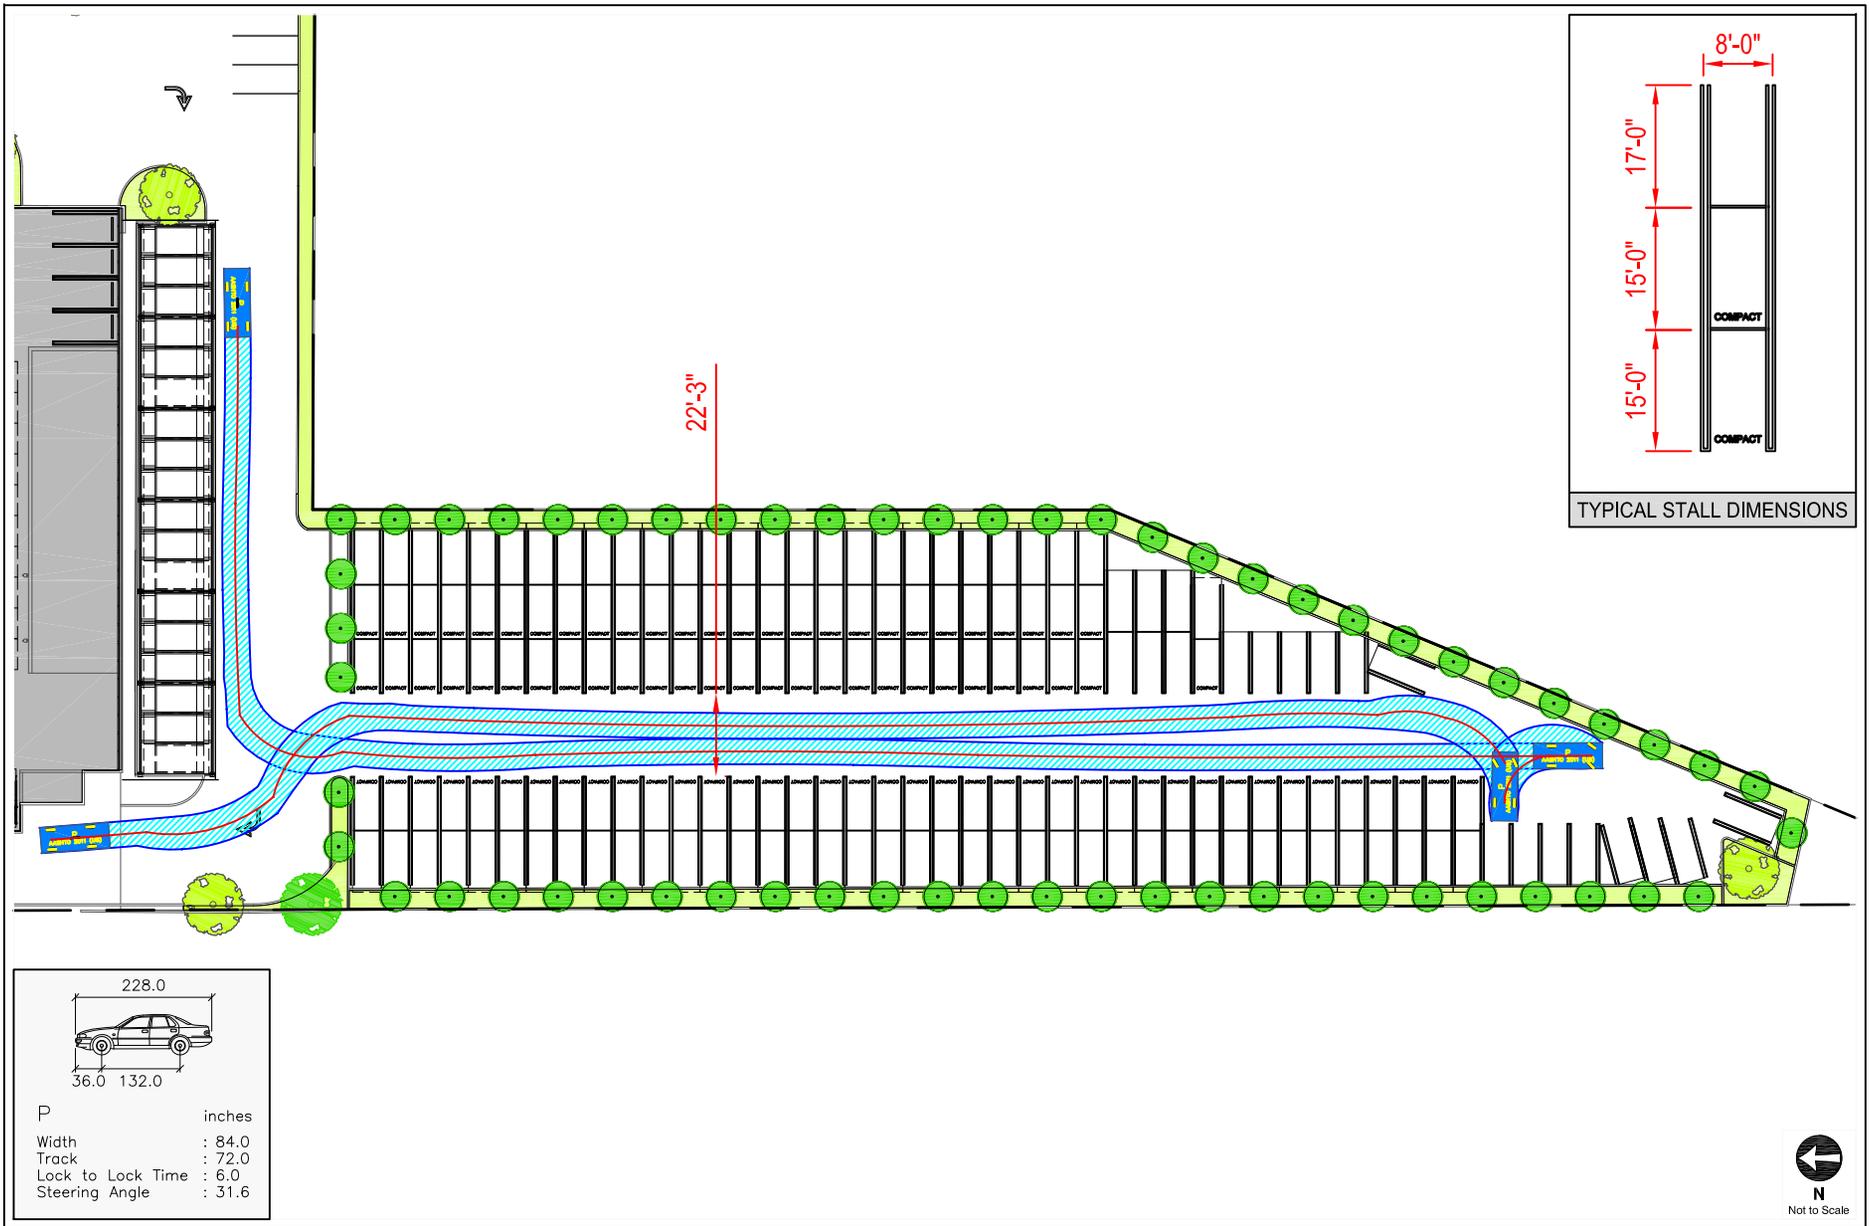
FIGURE
1

SOUTH LOT CIRCULATION WITH 3-POINT TURN AT END

Figure 1 shows the basic circulation through the south lot, which is a surface parking area that will be restriped with the new plan for dual- and triple-tandem spaces. This lot has only one aisle due to the tandem design. As such, all vehicles that reach the endpoint must execute a three-point turn. Based on the example in Figure 1, this may be accomplished, but it remains a tight turn for a large vehicle.

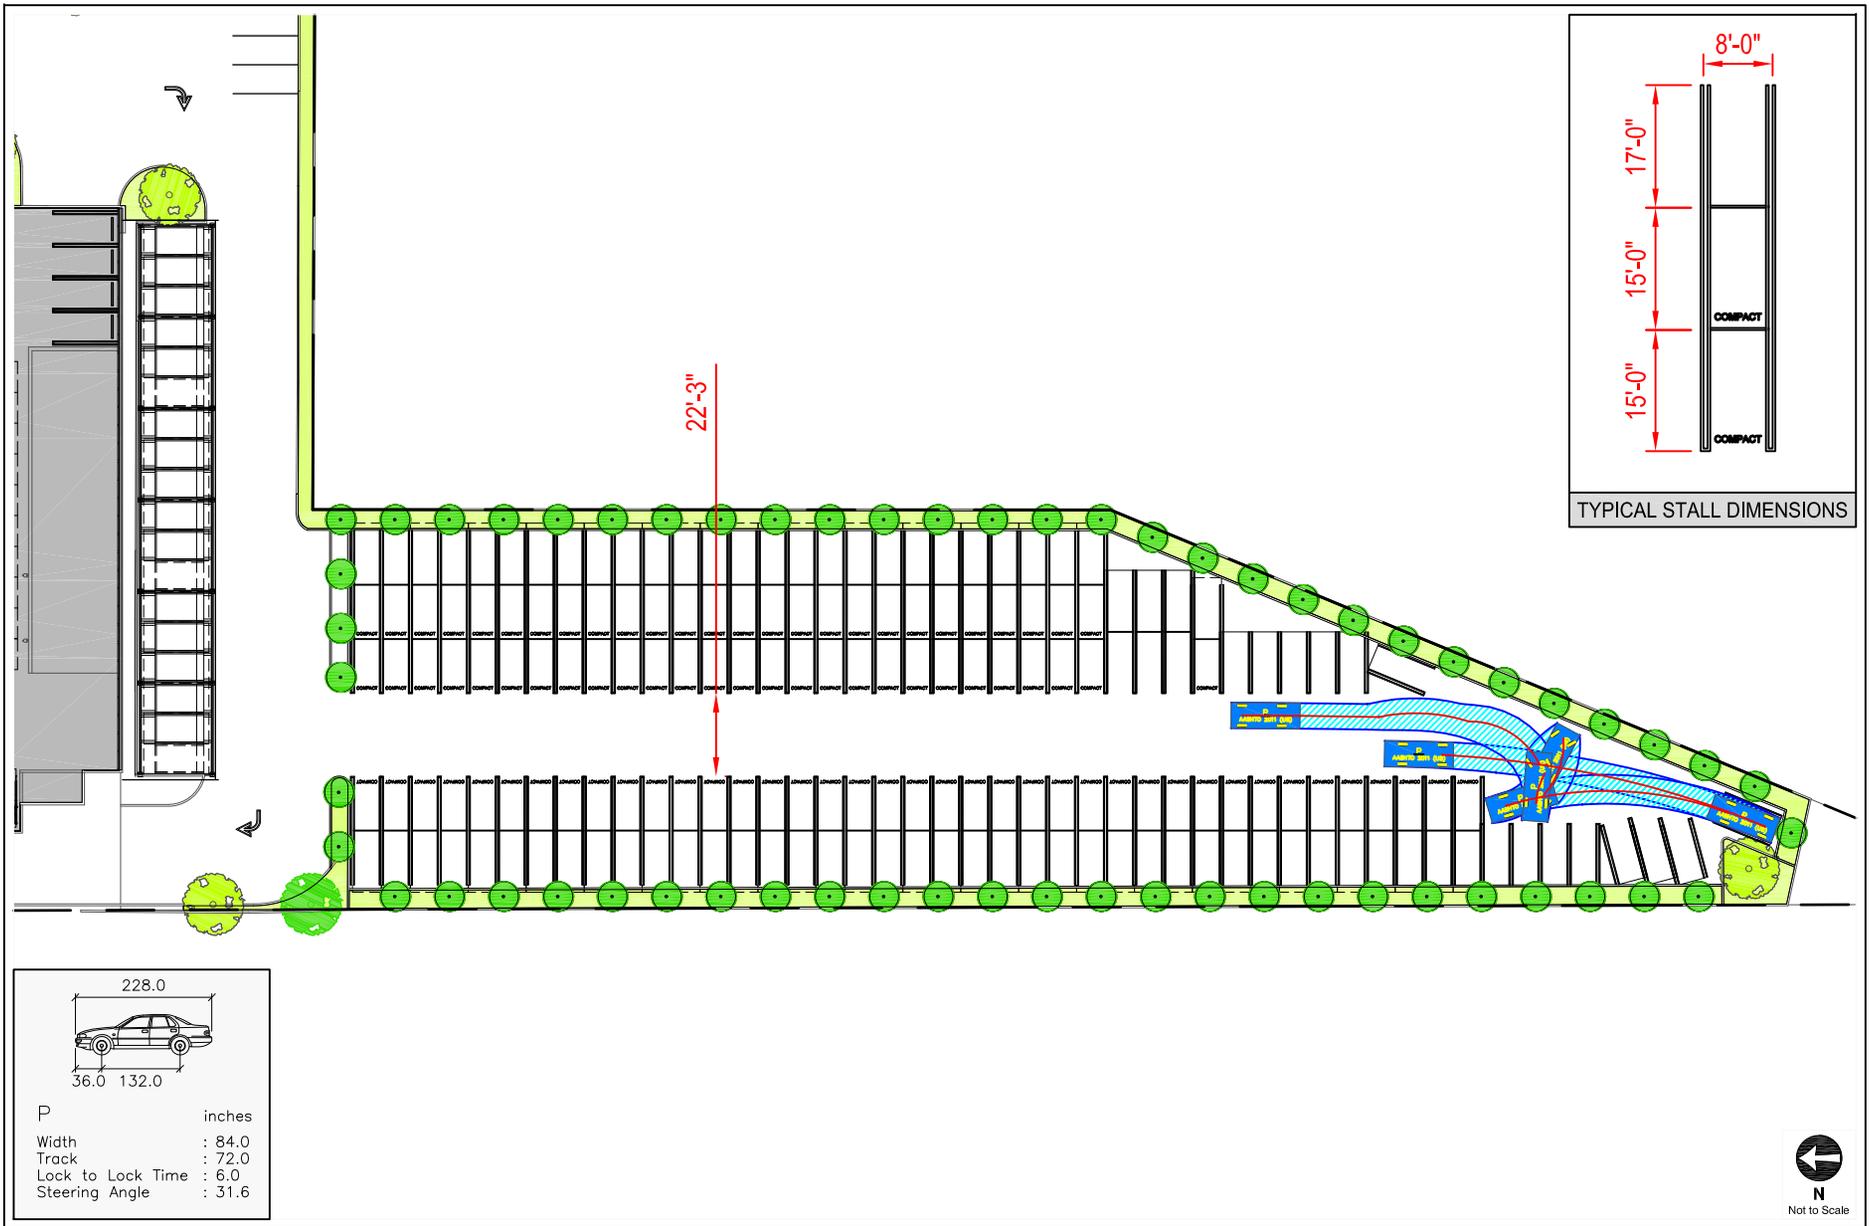
FIGURE
2

SOUTH LOT CIRCULATION - COMPLICATED PARKING SPACE 1

Figures 2 and 3 demonstrate the difficulties for vehicles accessing two constrained spaces inside the south lot, requiring a series of tight turns to execute the maneuver.

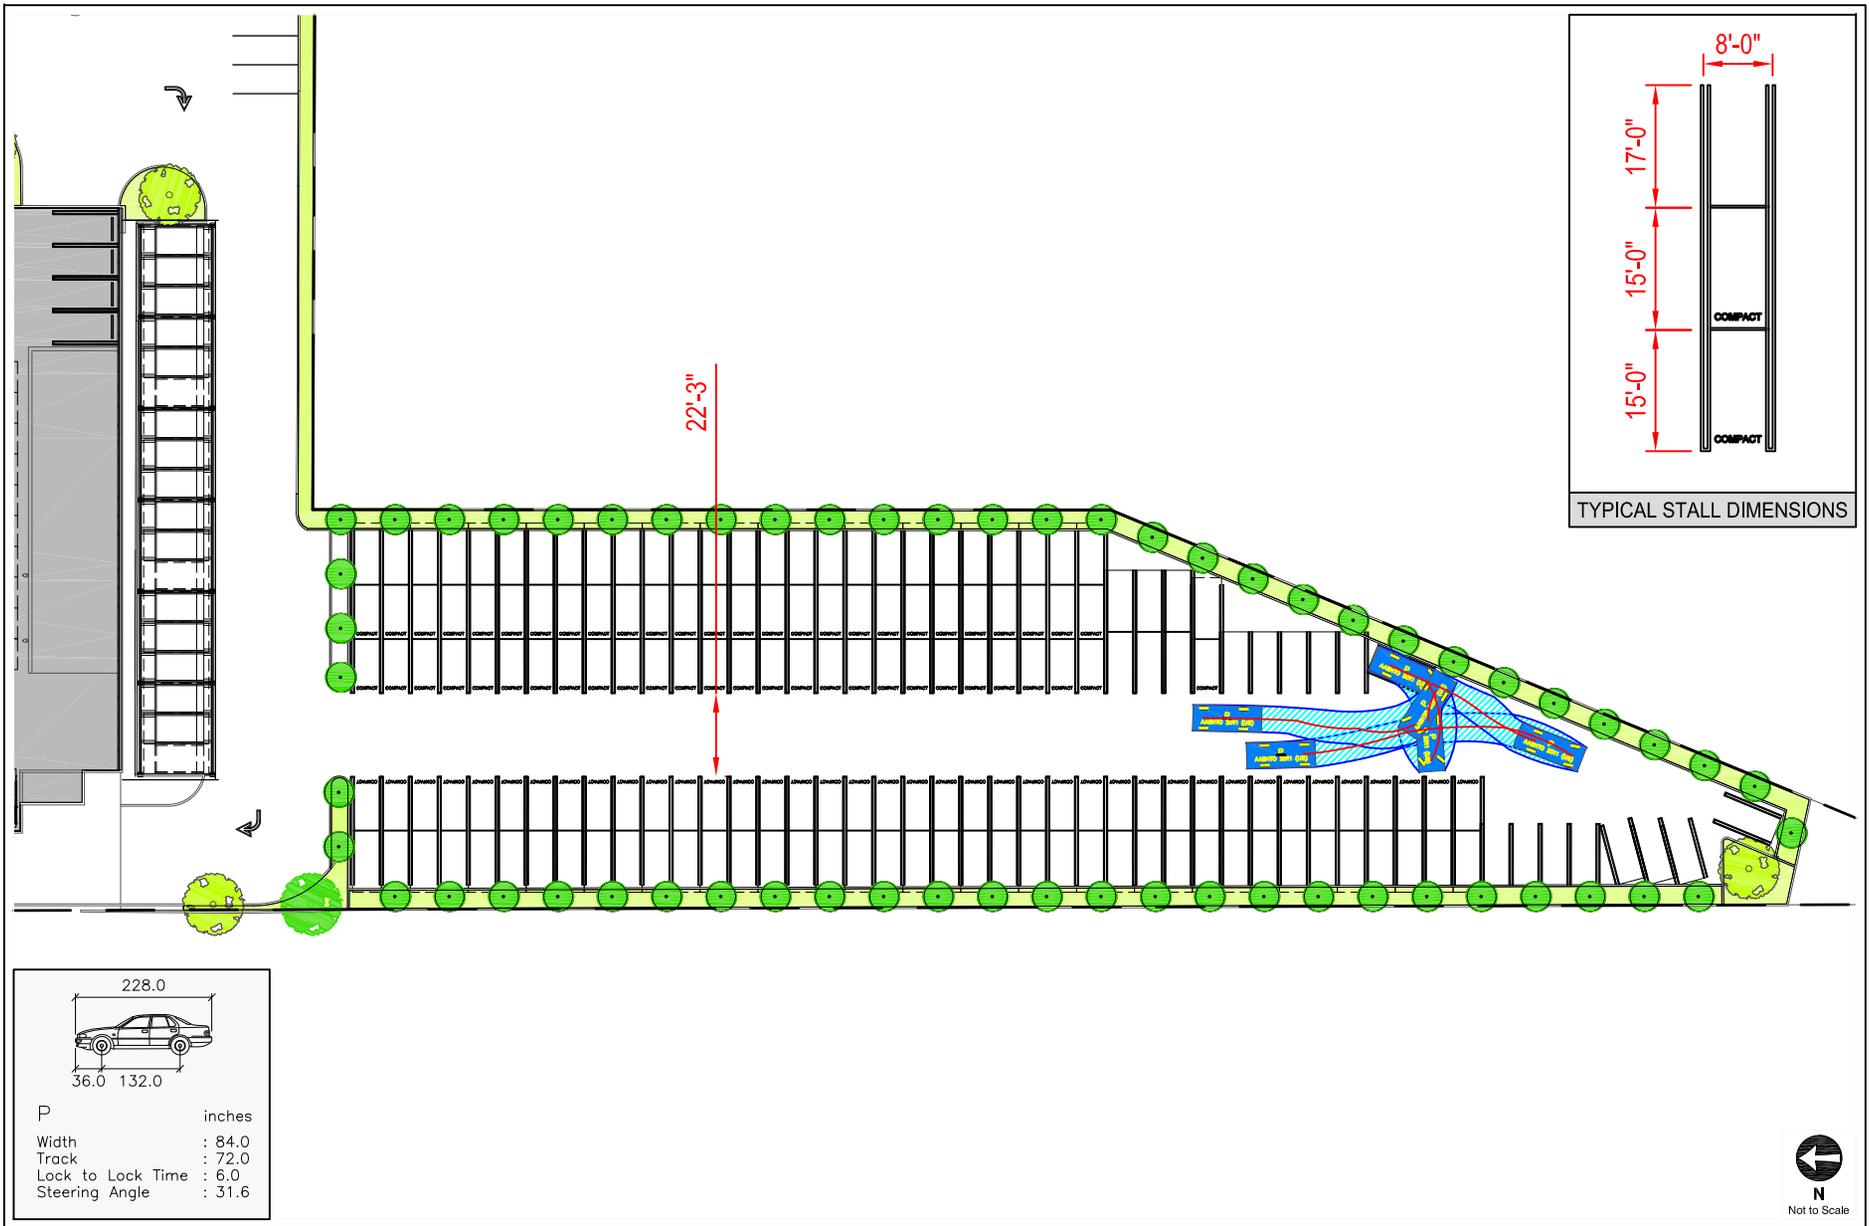
FIGURE
3

SOUTH LOT CIRCULATION - COMPLICATED PARKING SPACE 2

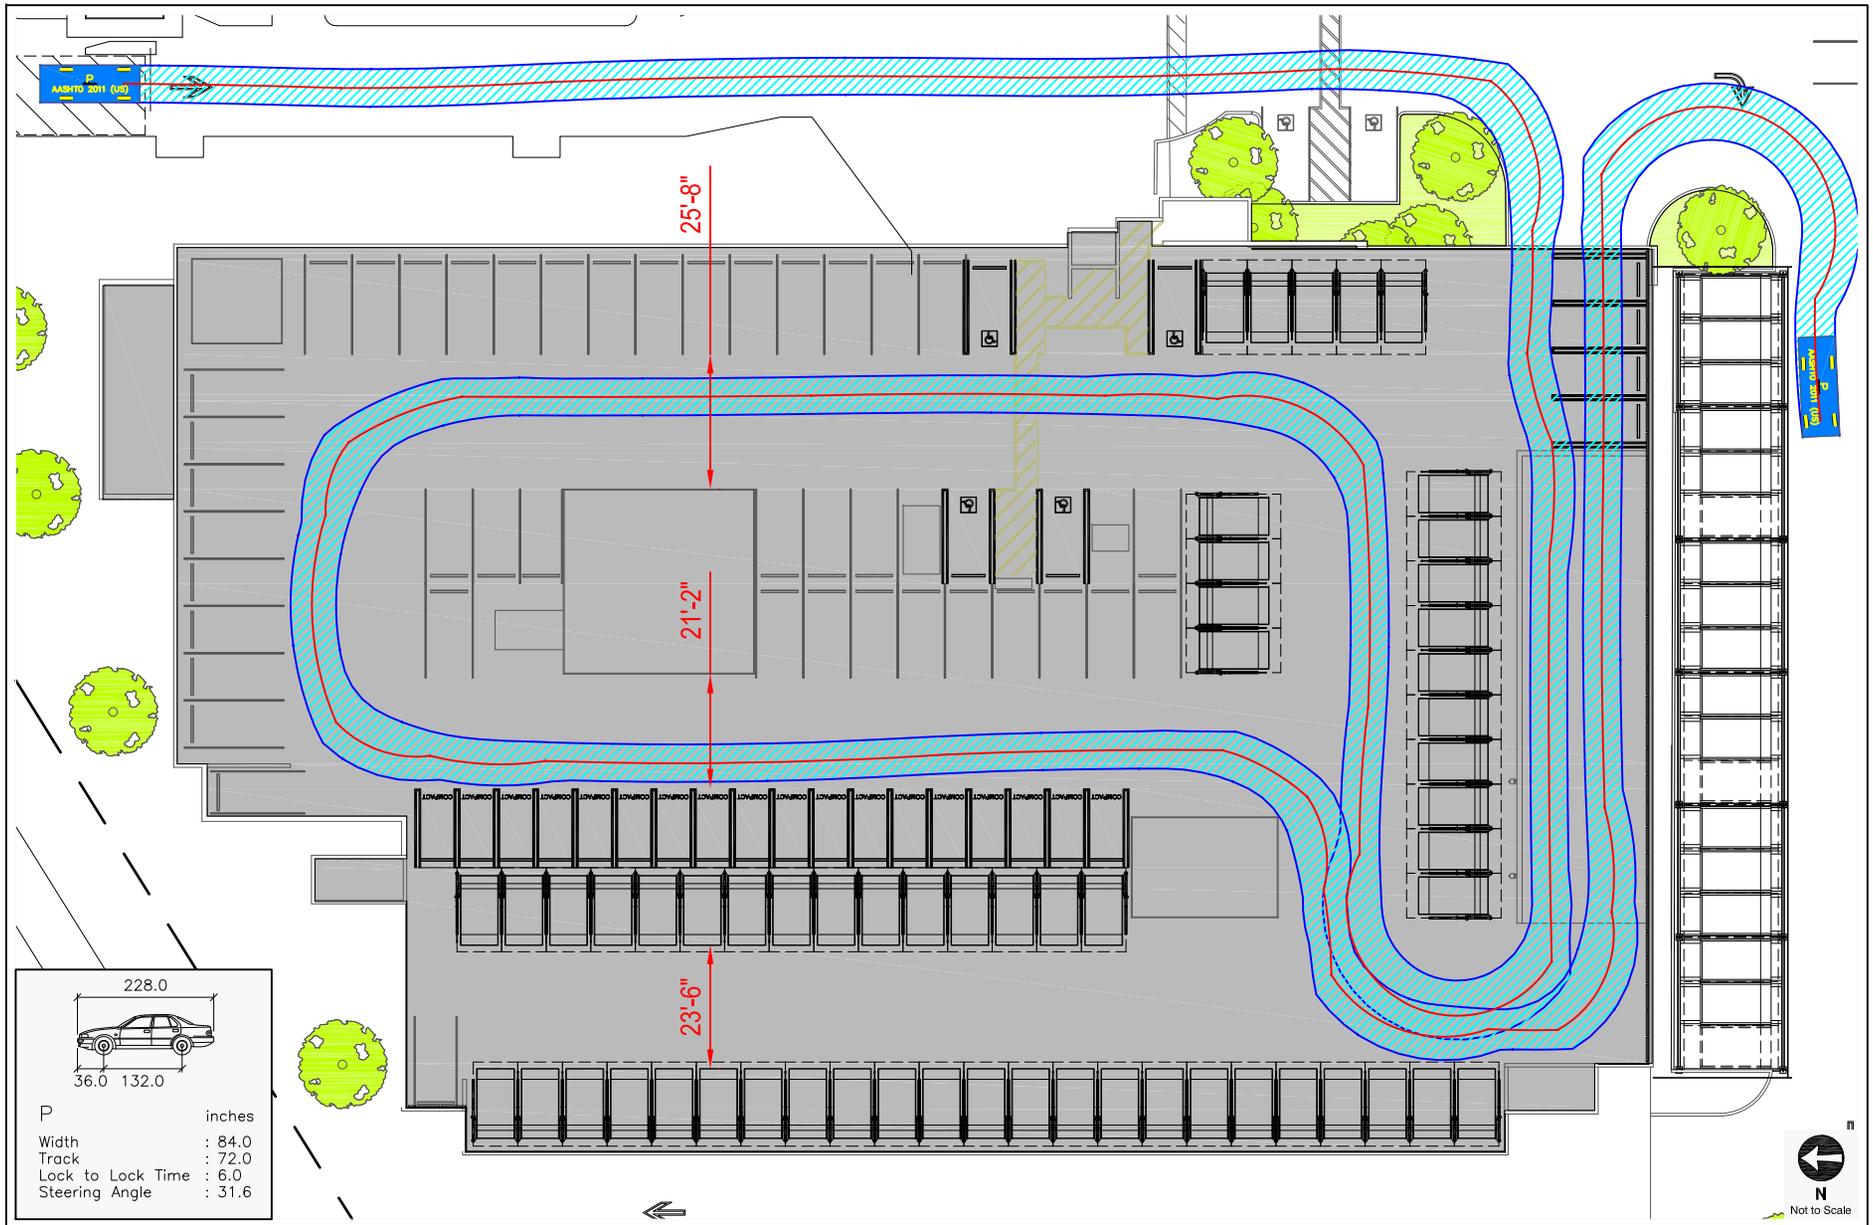
FIGURE
4

GARAGE ROOFTOP CIRCULATION

The garage rooftop section is generally navigable with wide aisles, as shown in Figure 4. During typical loading operations, the circulation is adequate. Figure 5 shows three locations where turnaround is difficult for large vehicles, but could be navigated by compact vehicles.

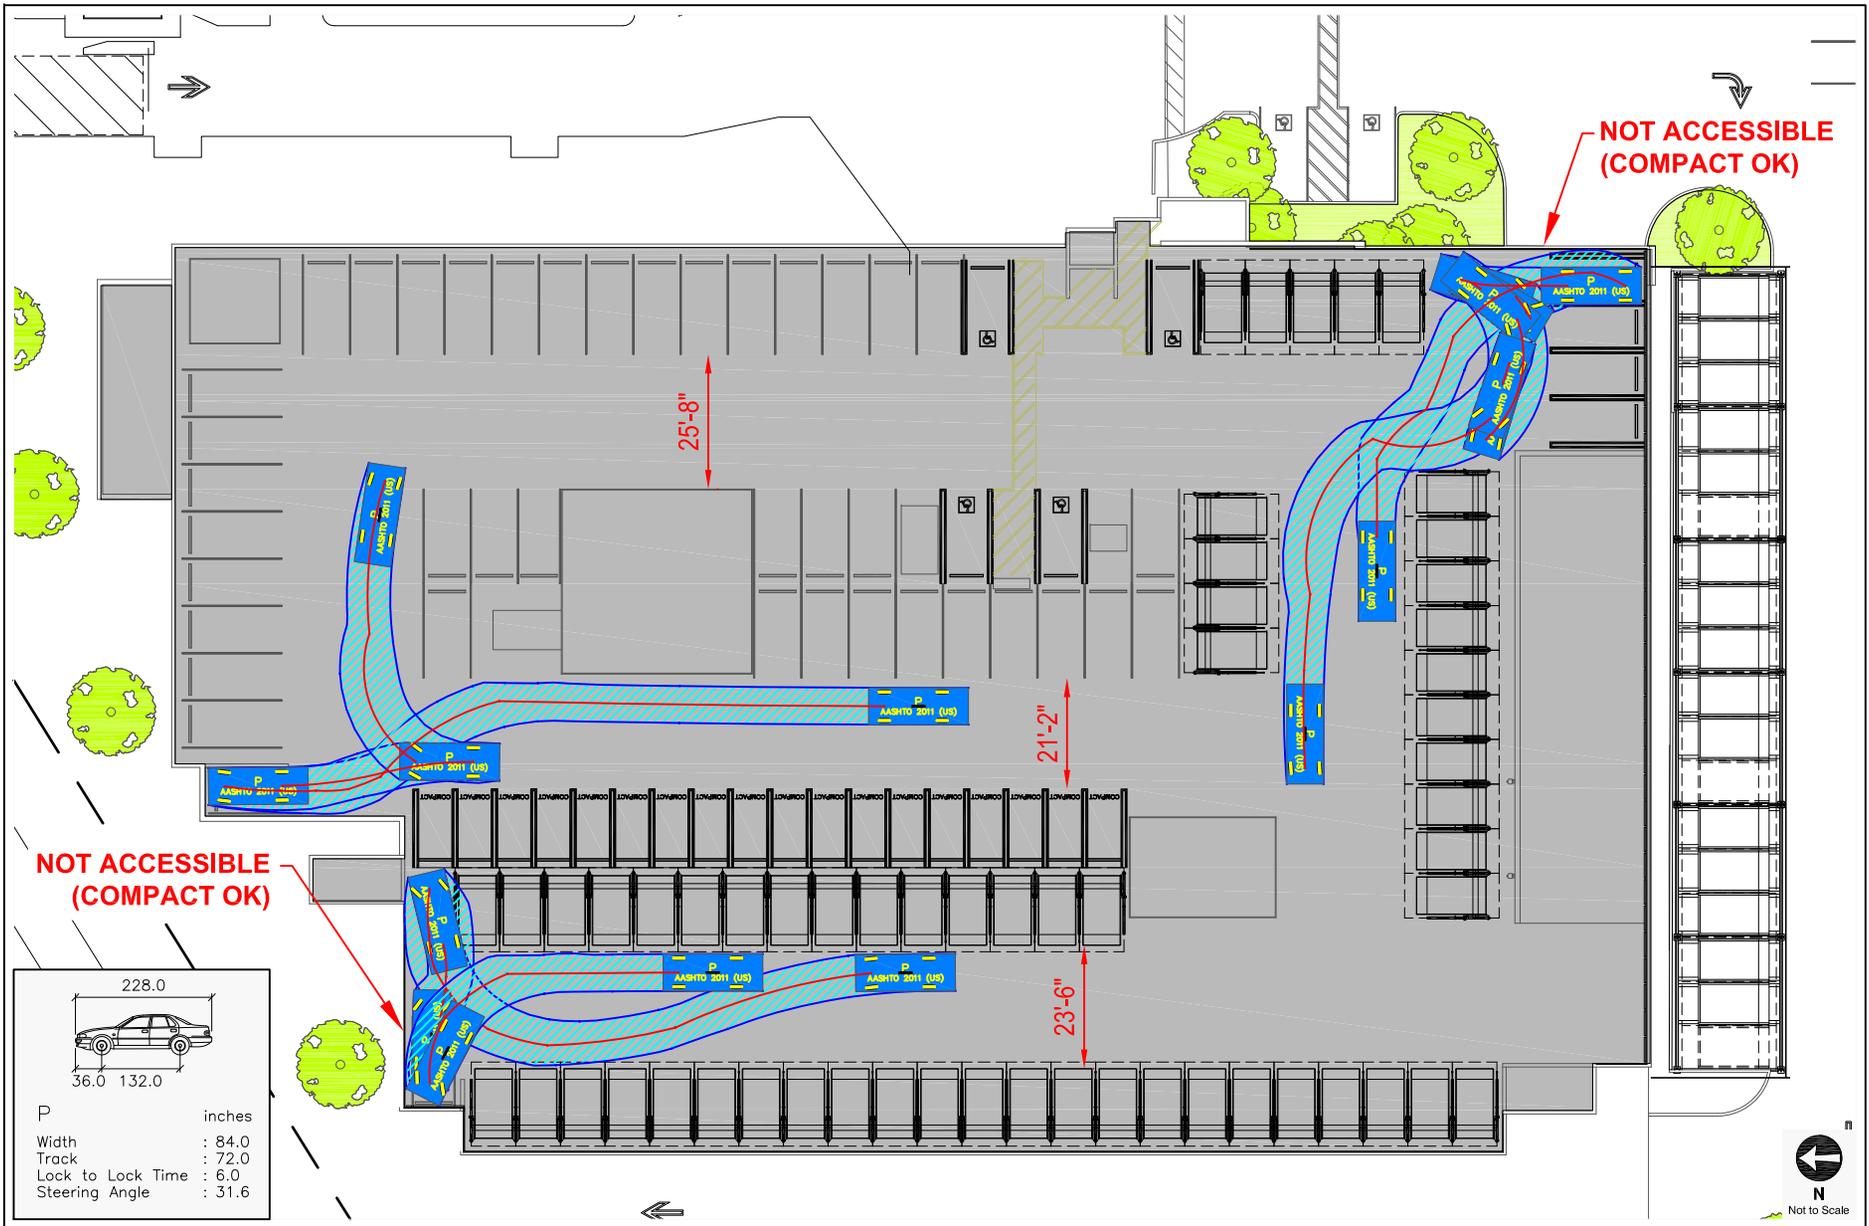
**FIGURE
5**

**PARKING GARAGE
TIGHT OR POOR-ACCESS SPACES**

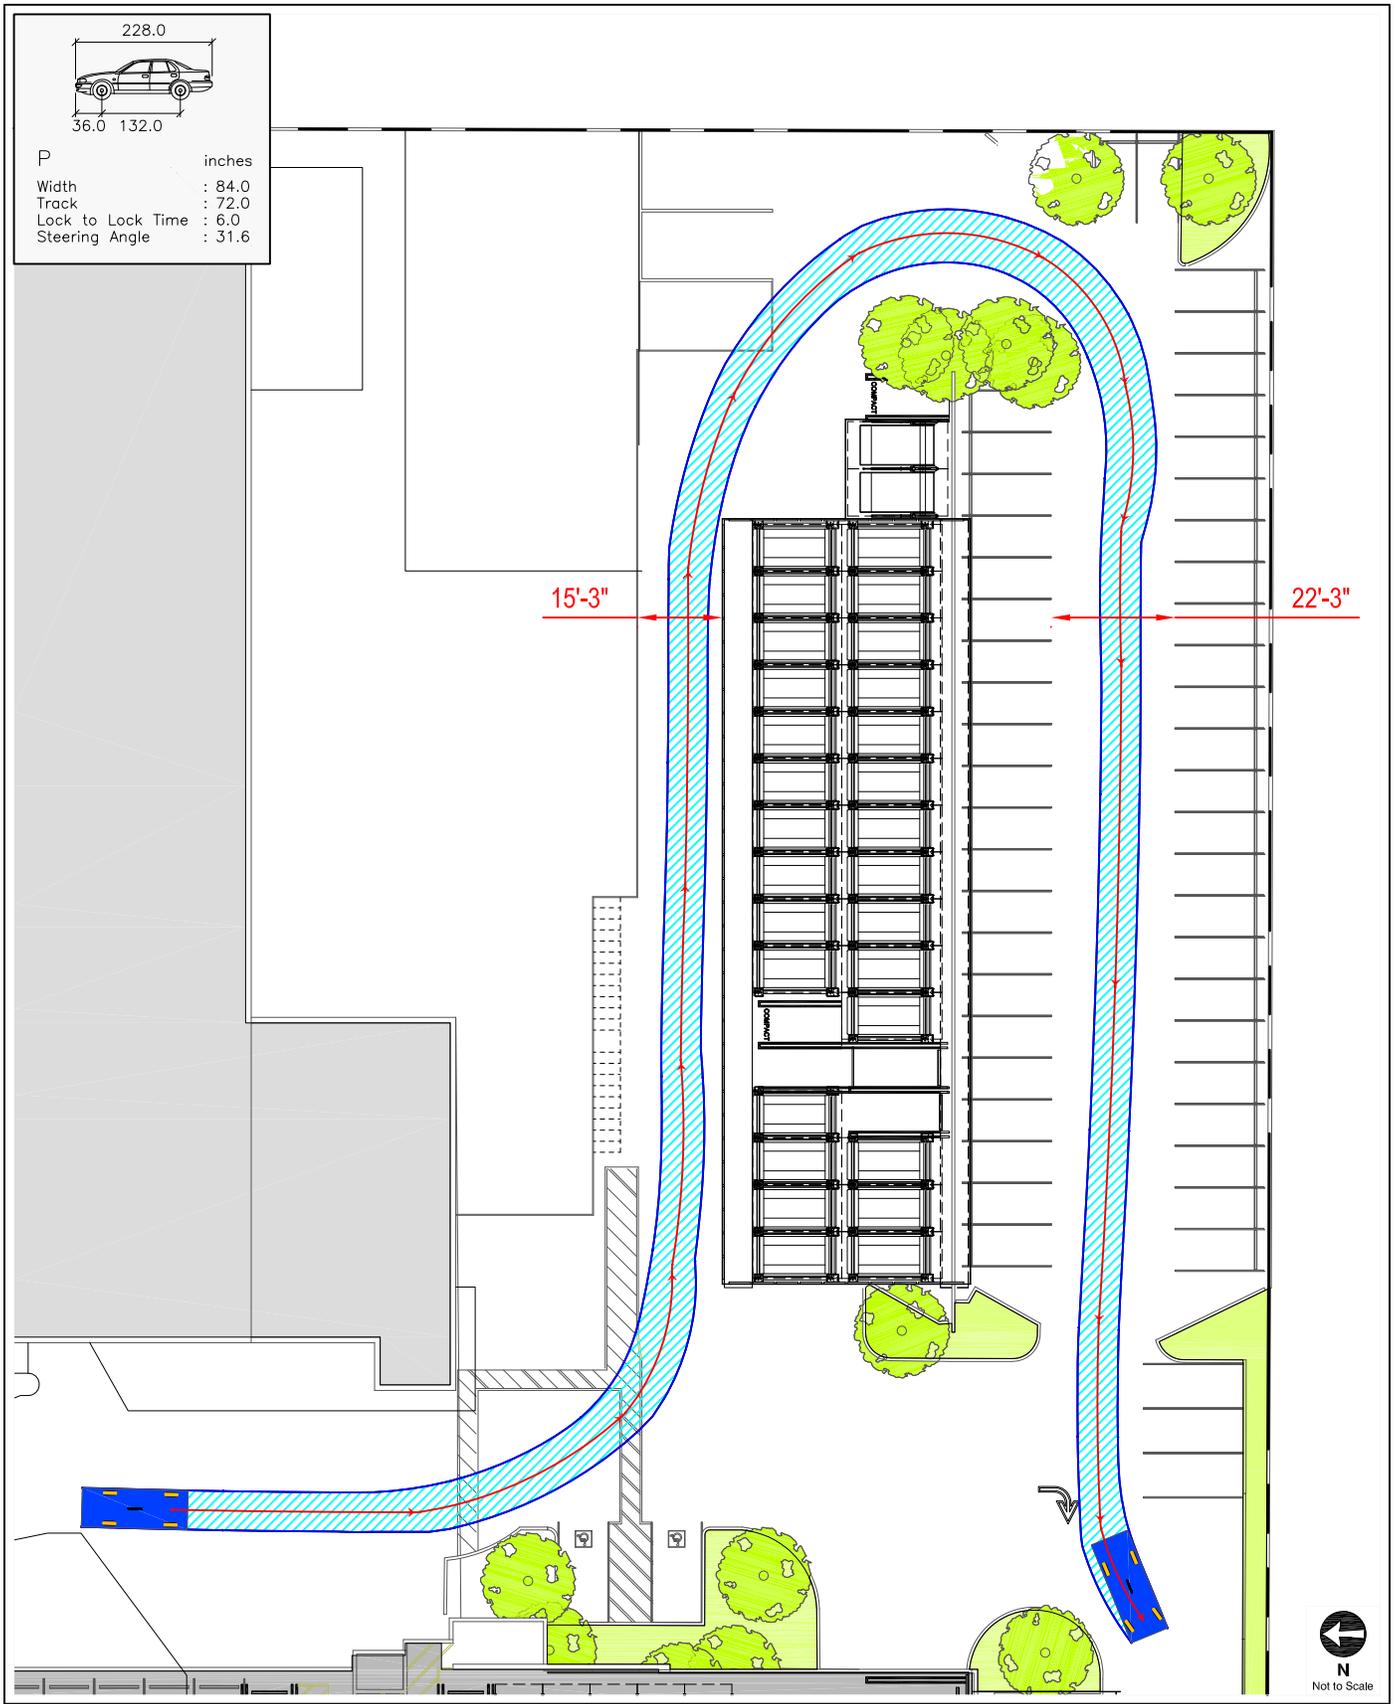
FIGURE
6

NORTH LOT CIRCULATION (STANDARD VEHICLE)

Figure 6 demonstrates that there are no significant circulation issues with the north lot for commuter vehicles.

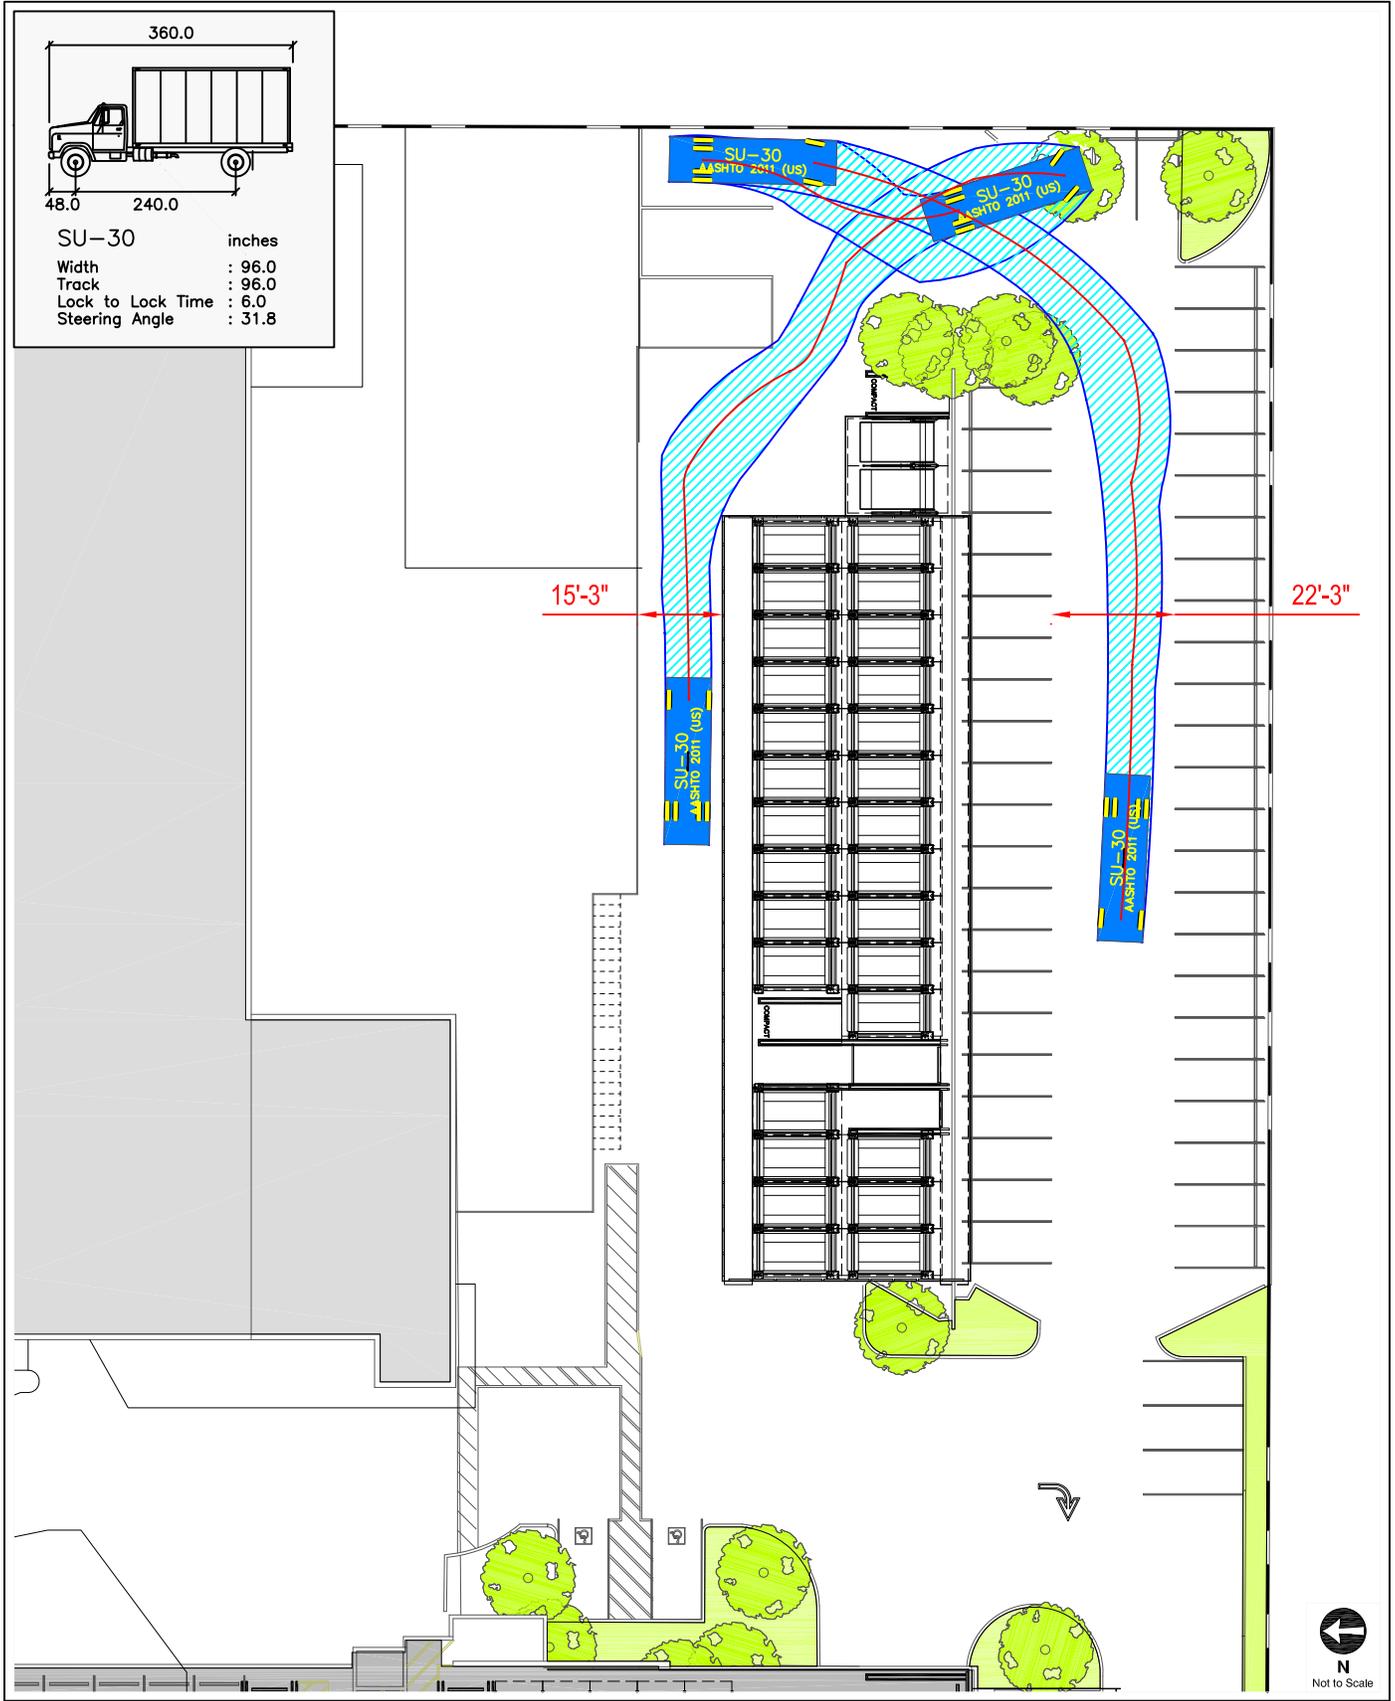
FIGURE 7A

NORTH LOT CIRCULATION (TRASH ENCLOSURE ACCESS)

Figure 7a shows the circulation for a 30-foot truck entering the location to "back-into" position and requires a clockwise approach. Figure 7b shows the circulation for a "head-into" position and requires a counter-clockwise approach. As shown, either approach can be accommodated for this vehicle depending upon the intended orientation; however the plan does depict a landscape tree which may cause obstruction if not trimmed to an appropriate clearance.

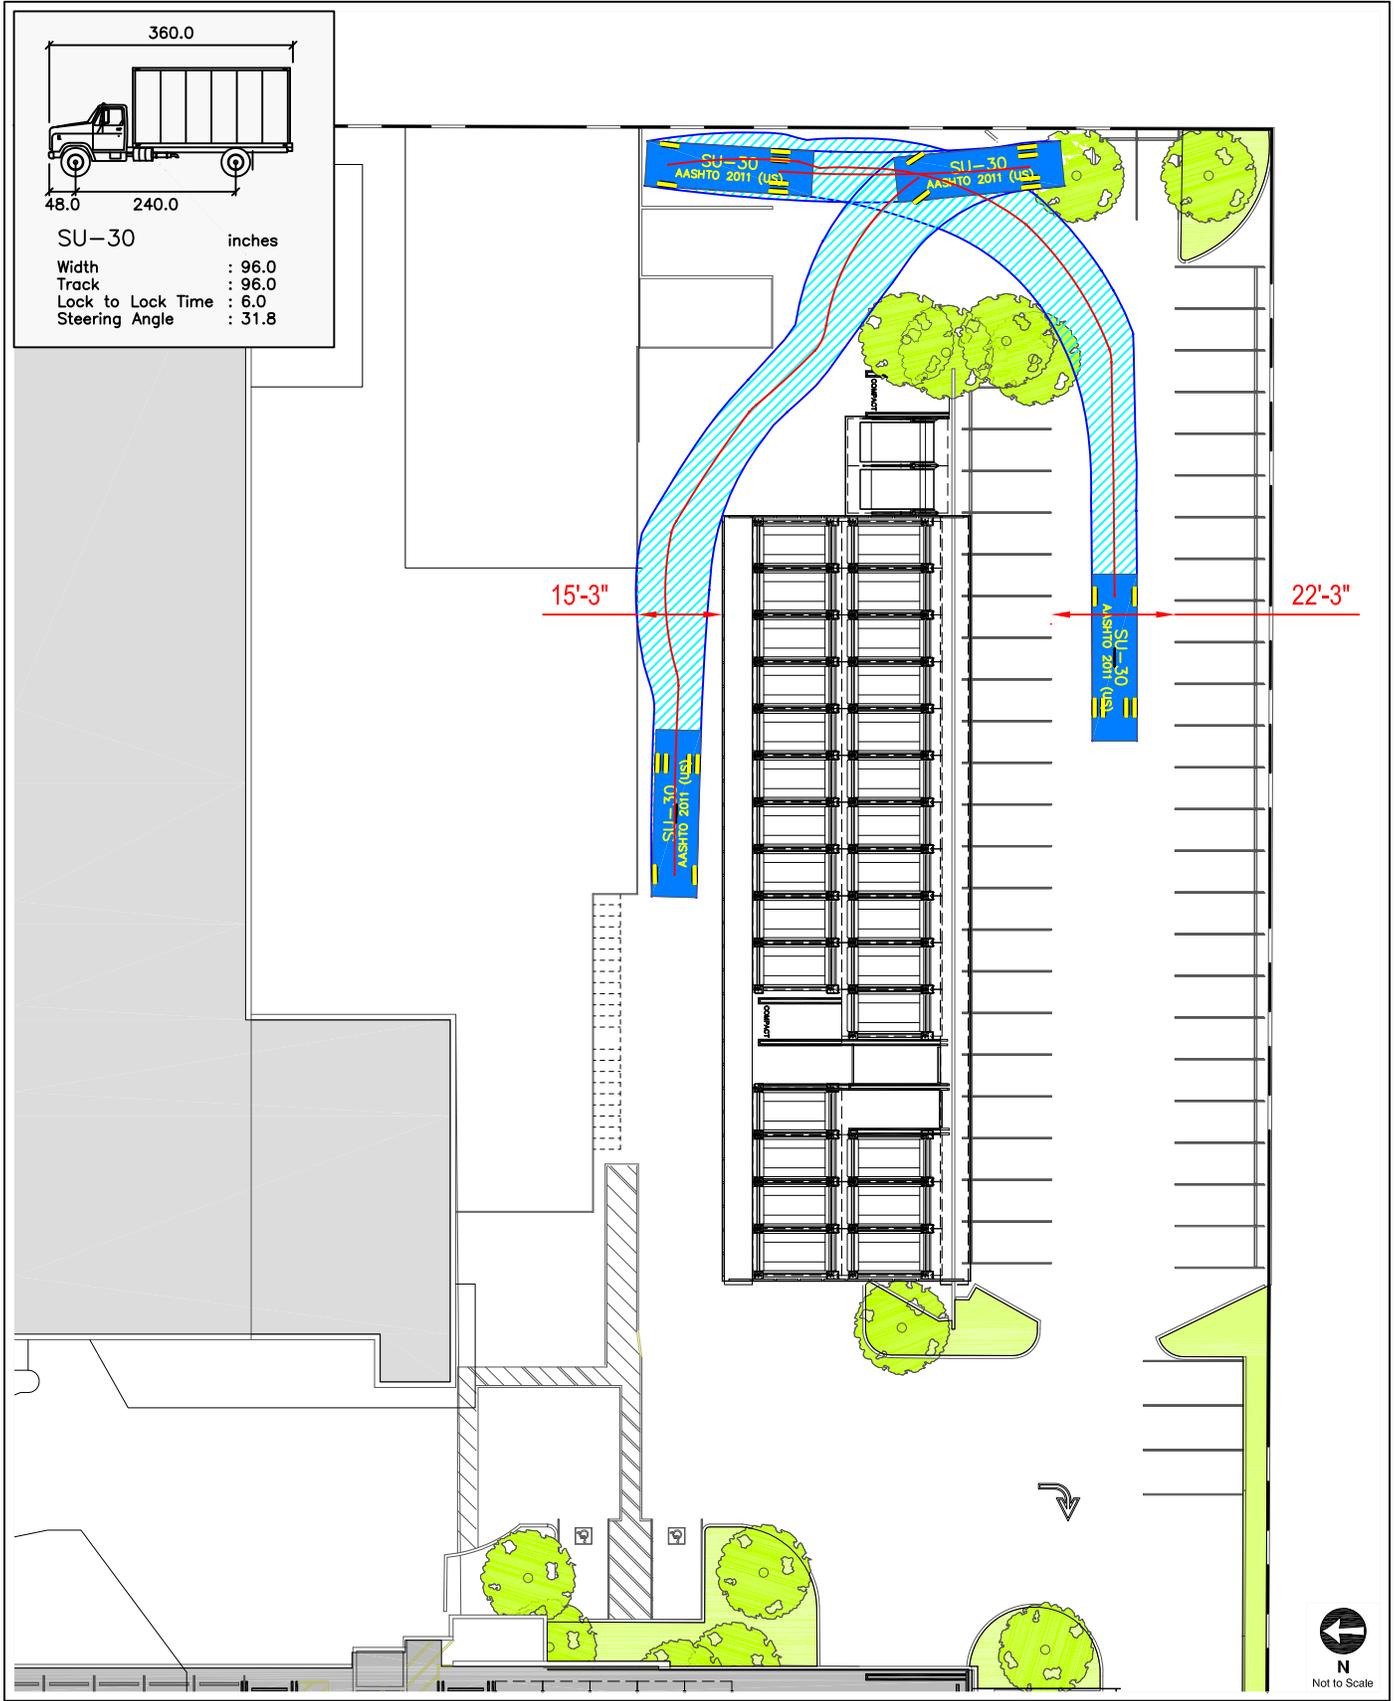
FIGURE 7B

NORTH LOT CIRCULATION (TRASH ENCLOSURE ACCESS)

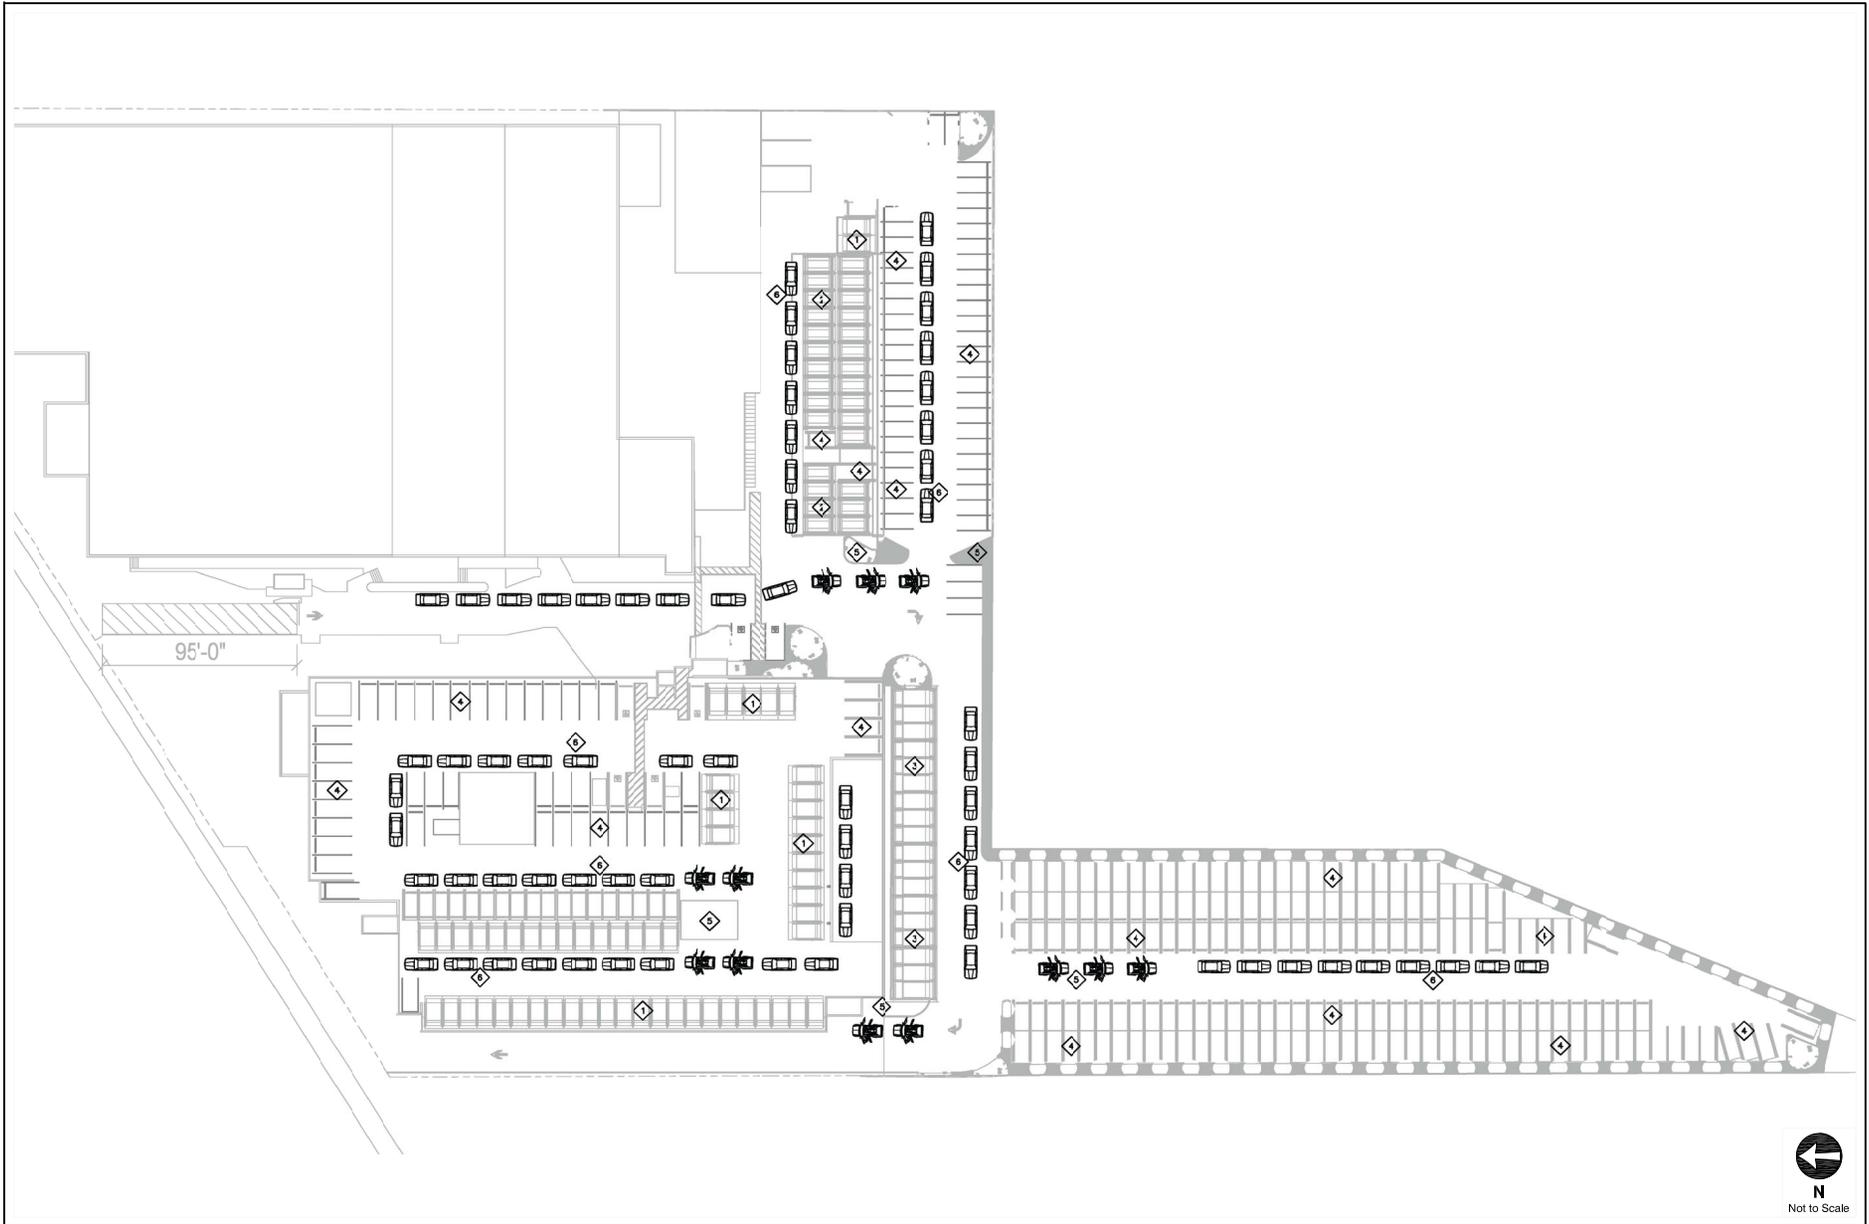
FIGURE
8

OPERATIONAL PLAN WITH VALET STACKING

Figure 8 illustrates the valet staging areas utilized during all operational hours (current and future), including the three shown and two internal to the garage. These stations will be managed throughout the day, not only during the peak hours. The internal valets can “float” to other areas when demand is greater elsewhere. As shown within all surface lots and the rooftop, stacked vehicles eliminate half of an aisle-width, which will reduce the circulation band. However, because this flow will be operated by professionals (not self-park), able to maintain emergency vehicle throughput at all times, no fatal flaws were identified in this operational portion of the design plan.

Based on the review of the operational valet staging (Figure 8), the amount of linear on-site storage is substantial without interfering with emergency access. Any delays created by equipment deficiency/failure or other loading/unloading issue, would not impact the amount of inbound queuing at the transaction gate (entry) since there is adequate room to hold vehicles on-site, and typically those vehicles will be far removed from the entry gate.
