## MEMORANDUM

**RE:** Assessment of Circulation and Parking for  
10950 Washington Boulevard Parking Improvement Project  
Culver City, California

**Ref:** J1614

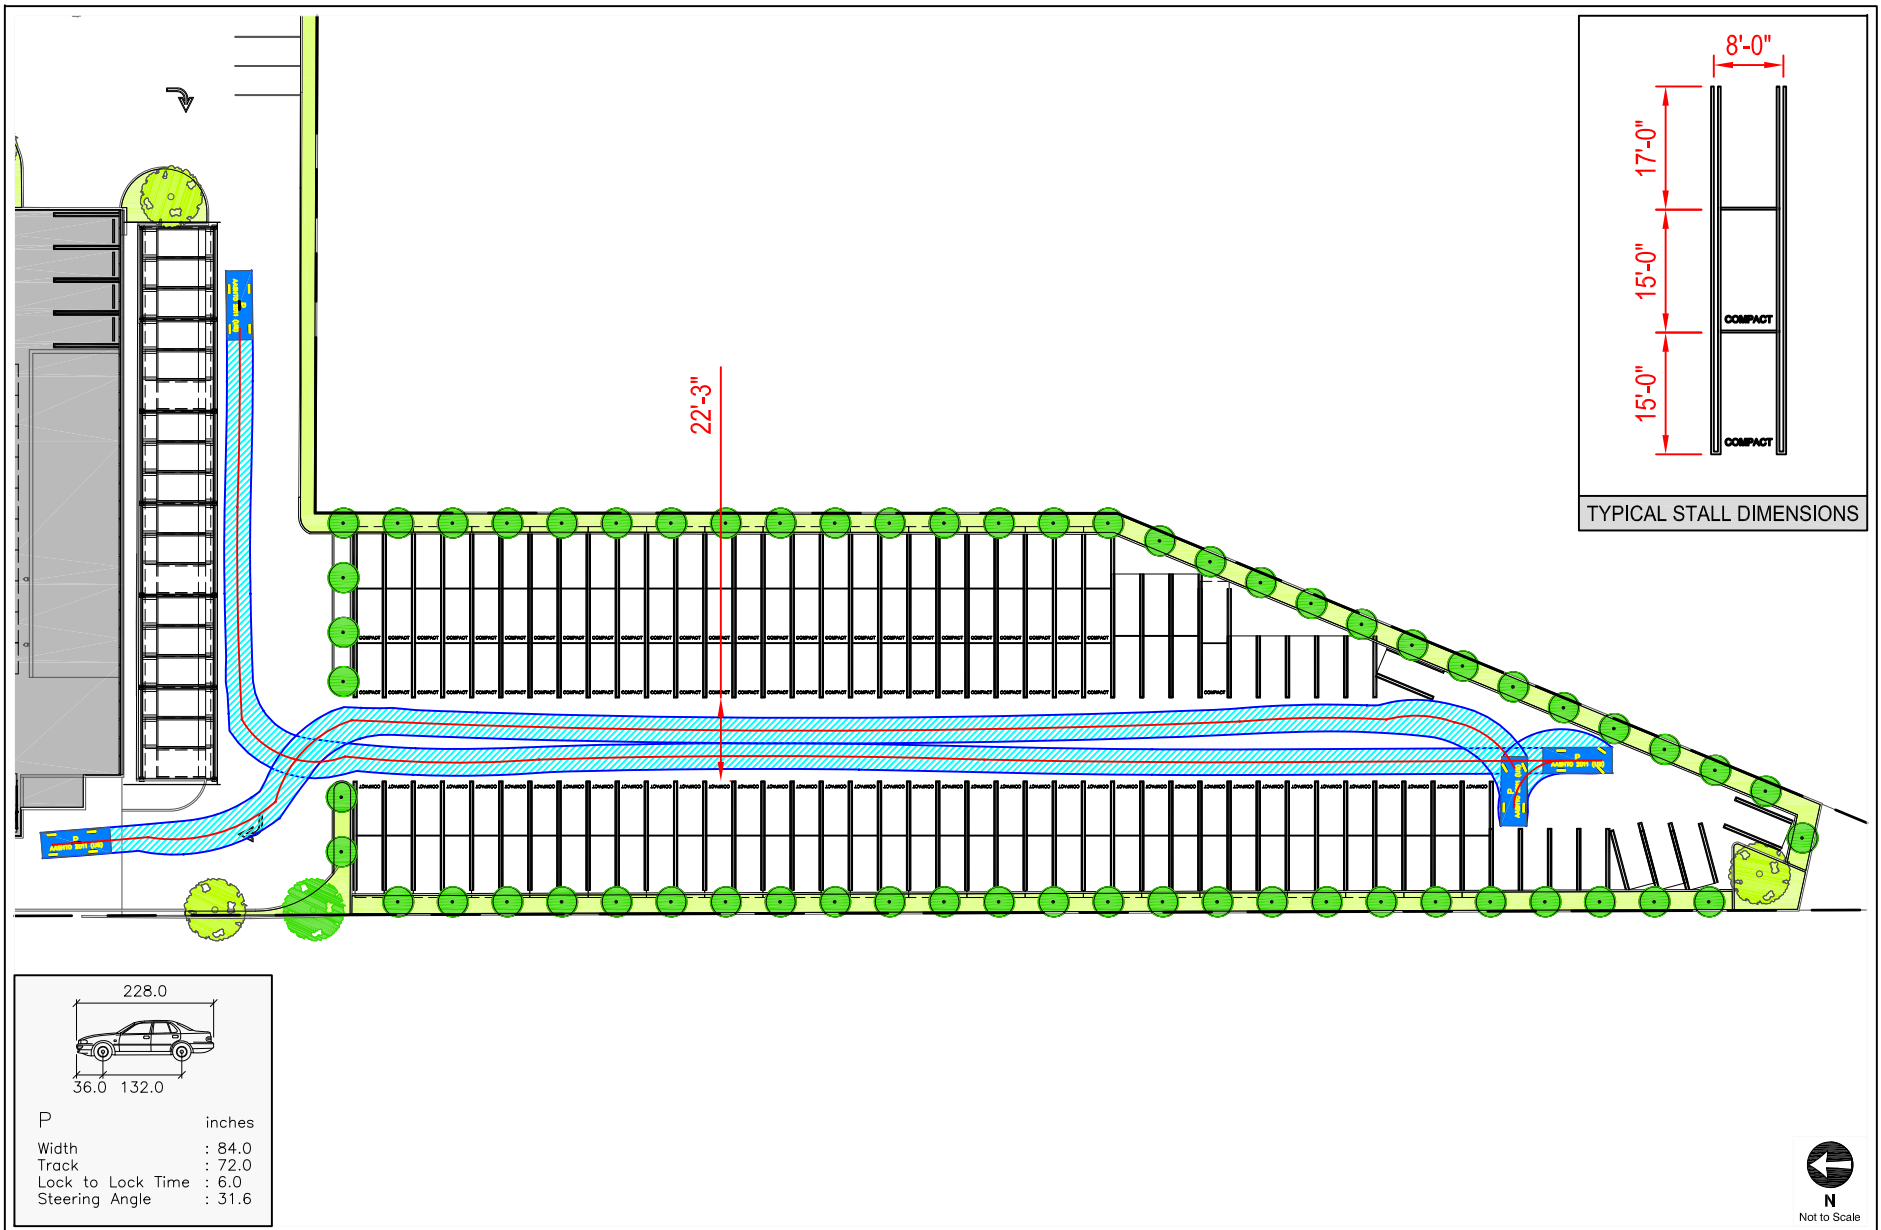
FIGURE  
1

SOUTH LOT CIRCULATION WITH 3-POINT TURN AT END

Figure 1 shows the basic circulation through the south lot, which is a surface parking area that will be restriped with the new plan for dual- and triple-tandem spaces. This lot has only one aisle due to the tandem design. As such, all vehicles that reach the endpoint must execute a three-point turn. Based on the example in Figure 1, this may be accomplished, but it remains a tight turn for a large vehicle.

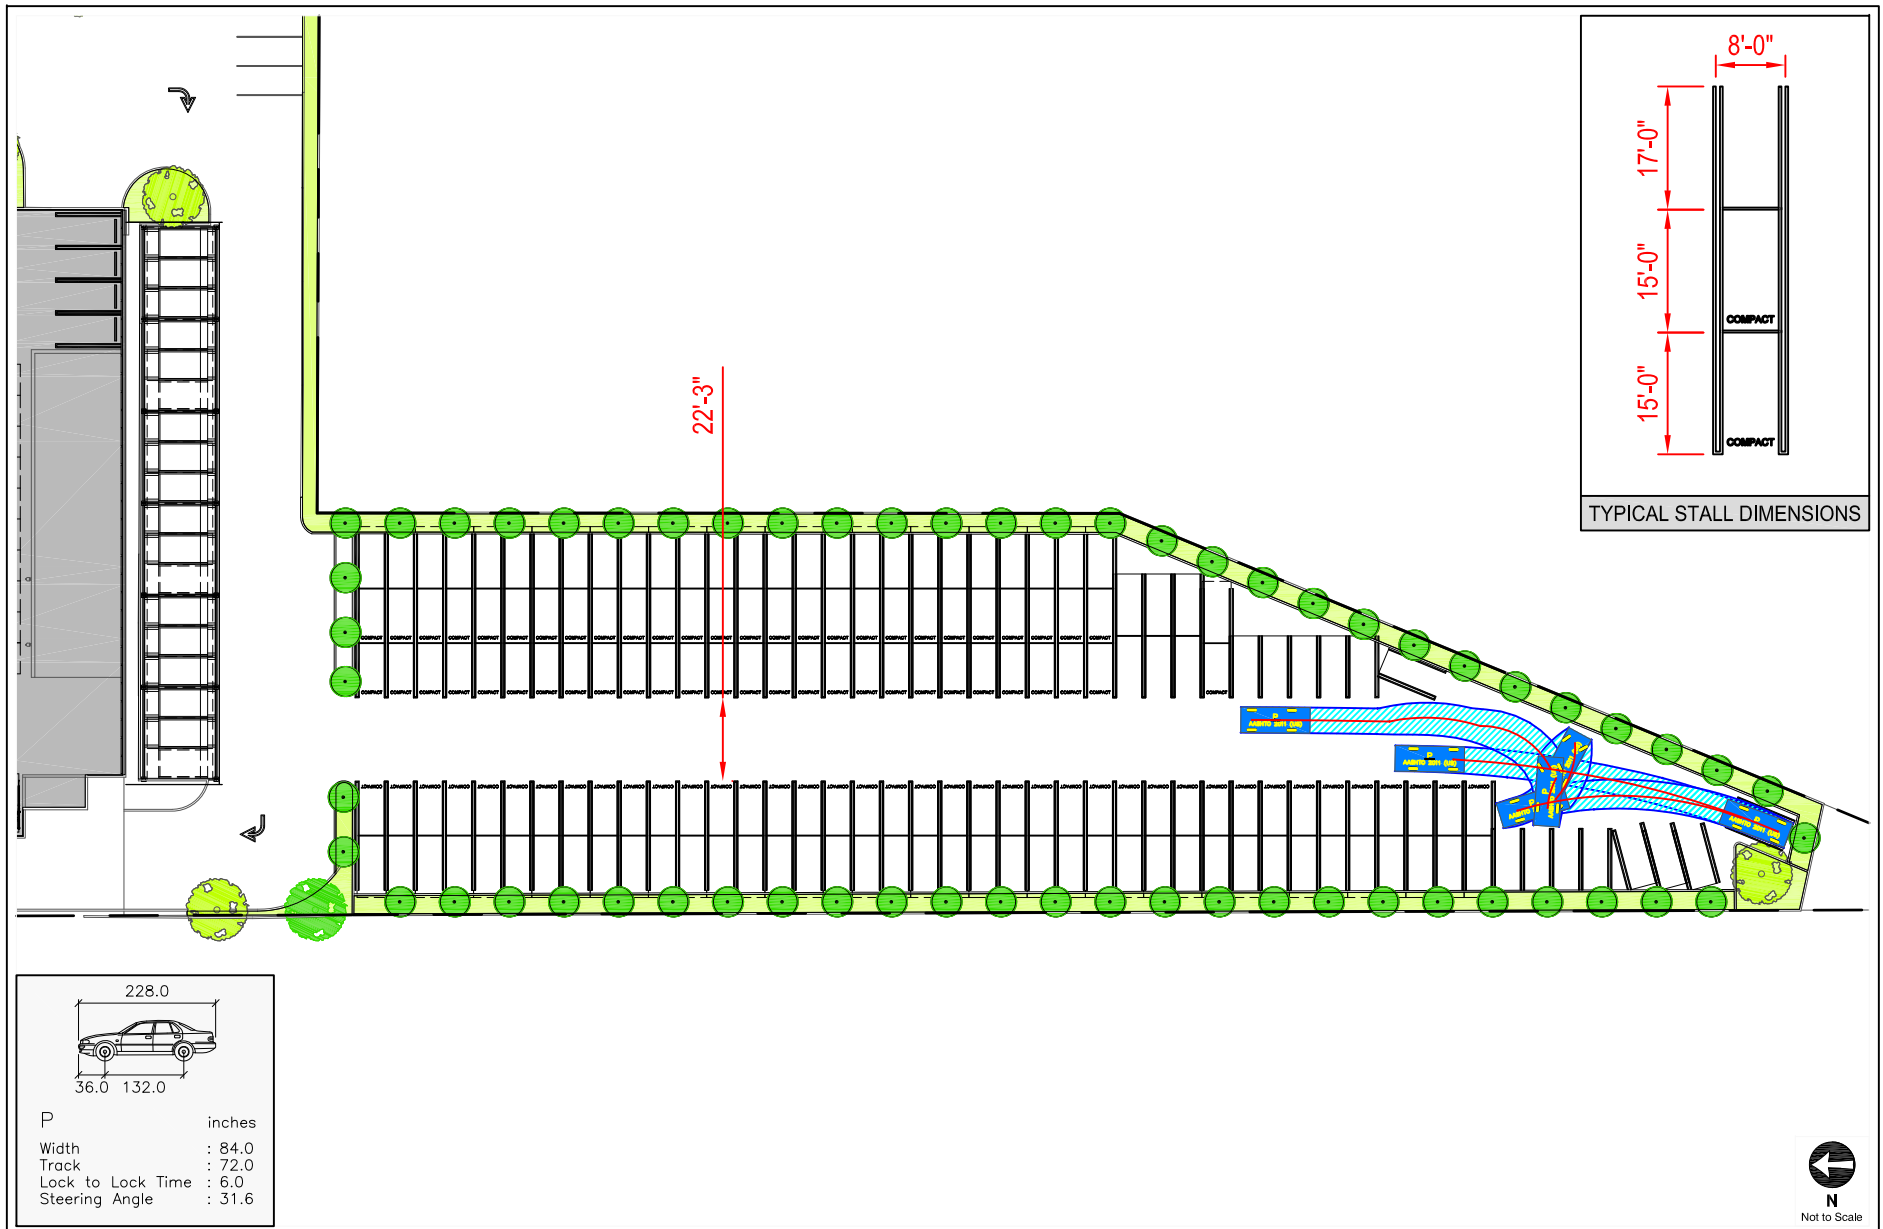
FIGURE  
2

SOUTH LOT CIRCULATION - COMPLICATED PARKING SPACE 1

Figures 2 and 3 demonstrate the difficulties for vehicles accessing two constrained spaces inside the south lot, requiring a series of tight turns to execute the maneuver.

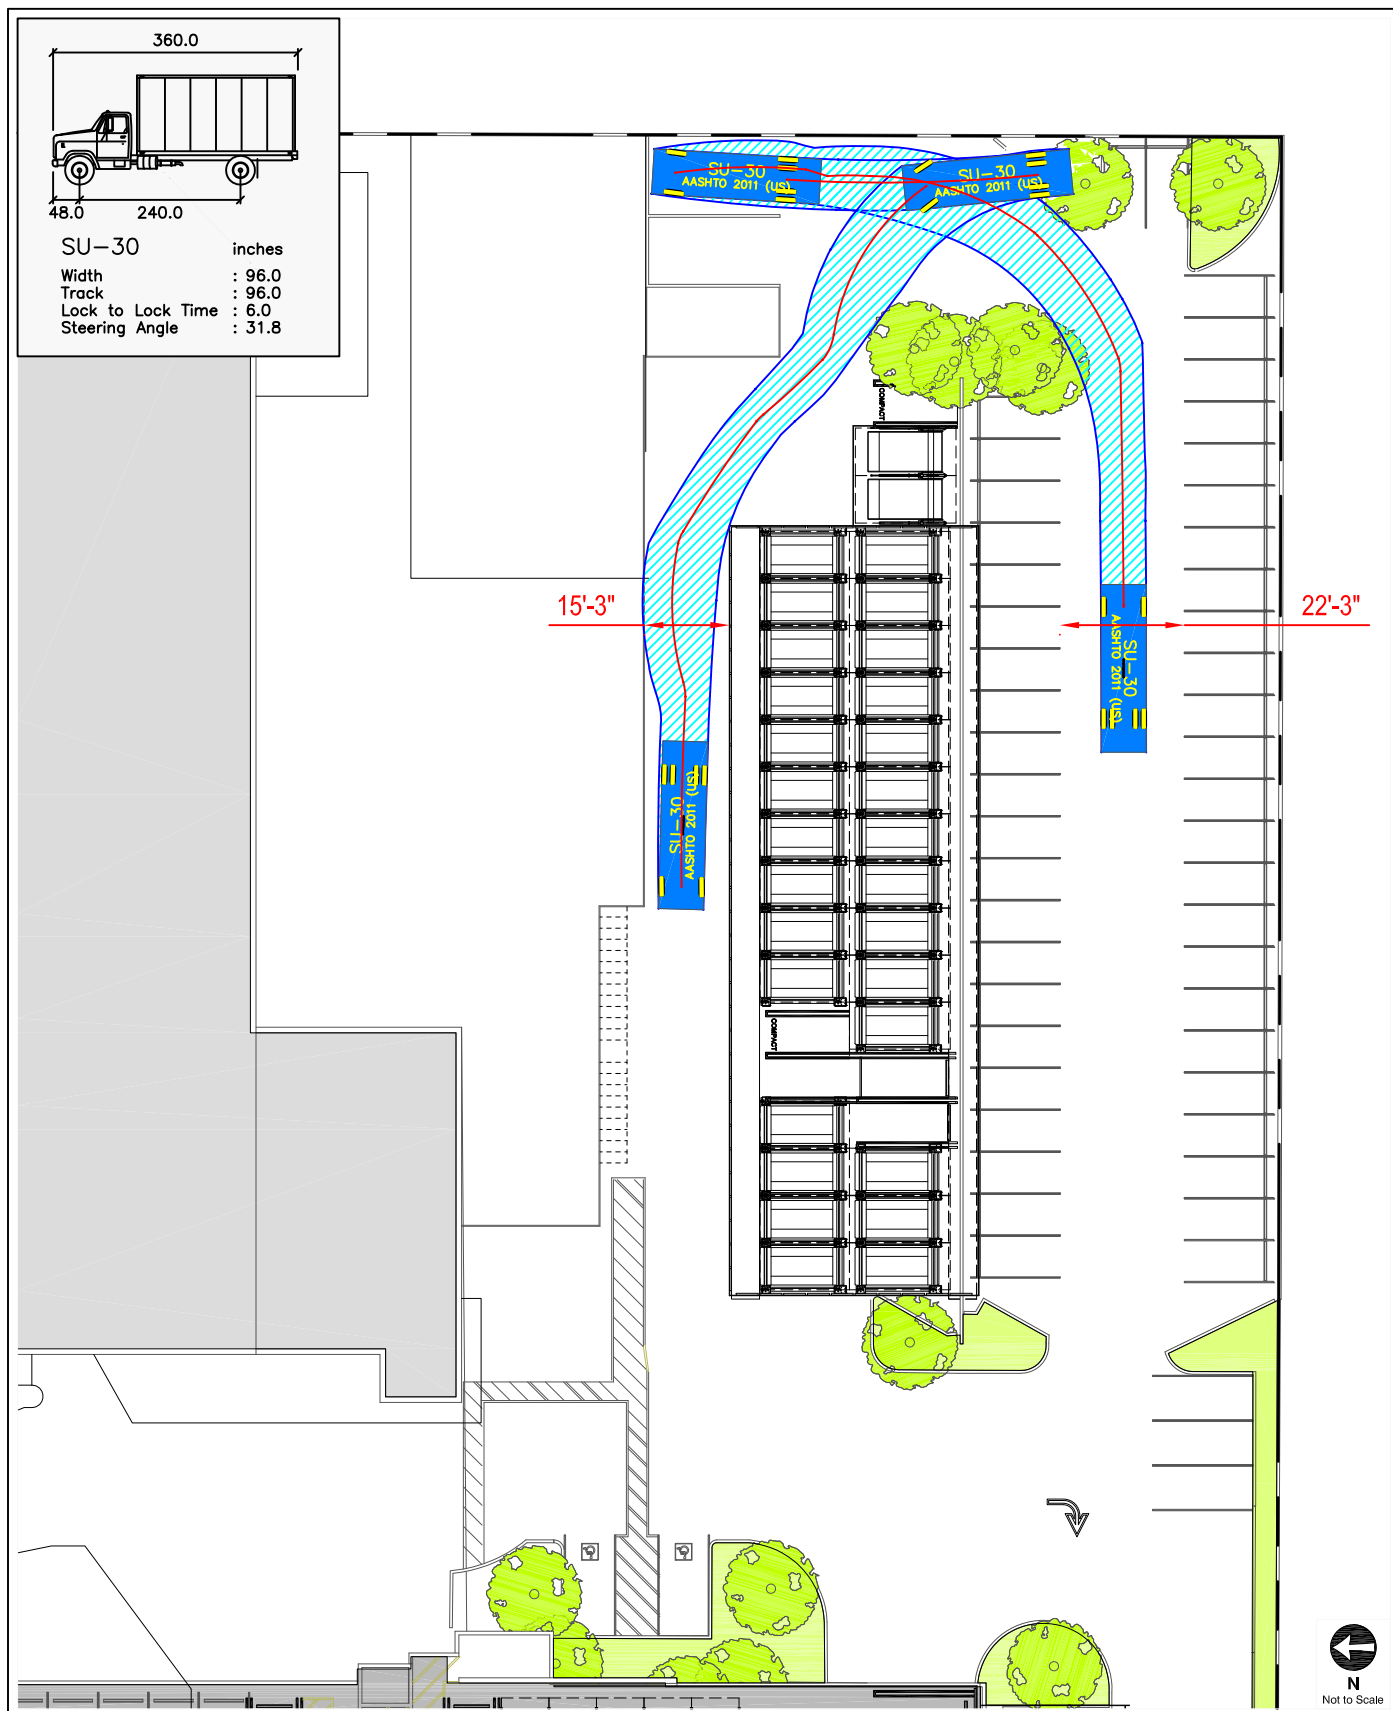
FIGURE  
7B

NORTH LOT CIRCULATION (TRASH ENCLOSURE ACCESS)

Figure 7a shows the circulation for a 30-foot truck entering the location to "back-into" position and requires a clockwise approach. Figure 7b shows the circulation for a "head-into" position and requires a counter-clockwise approach. As shown, either approach can be accommodated for this vehicle depending upon the intended orientation; however the plan does depict a landscape tree which may cause obstruction if not trimmed to an appropriate clearance.
