MEMORANDUM

RE: Assessment of Circulation and Parking for
10950 Washington Boulevard Parking Improvement Project
Culver City, California

Ref: J1614

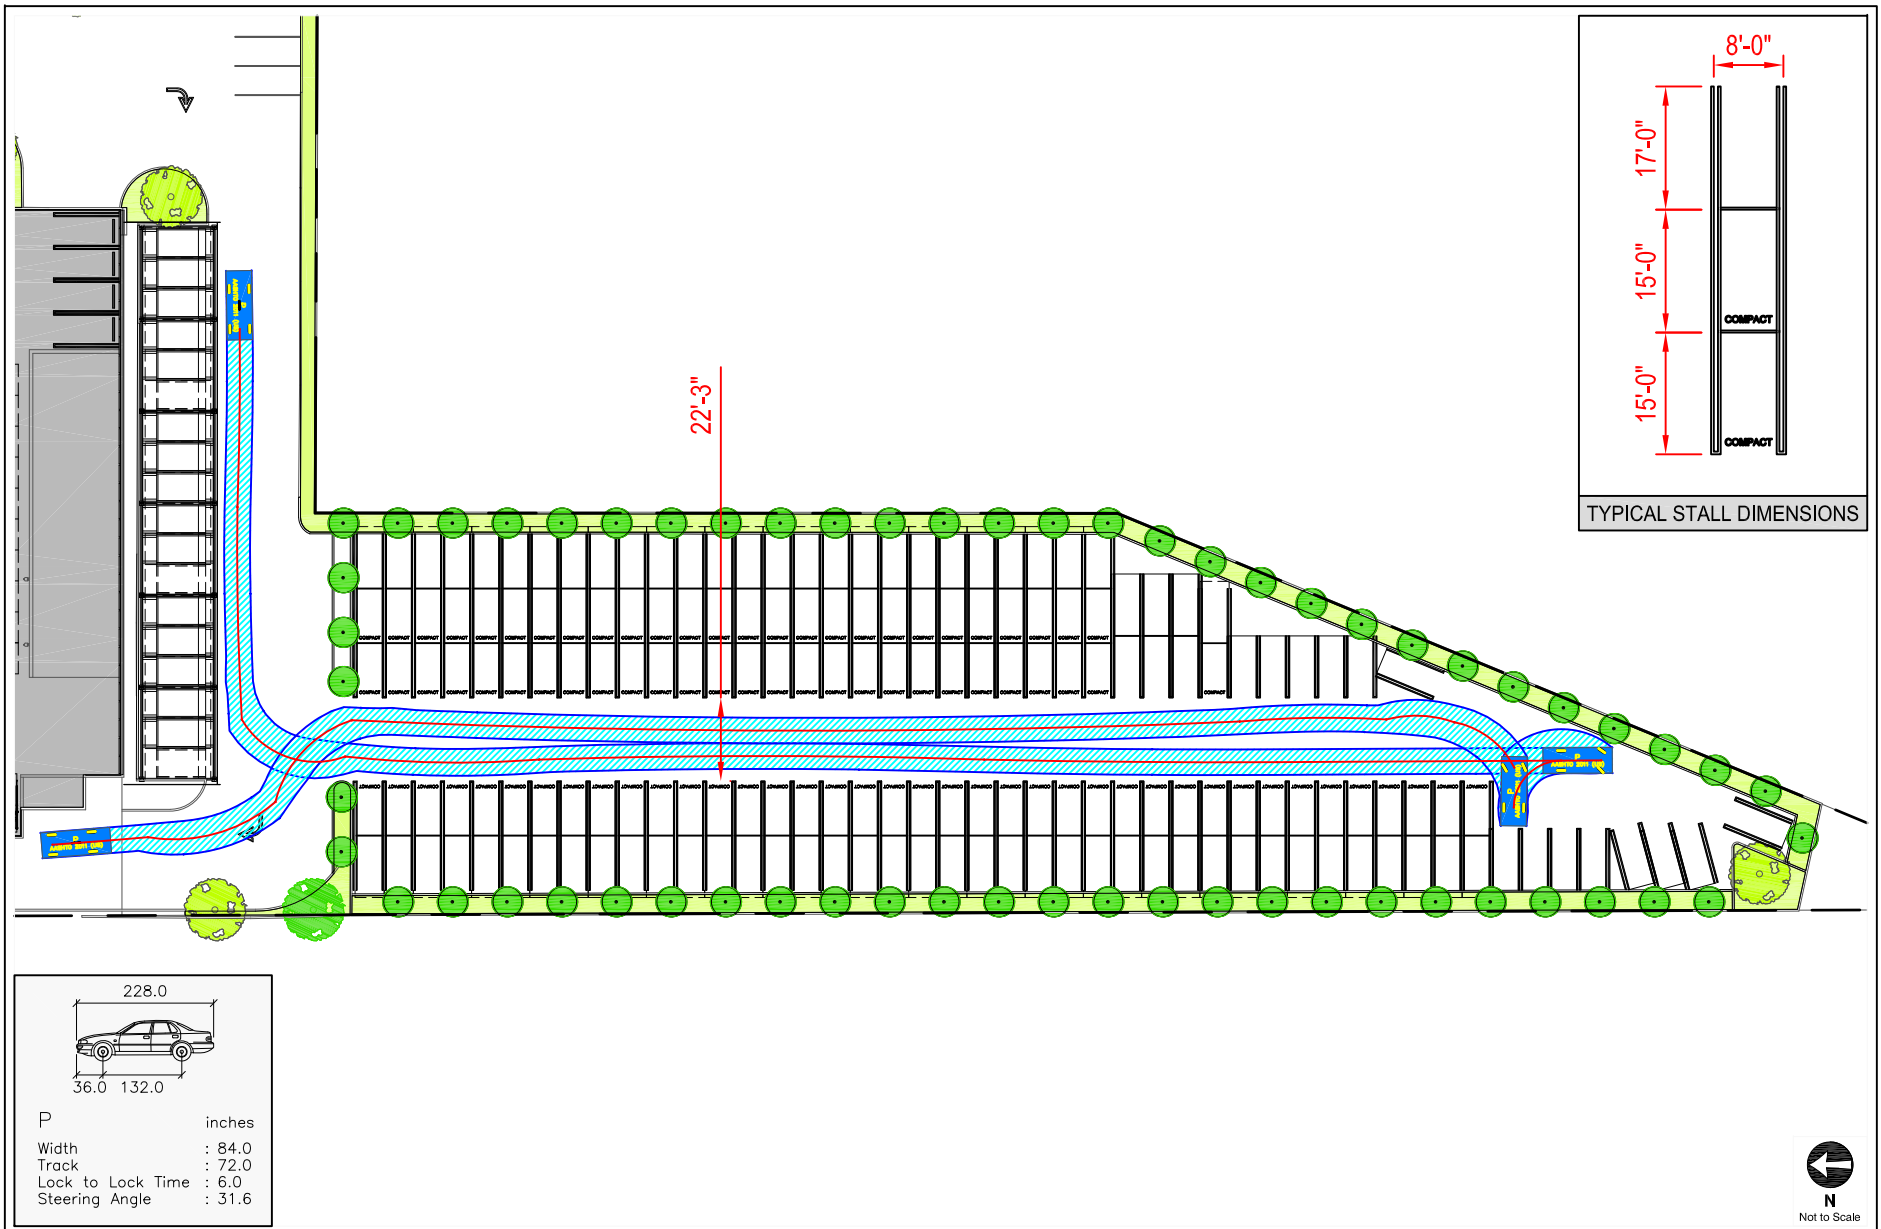
FIGURE
1

SOUTH LOT CIRCULATION WITH 3-POINT TURN AT END

Figure 1 shows the basic circulation through the south lot, which is a surface parking area that will be restriped with the new plan for dual- and triple-tandem spaces. This lot has only one aisle due to the tandem design. As such, all vehicles that reach the endpoint must execute a three-point turn. Based on the example in Figure 1, this may be accomplished, but it remains a tight turn for a large vehicle.

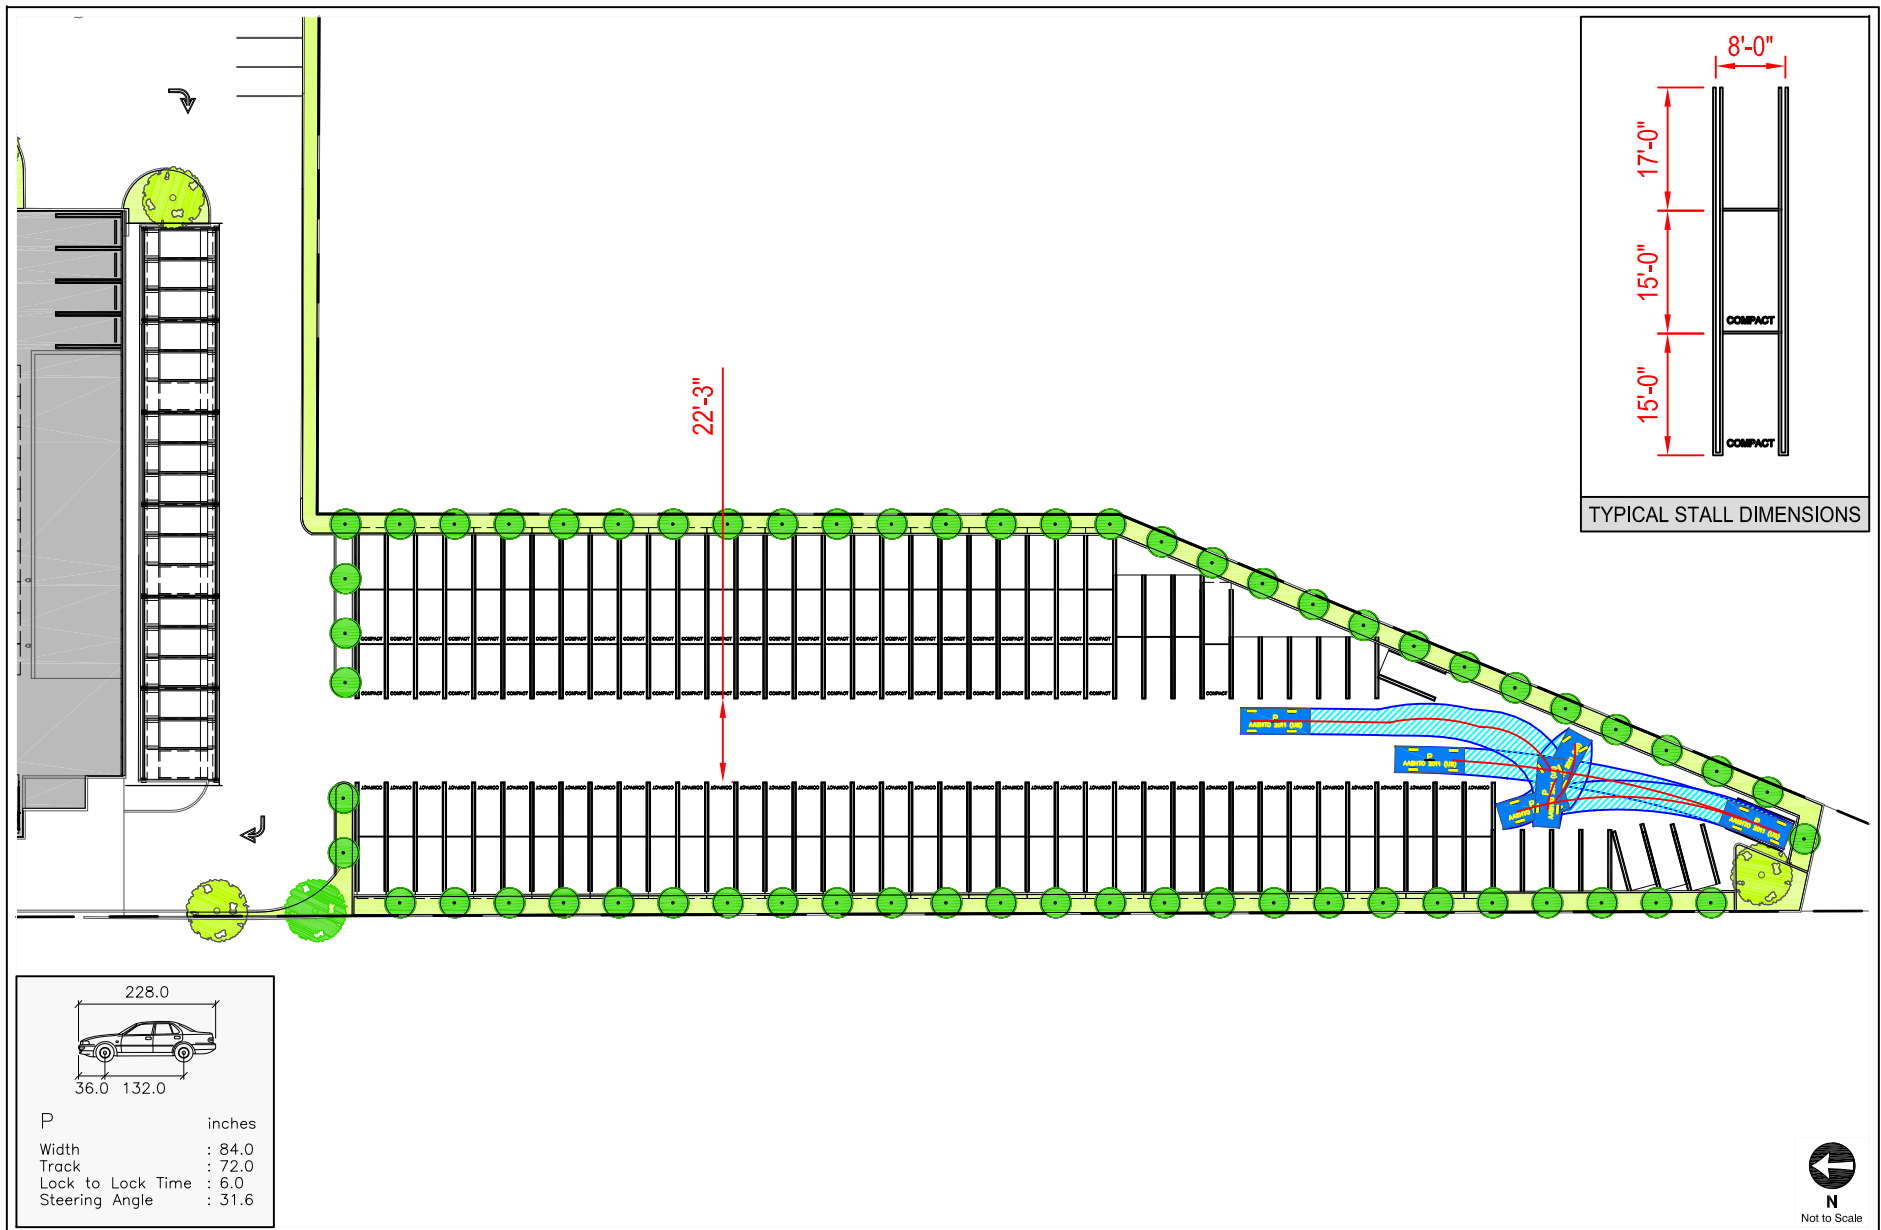
FIGURE
2

SOUTH LOT CIRCULATION - COMPLICATED PARKING SPACE 1

Figures 2 and 3 demonstrate the difficulties for vehicles accessing two constrained spaces inside the south lot, requiring a series of tight turns to execute the maneuver.

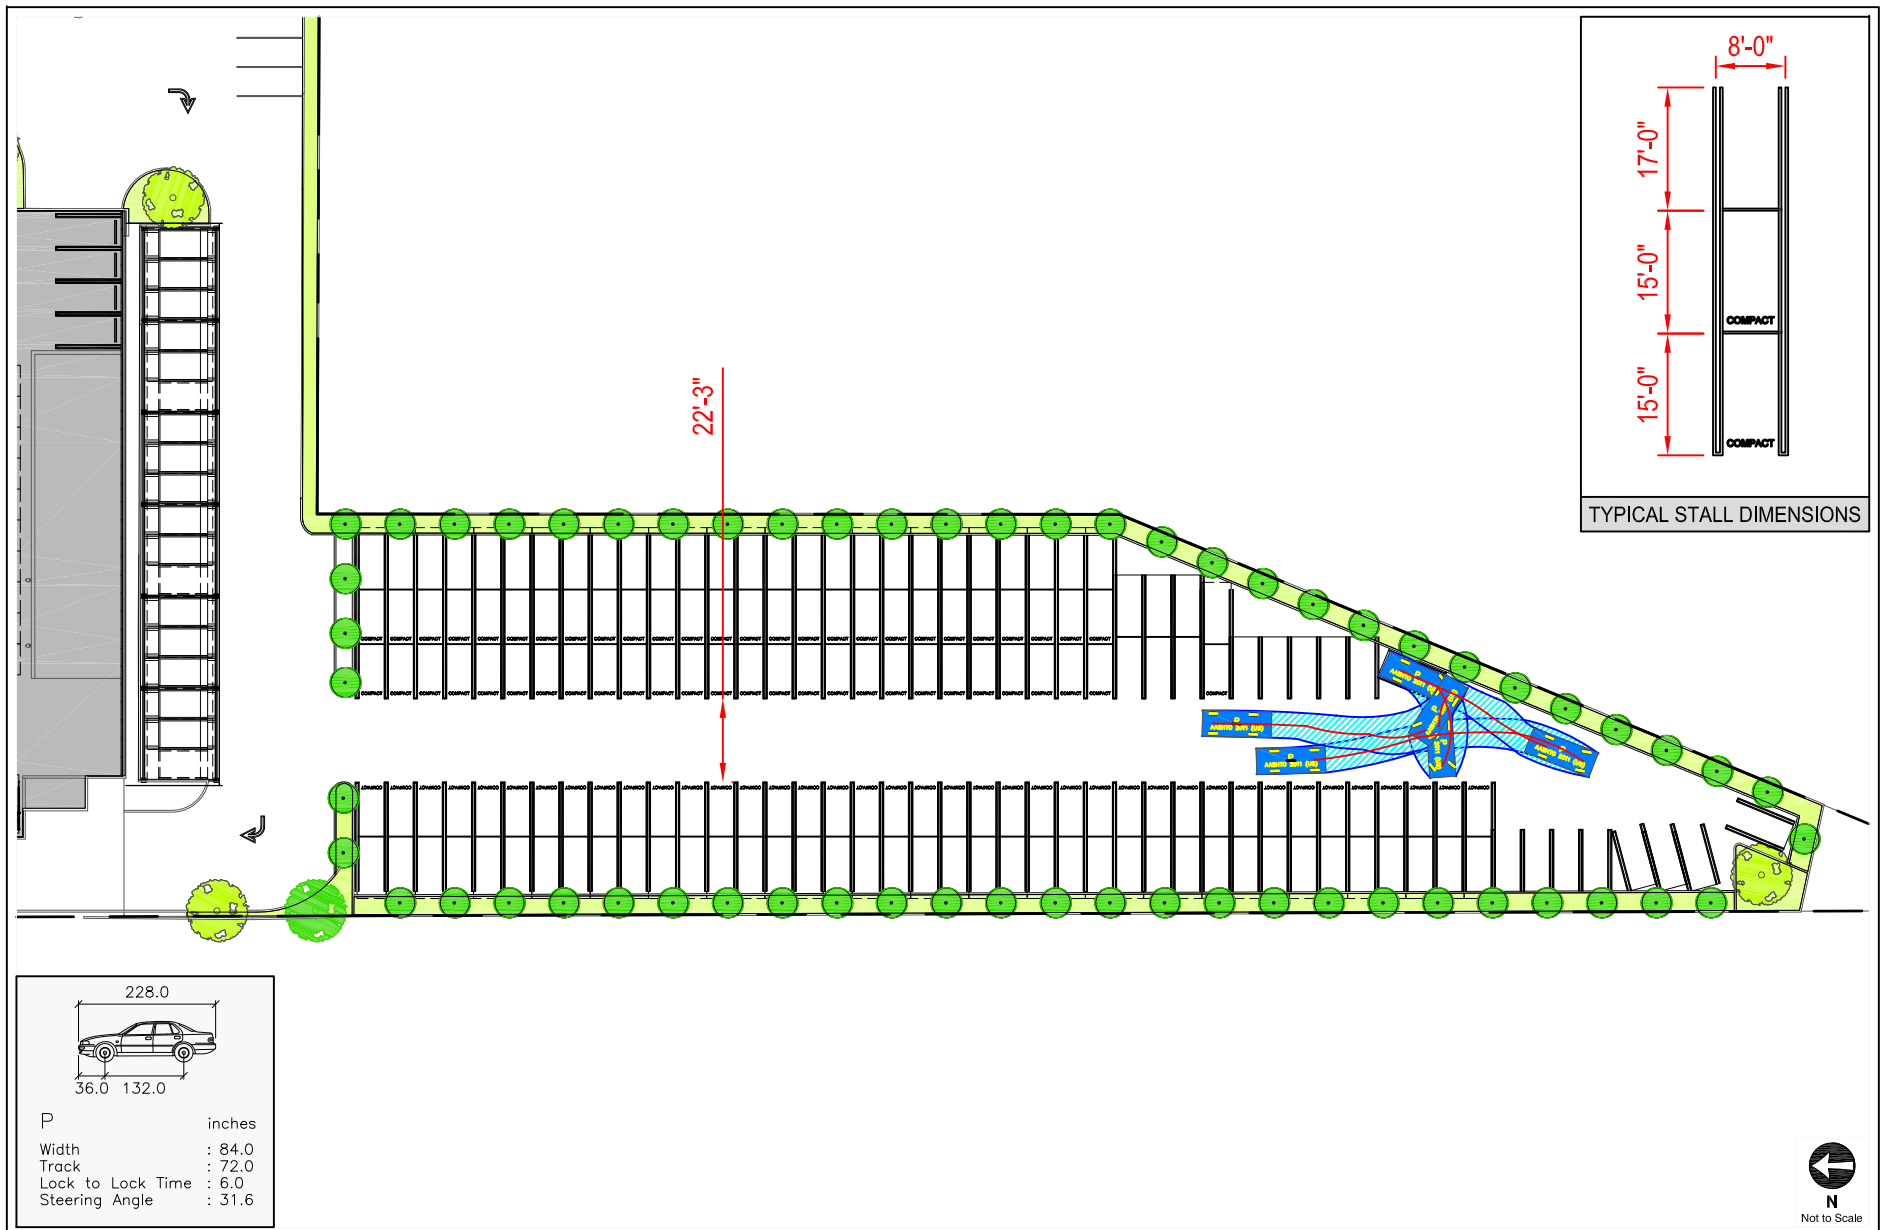
FIGURE
3

SOUTH LOT CIRCULATION - COMPLICATED PARKING SPACE 2

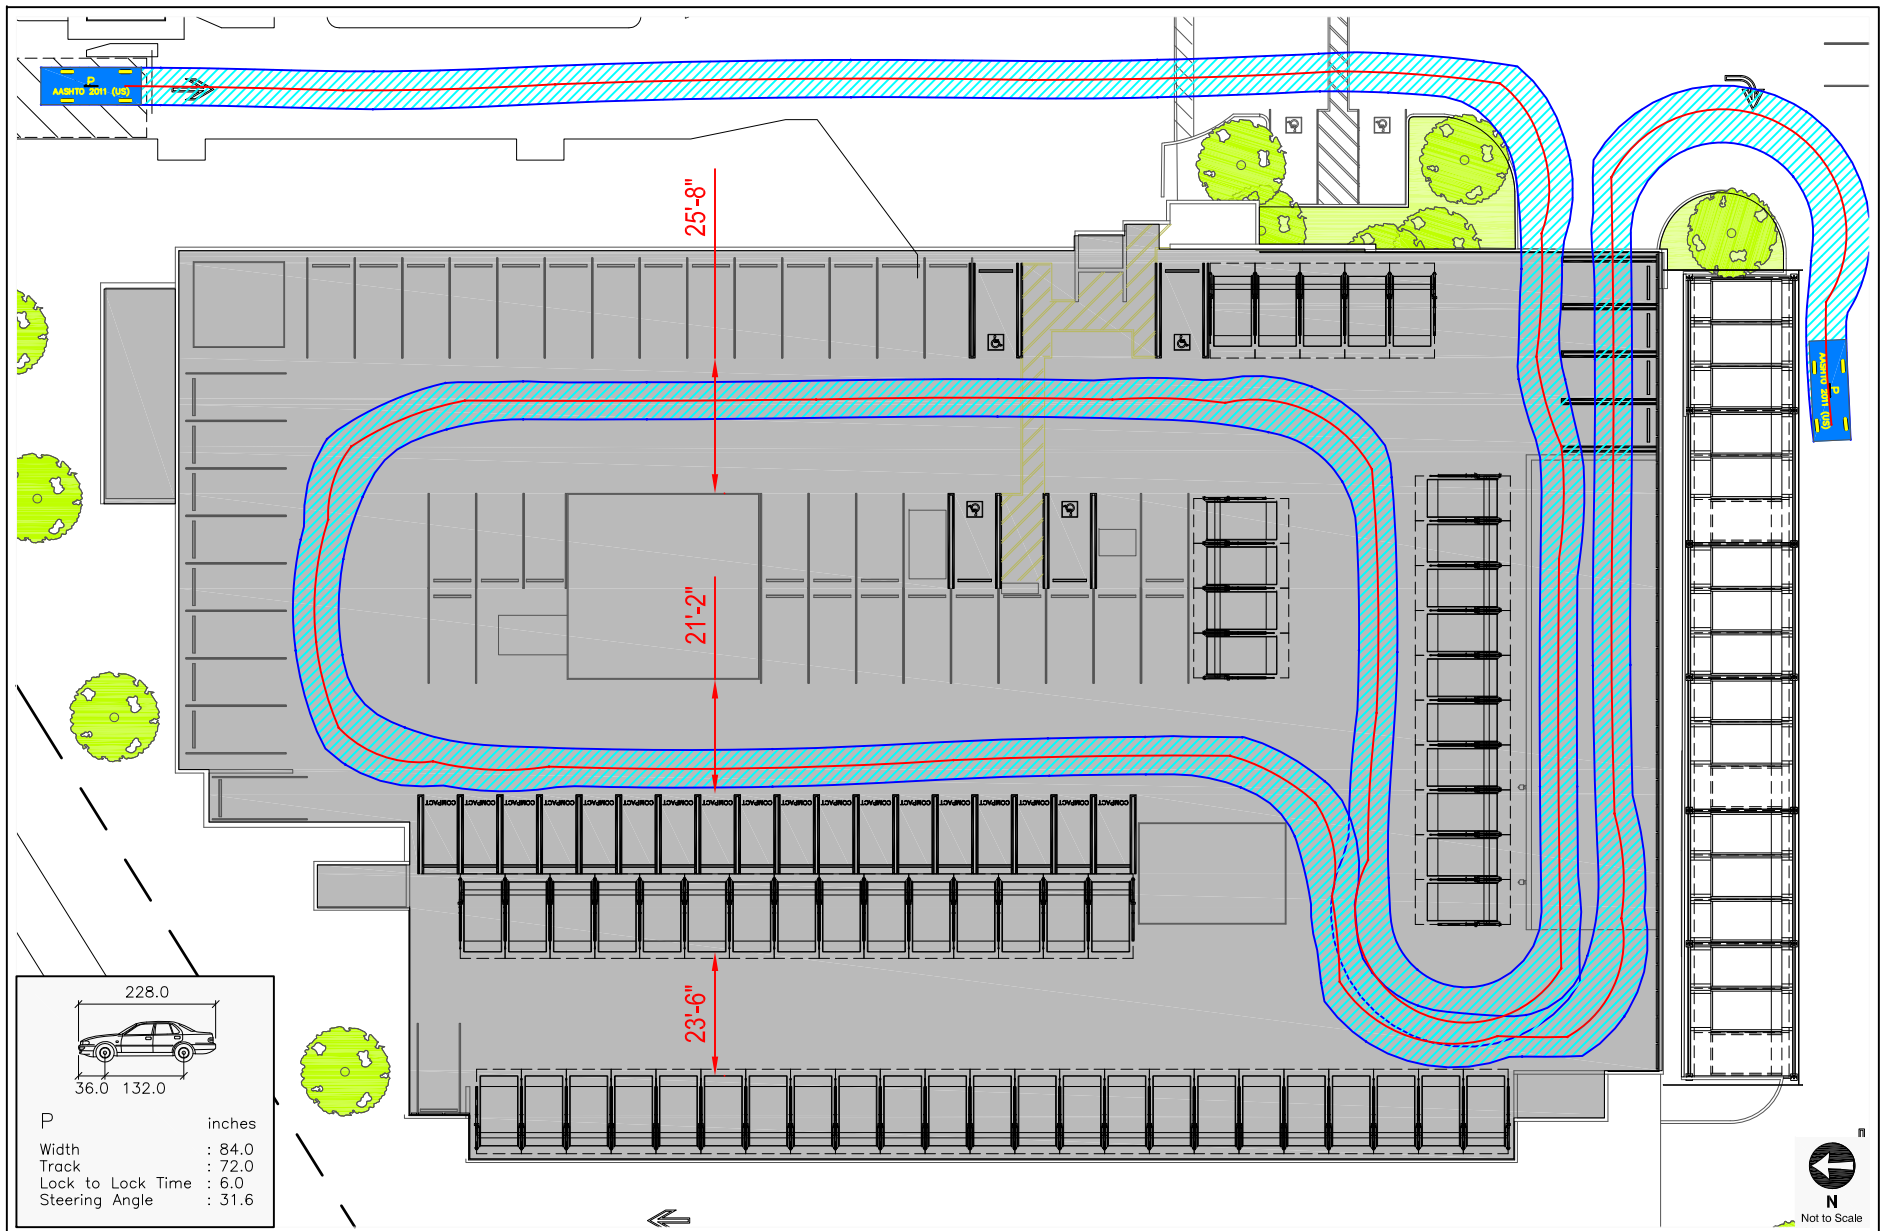
FIGURE
4

GARAGE ROOFTOP CIRCULATION

The garage rooftop section is generally navigable with wide aisles, as shown in Figure 4. During typical loading operations, the circulation is adequate. Figure 5 shows three locations where turnaround is difficult for large vehicles, but could be navigated by compact vehicles.

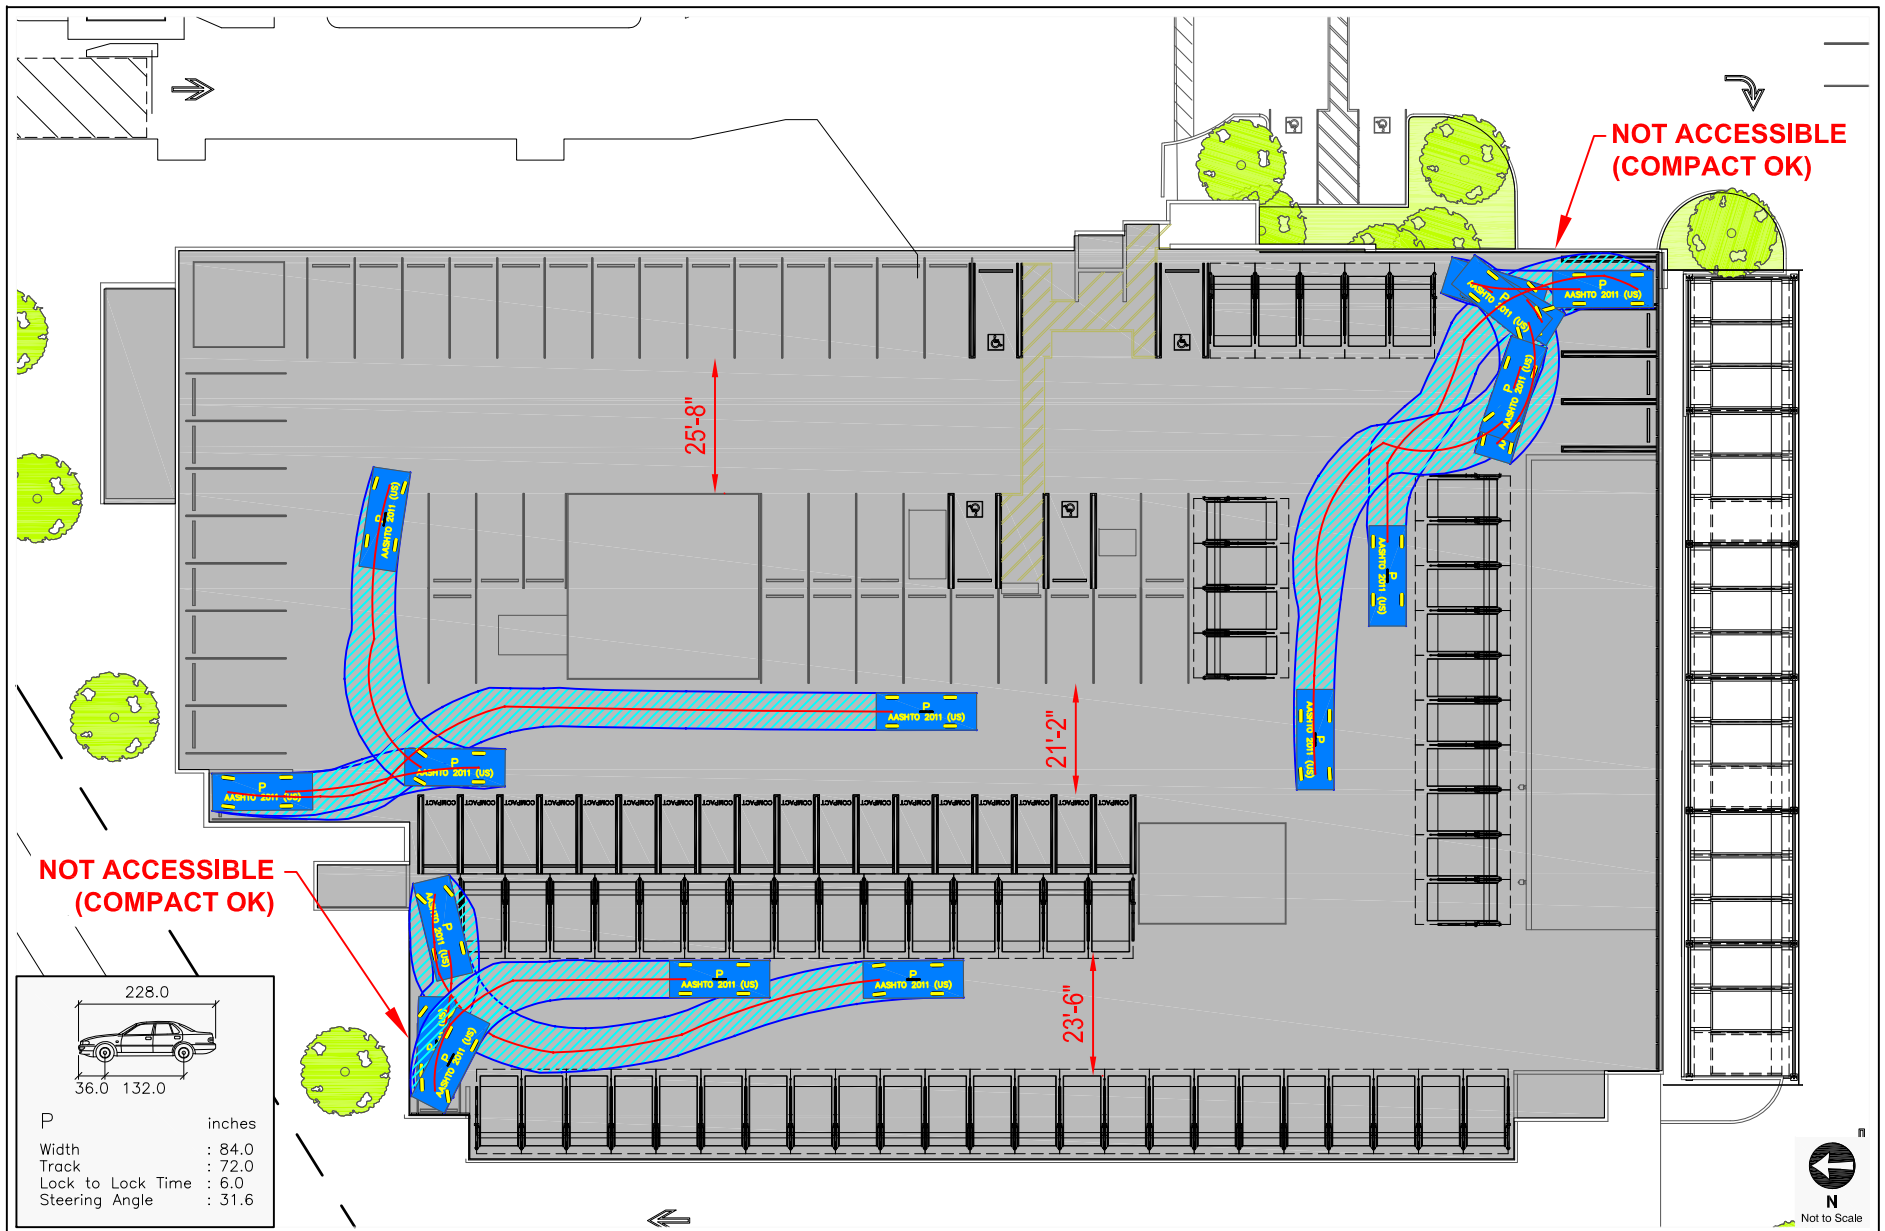
FIGURE
5

PARKING GARAGE
TIGHT OR POOR-ACCESS SPACES

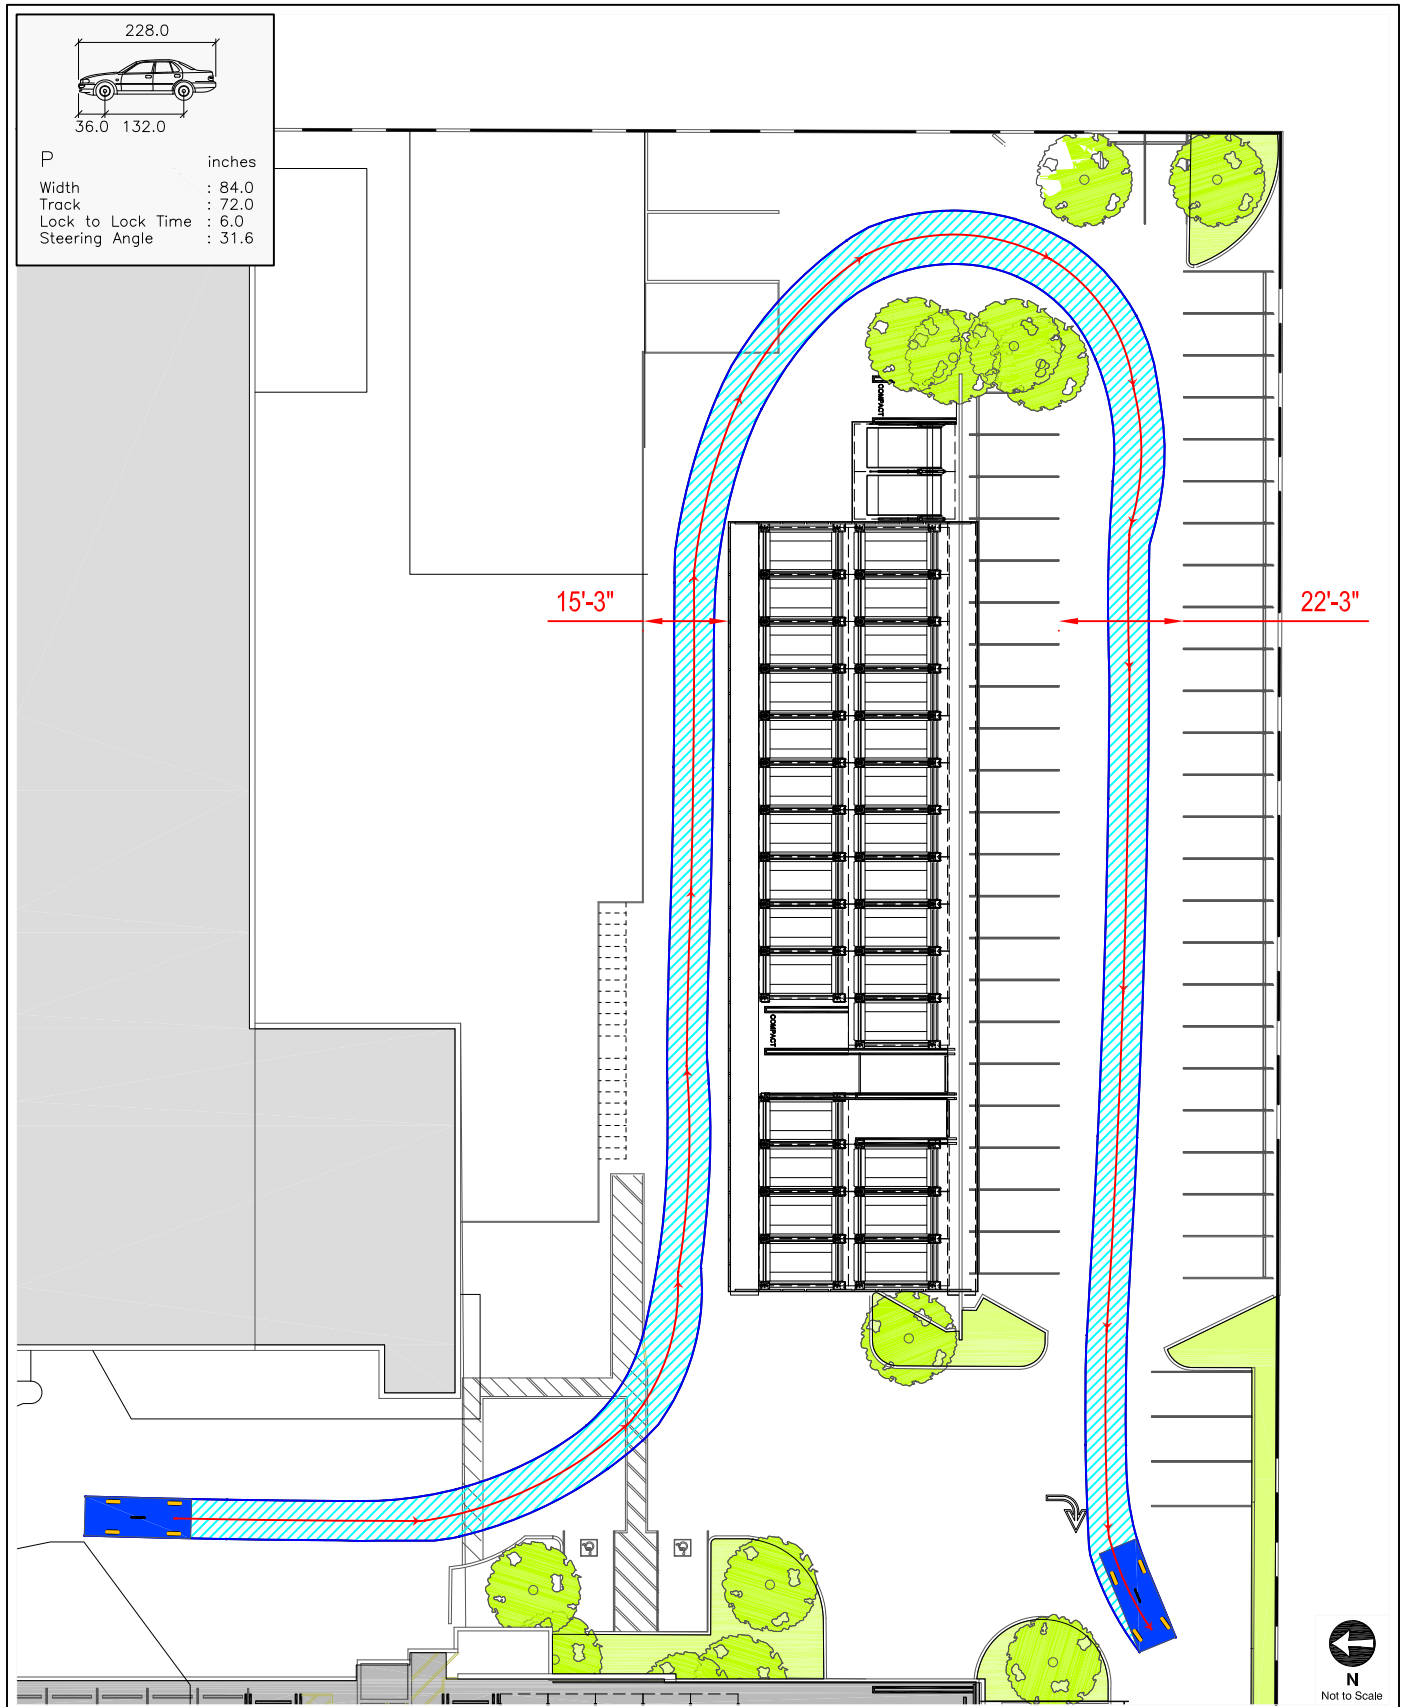
FIGURE
6

NORTH LOT CIRCULATION (STANDARD VEHICLE)

Figure 6 demonstrates that there are no significant circulation issues with the north lot for commuter vehicles.

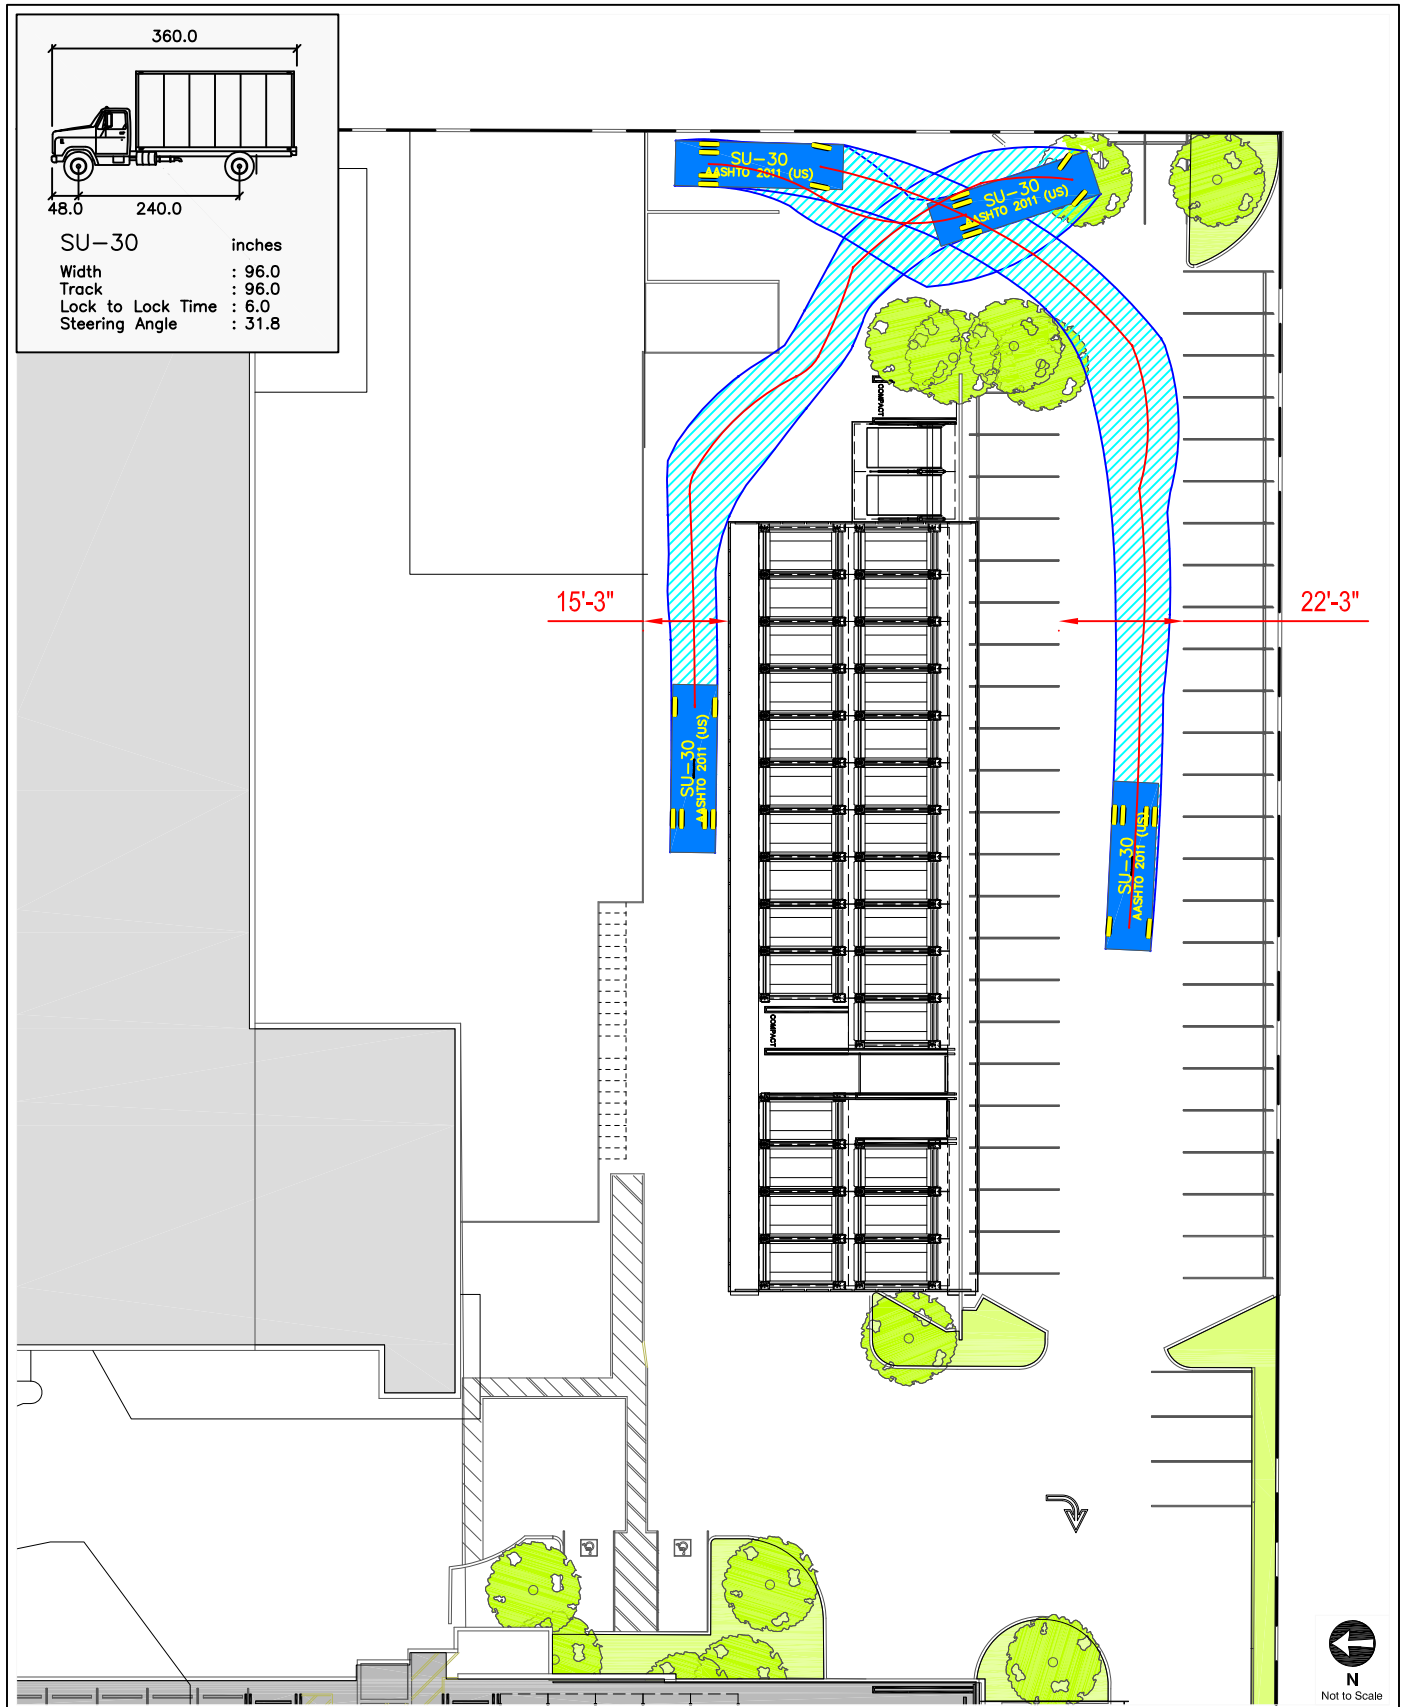
FIGURE
7A

NORTH LOT CIRCULATION (TRASH ENCLOSURE ACCESS)

Figure 7a shows the circulation for a 30-foot truck entering the location to "back-into" position and requires a clockwise approach. Figure 7b shows the circulation for a "head-into" position and requires a counter-clockwise approach. As shown, either approach can be accommodated for this vehicle depending upon the intended orientation; however the plan does depict a landscape tree which may cause obstruction if not trimmed to an appropriate clearance.

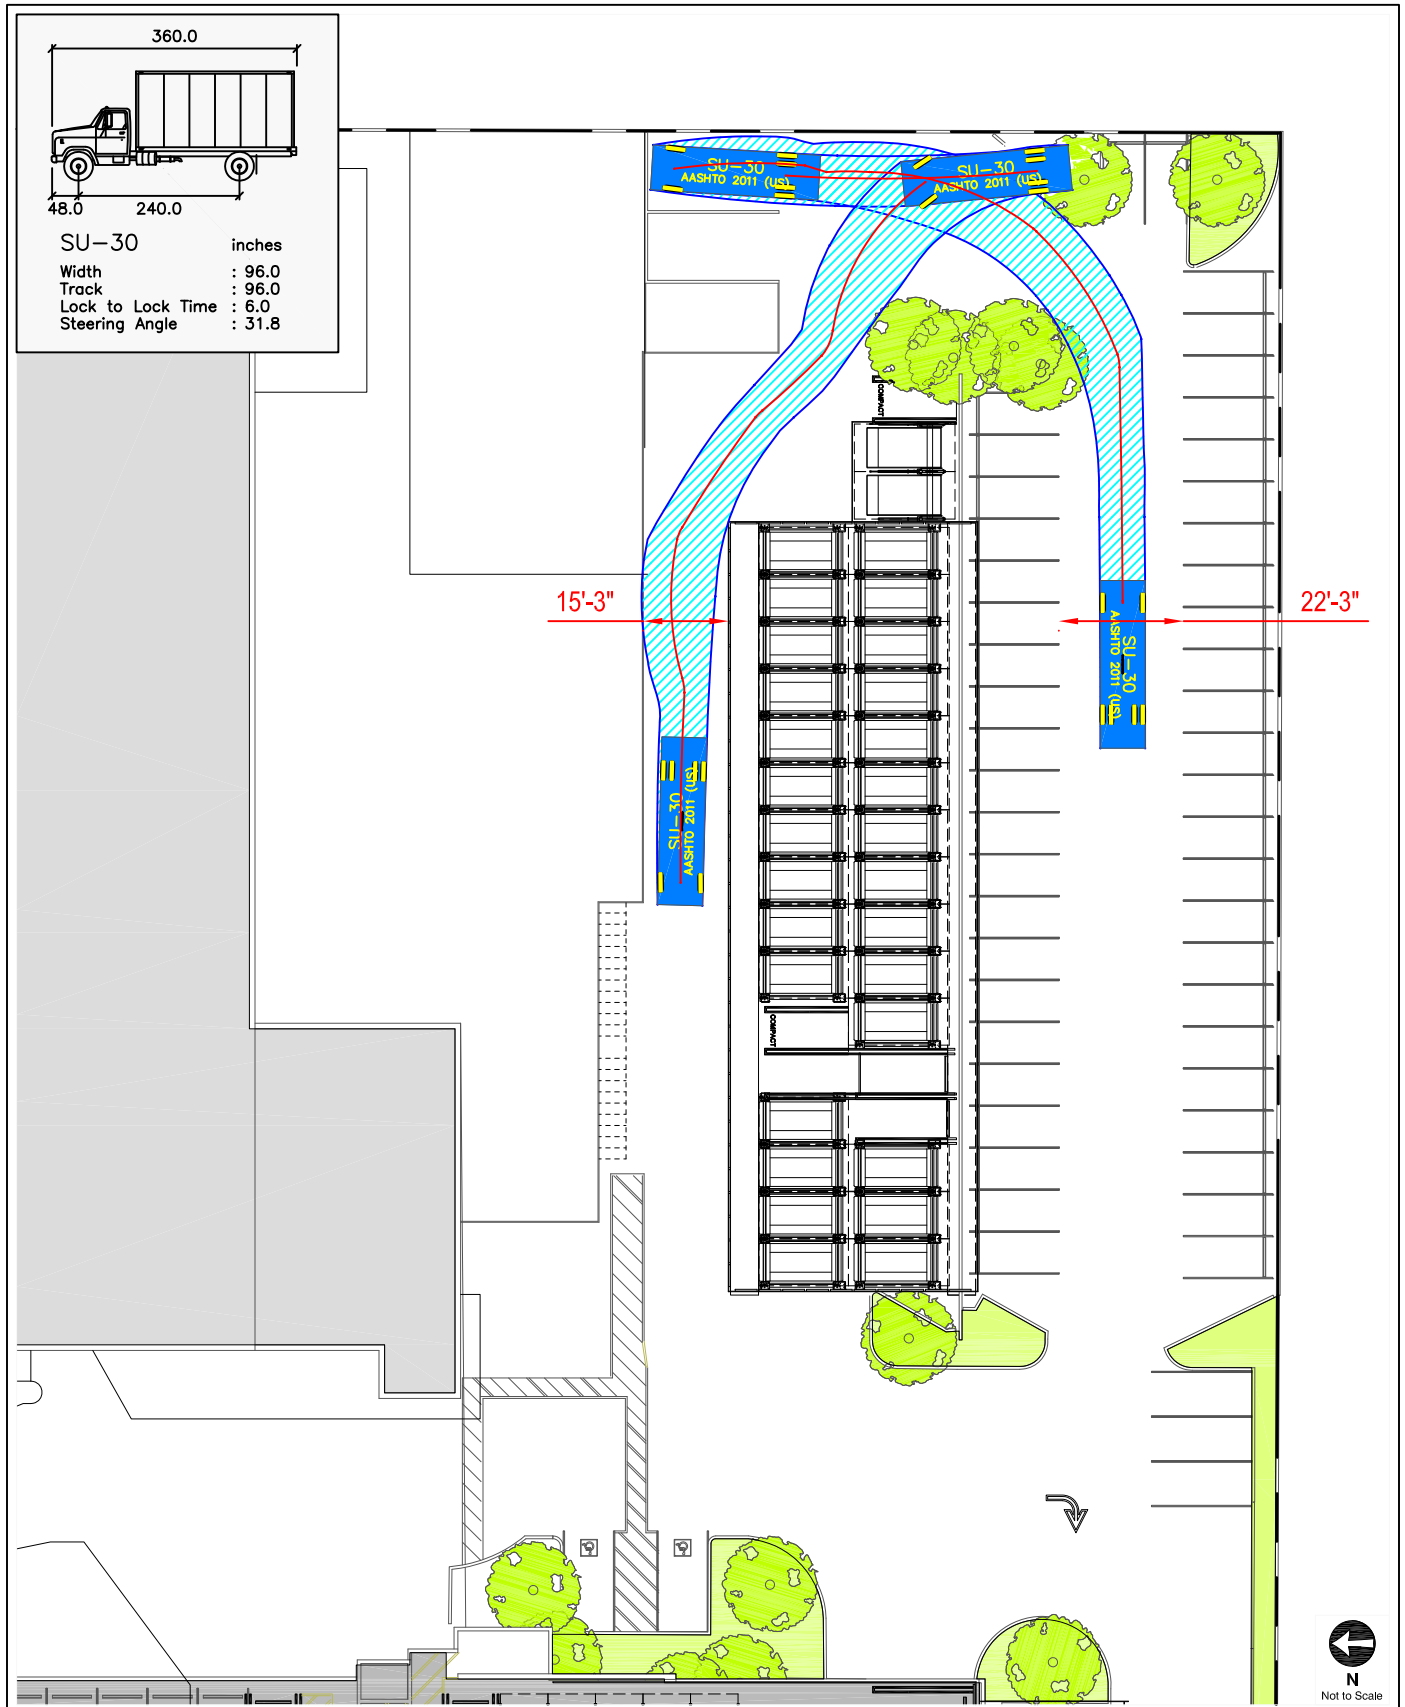
FIGURE
7B

NORTH LOT CIRCULATION (TRASH ENCLOSURE ACCESS)

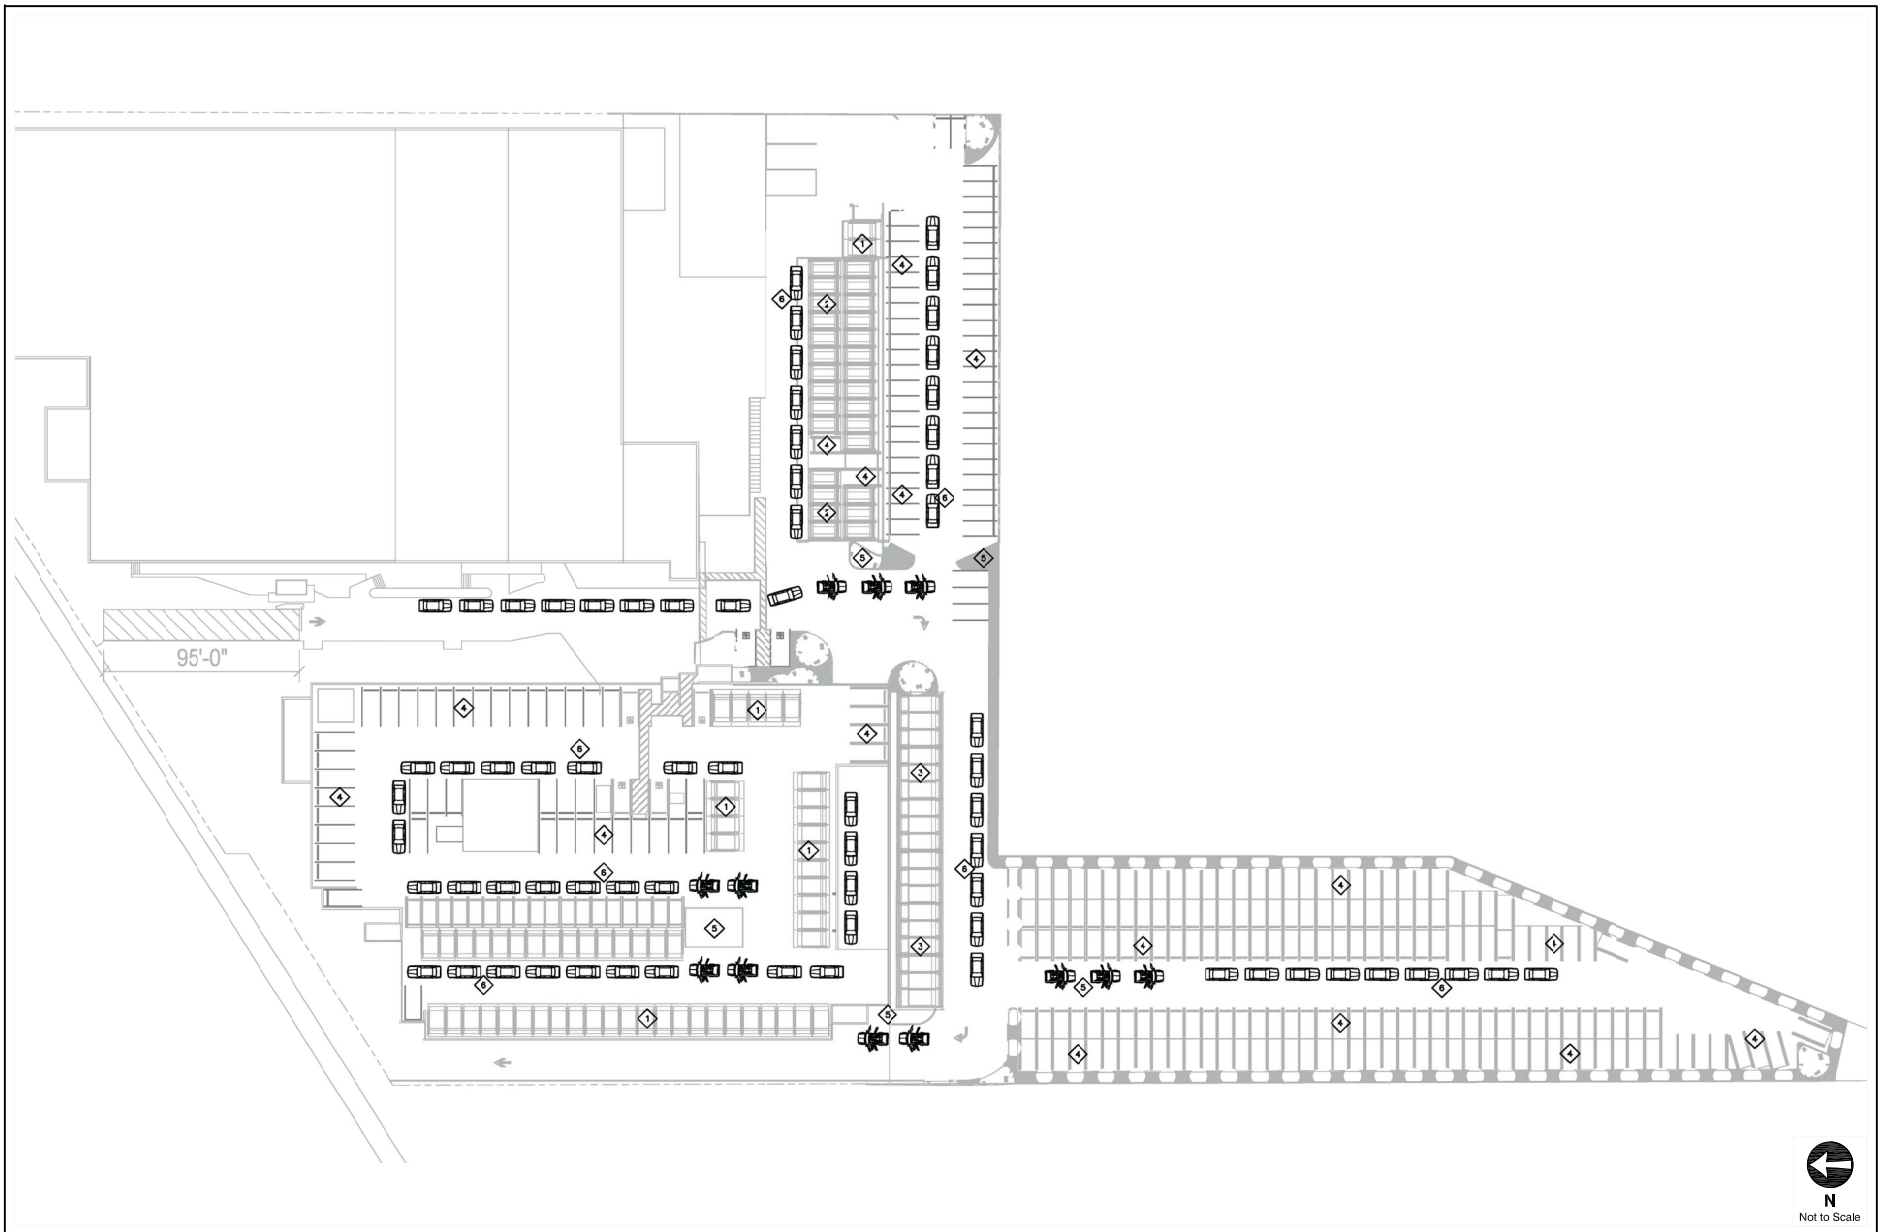
FIGURE
8

OPERATIONAL PLAN WITH VALET STACKING

Figure 8 illustrates the valet staging areas utilized during all operational hours (current and future), including the three shown and two internal to the garage. These stations will be managed throughout the day, not only during the peak hours. The internal valets can “float” to other areas when demand is greater elsewhere. As shown within all surface lots and the rooftop, stacked vehicles eliminate half of an aisle-width, which will reduce the circulation band. However, because this flow will be operated by professionals (not self-park), able to maintain emergency vehicle throughput at all times, no fatal flaws were identified in this operational portion of the design plan.

Based on the review of the operational valet staging (Figure 8), the amount of linear on-site storage is substantial without interfering with emergency access. Any delays created by equipment deficiency/failure or other loading/unloading issue, would not impact the amount of inbound queuing at the transaction gate (entry) since there is adequate room to hold vehicles on-site, and typically those vehicles will be far removed from the entry gate.
