MEMORANDUM

RE: Assessment of Circulation and Parking for
10950 Washington Boulevard Parking Improvement Project
Culver City, California

Ref: J1614

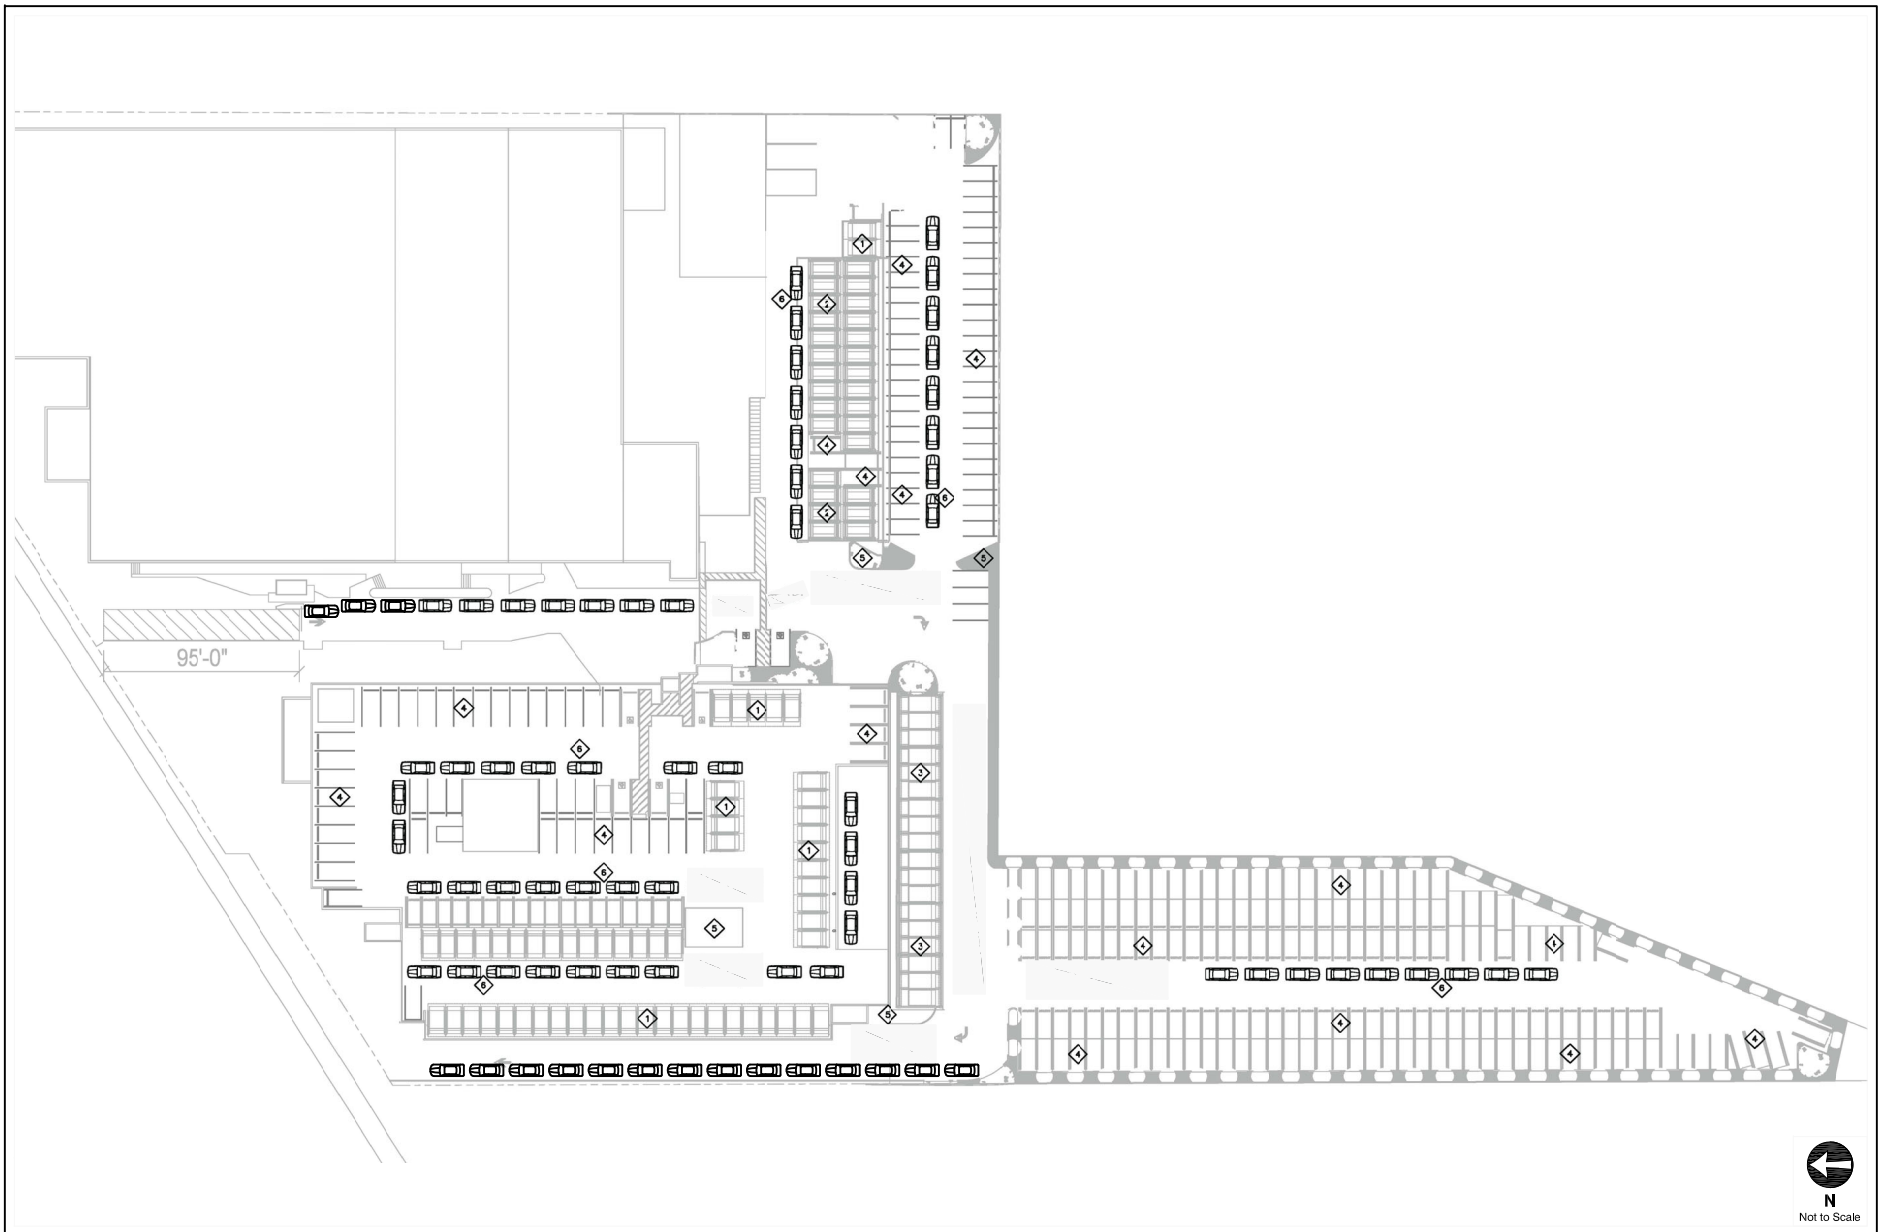
FIGURE
9

STACKING DURING POWER FAILURE

The plan identifies 369 surface parking spaces, with 88 ground-level stacker spaces, equating to 457 spaces that remain accessible during a catastrophic power outage. This does not include any non-emergency vehicle linear space throughout the site which is estimated to provide temporary parking for more than 70 vehicles (see Figure 9). This value, combined with the surface spaces, equates to space for harboring approximately 530 vehicles without interfering with emergency vehicle paths.

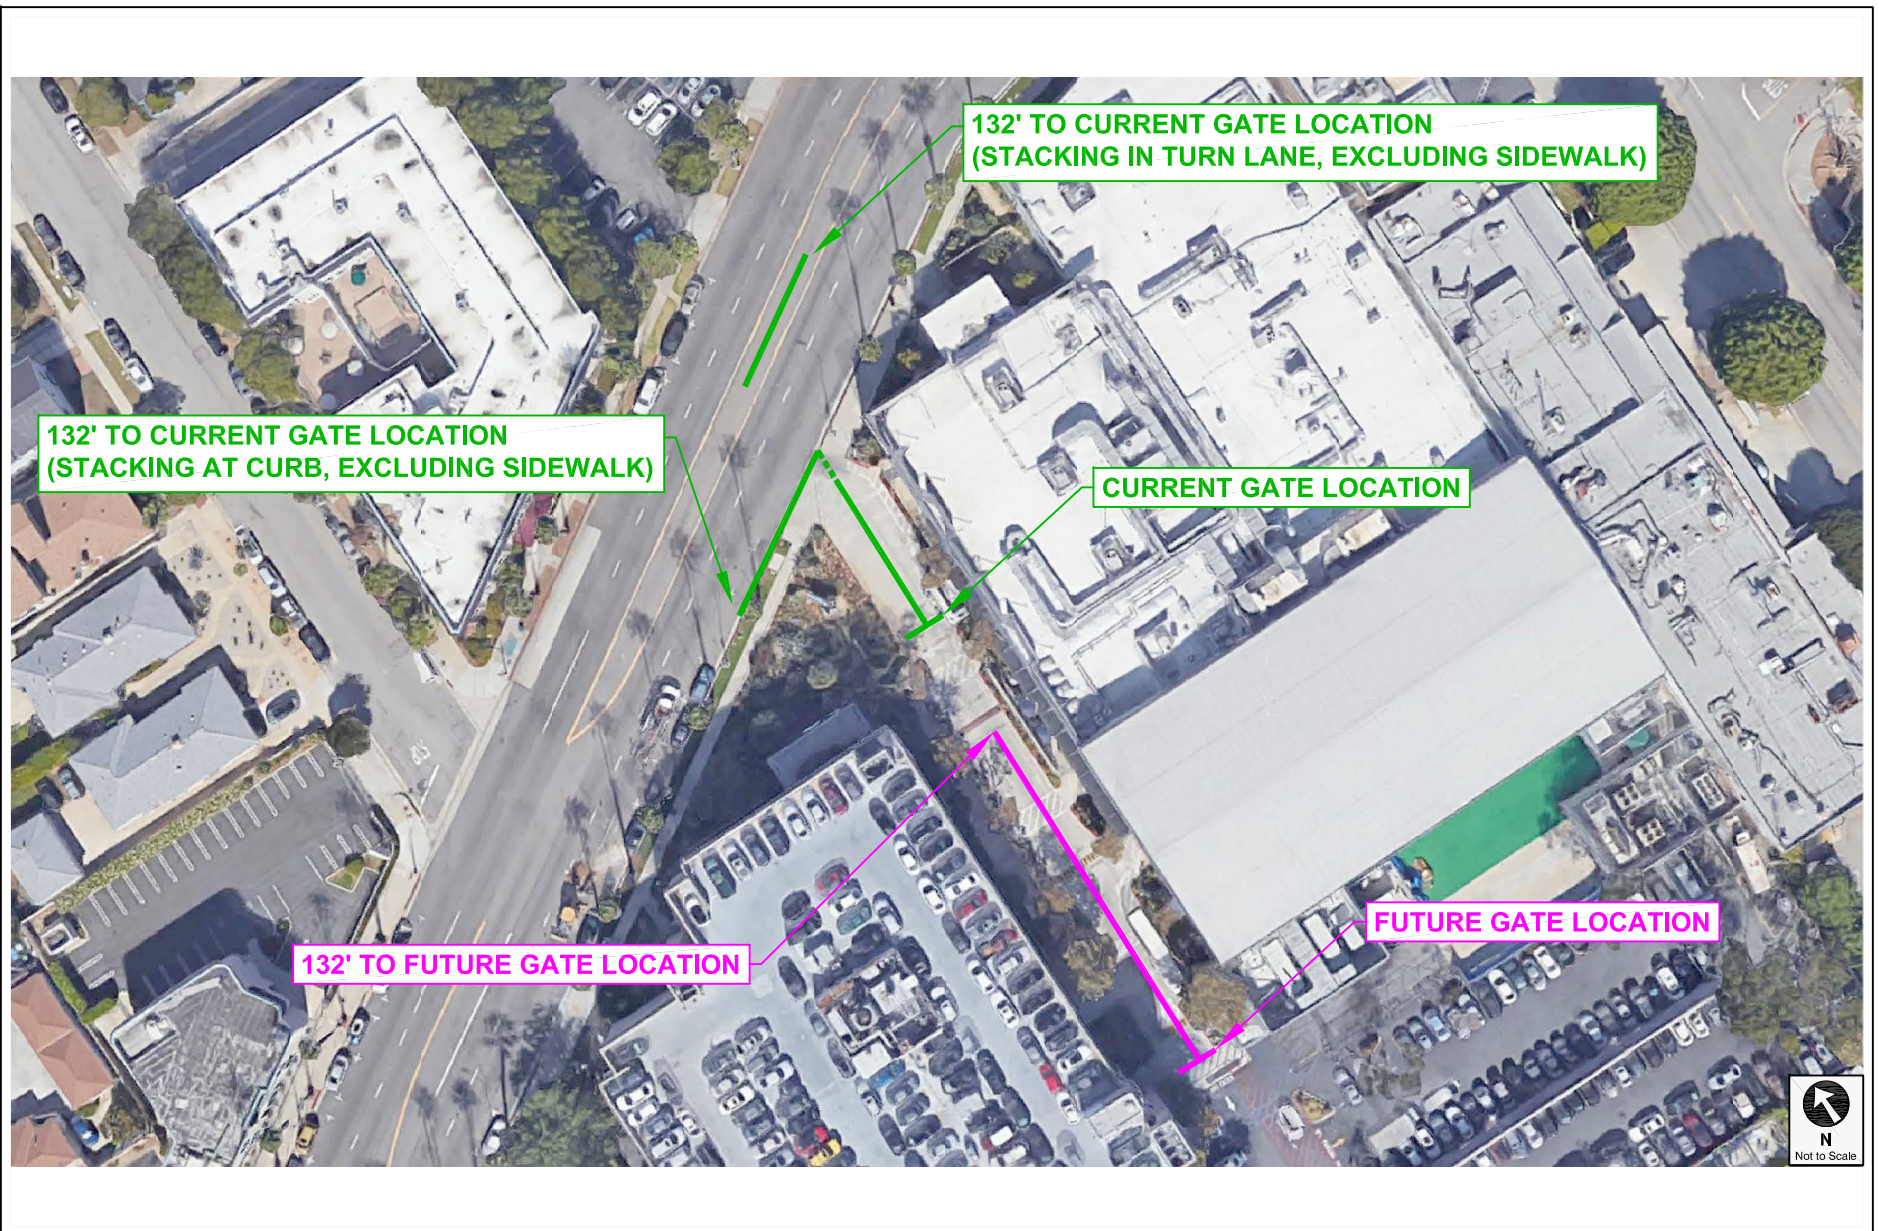
FIGURE
10

VEHICLE STACKING (NEAR VS. FAR GATE)

For a worst-case condition, assuming all vehicles are stacked in a single lane (employees only), the queue would extend to Washington Boulevard by approximately 50 feet (132 feet less 82 feet). This equates to approximately two vehicle lengths.

82 feet) is not in operation during the peak hours, instead utilizing the new transaction location at 280 feet. Operators of the facility have identified the need to maintain this near gate placement as a security measure to control entries outside of the peak hours. As such, the Project reserves the right to operate the near gate during off-peak hours to control entry during non-busy periods when stacking is not a concern, but security is paramount. Figure 10 shows the potential stacking at the near gate as well as the improved condition at the peak demand gate. As shown, the potential future stacking can be fully accommodated on site during peak inbound traffic conditions.
