**Re: Lenco Sole Source for the Lenco BearCat®**

U.S. ARMY ABERDEEN TEST CENTER  
ABERDEEN PROVING GROUND, MARYLAND 21005-5059  
TEST RECORD

ATEC Project No.: 2007-DT-ATC-AFSPT-D2979  
Test Type and Title: Armored Vehicle Roll-Over  
Test

Test Record No.: AD-V-25-07

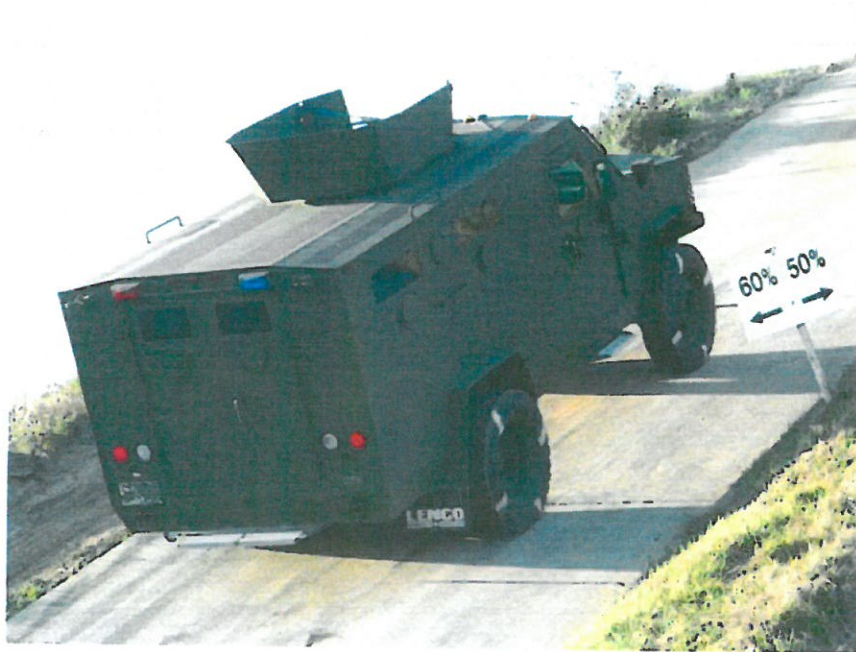
Figure 4. The BearCat ascending the 60-percent longitudinal grade.

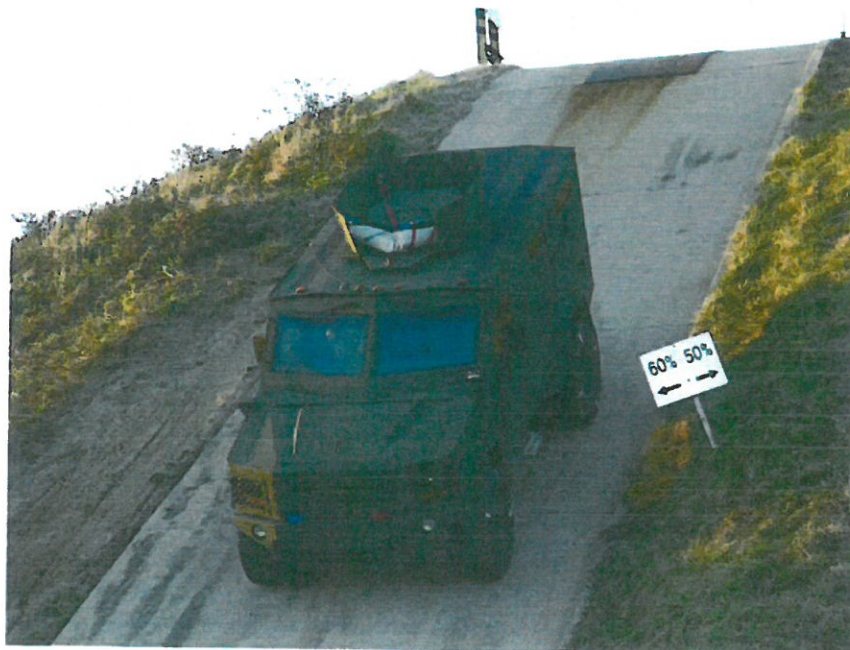
Figure 5. The BearCat descending the 60-percent longitudinal grade.

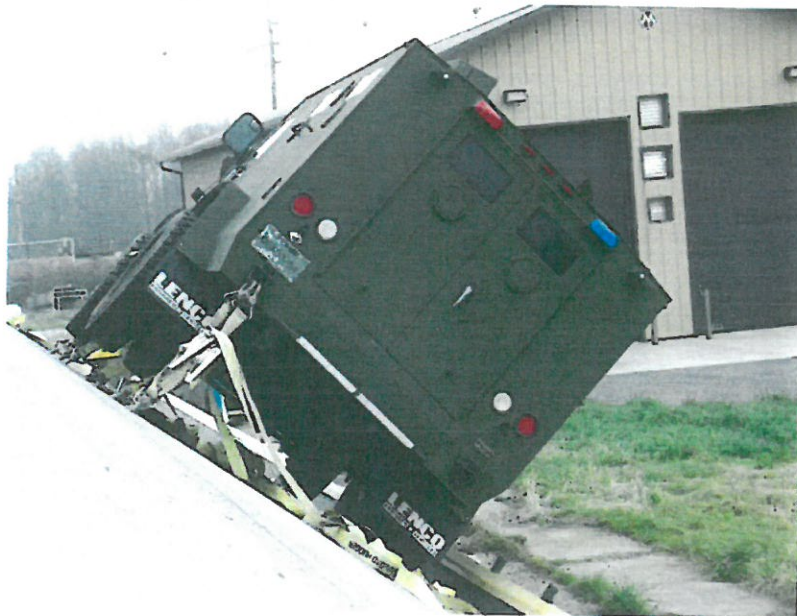
Figure 6. BearCat on the Tilt Table at rollover threshold.

g. Tilt Table. The static rollover threshold of the BearCat at GCW was measured using the ATC Tilt Table. Maximum side slope angle (accuracy  $\pm 0.2$  degree of reading) and simulated lateral acceleration (accuracy  $\pm 0.01$  degree of reading) were determined with both the left and right side of the vehicle positioned upslope. Static rollover results are presented in Table 7. A photograph of the BearCat on the Tilt Table is shown in Figure 6.

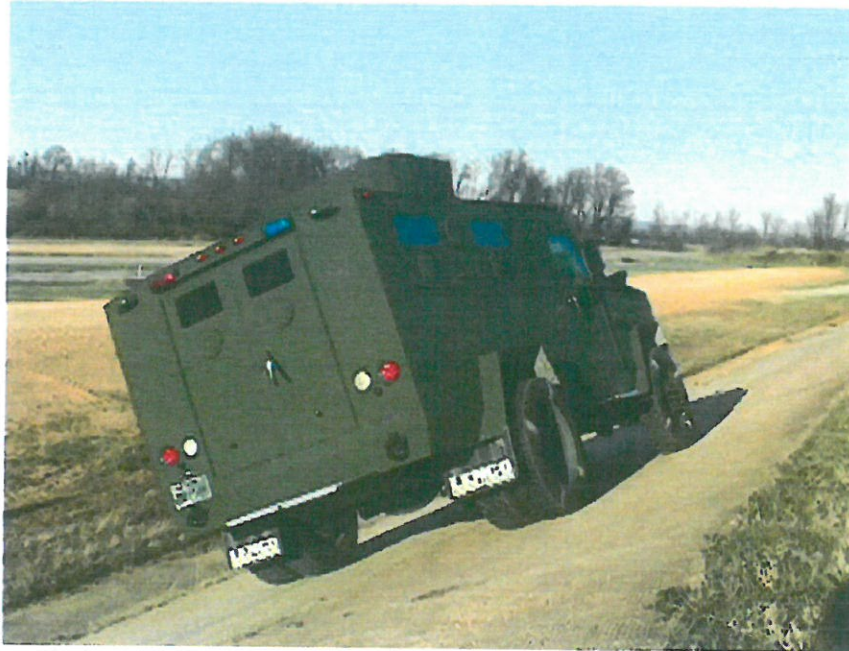
Figure 7. The BearCat negotiating the 40-percent side slope.

h. Side Slope Operation. The ability of the BearCat to traverse the 20 percent, 30 percent and 40 percent side slope was tested at MTA. The BearCat successfully negotiated the 20 percent, 30 percent and 40 percent side slopes with each side upslope while performing a sinusoidal steering pattern the length of the course at a speed of approximately 8 kilometers per hour (kph) (5 miles per hour (mph)). A photograph of the BearCat traversing the 40 percent side slope is presented in Figure 7.
