CONDITION ASSESSMENT REPORT

## IVY SUBSTATION

9070 Venice Boulevard, Culver City, California

December 21, 2017

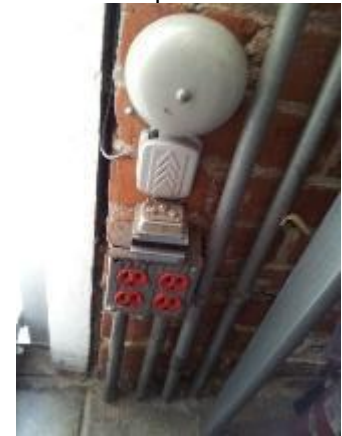
E-6: Fire alarm sprinkler bell and receptacle outlet

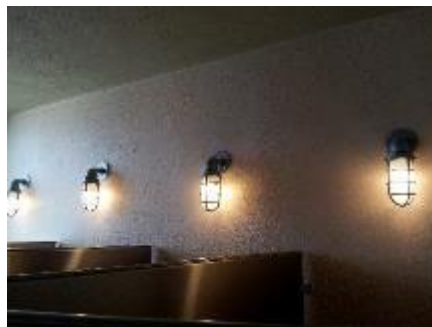
E-7: Vapor tight wall sconces found in both men's and women's restroom

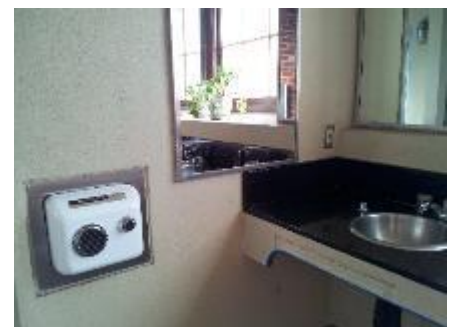
E-8: Hand dryer and GFCI in men's restroom

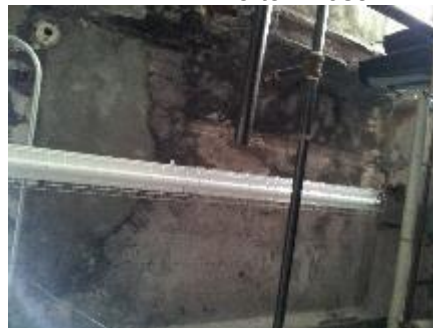
E-13: Fluorescent strip light wire guard in utility room

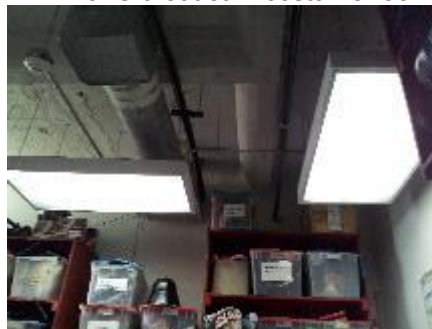
E-18: Troffer lights in costume room

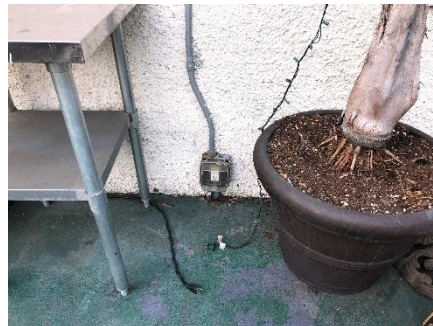
E-34: Exterior GFI Outlet

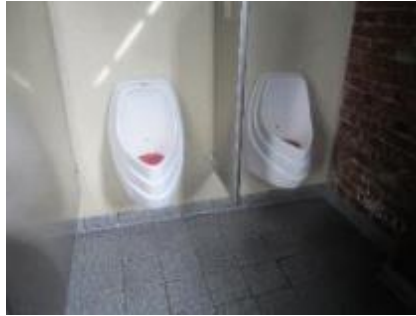
- Urinals are waterless-type and in good condition. One urinal is not installed at ADA compliant height. (See P-1)
- Lavatories in both Men's and Women's restrooms are counter-top mounted, stainless-steel bowl. The bowls are in good condition. Two (2) faucets are not ADA compliant. Lavatory p-trap insulation are old and require replacement. Angle valves are old.

P-1: One urinal shall be ADA accessible

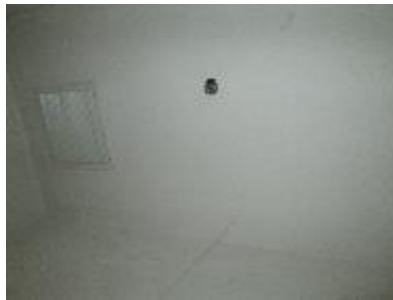
- Most recessed sprinkler heads are missing the escutcheons. (See P-3)

P-3: Existing recessed sprinkler head with no escutcheon

- a. Replace missing escutcheons for sprinkler heads.

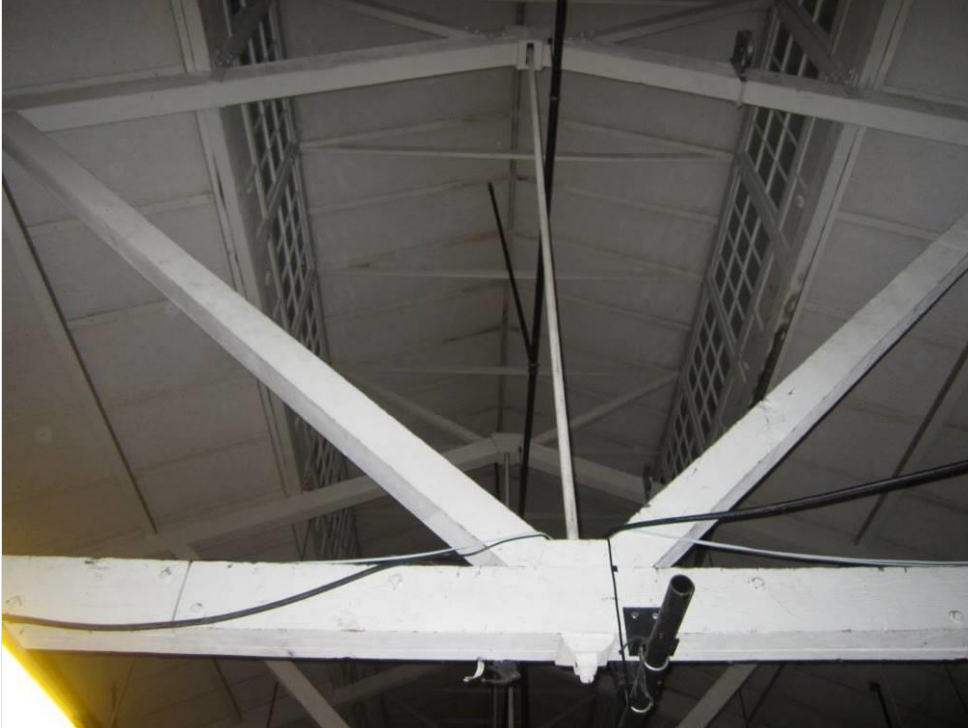
28. Split in wood truss member (Photo 28).
29. Underside of concrete mezzanine slab located at the south end of the building. Note significant water staining and missing concrete at the bottom of the steel I-beams (Photo 29).

Photo 28 – Split in wood truss member.
